AAIB Bulletin No: 11/95 **Ref: EW/G95/08/15** **Category: 1.3**

Aircraft Type and Registration: Piper PA-32R-300 Cherokee Lance G-GOMM

Date & Time (UTC): 15 August 1995 at 1110 hrs

Location: Eyehurst Farm, Kingswood, Surrey

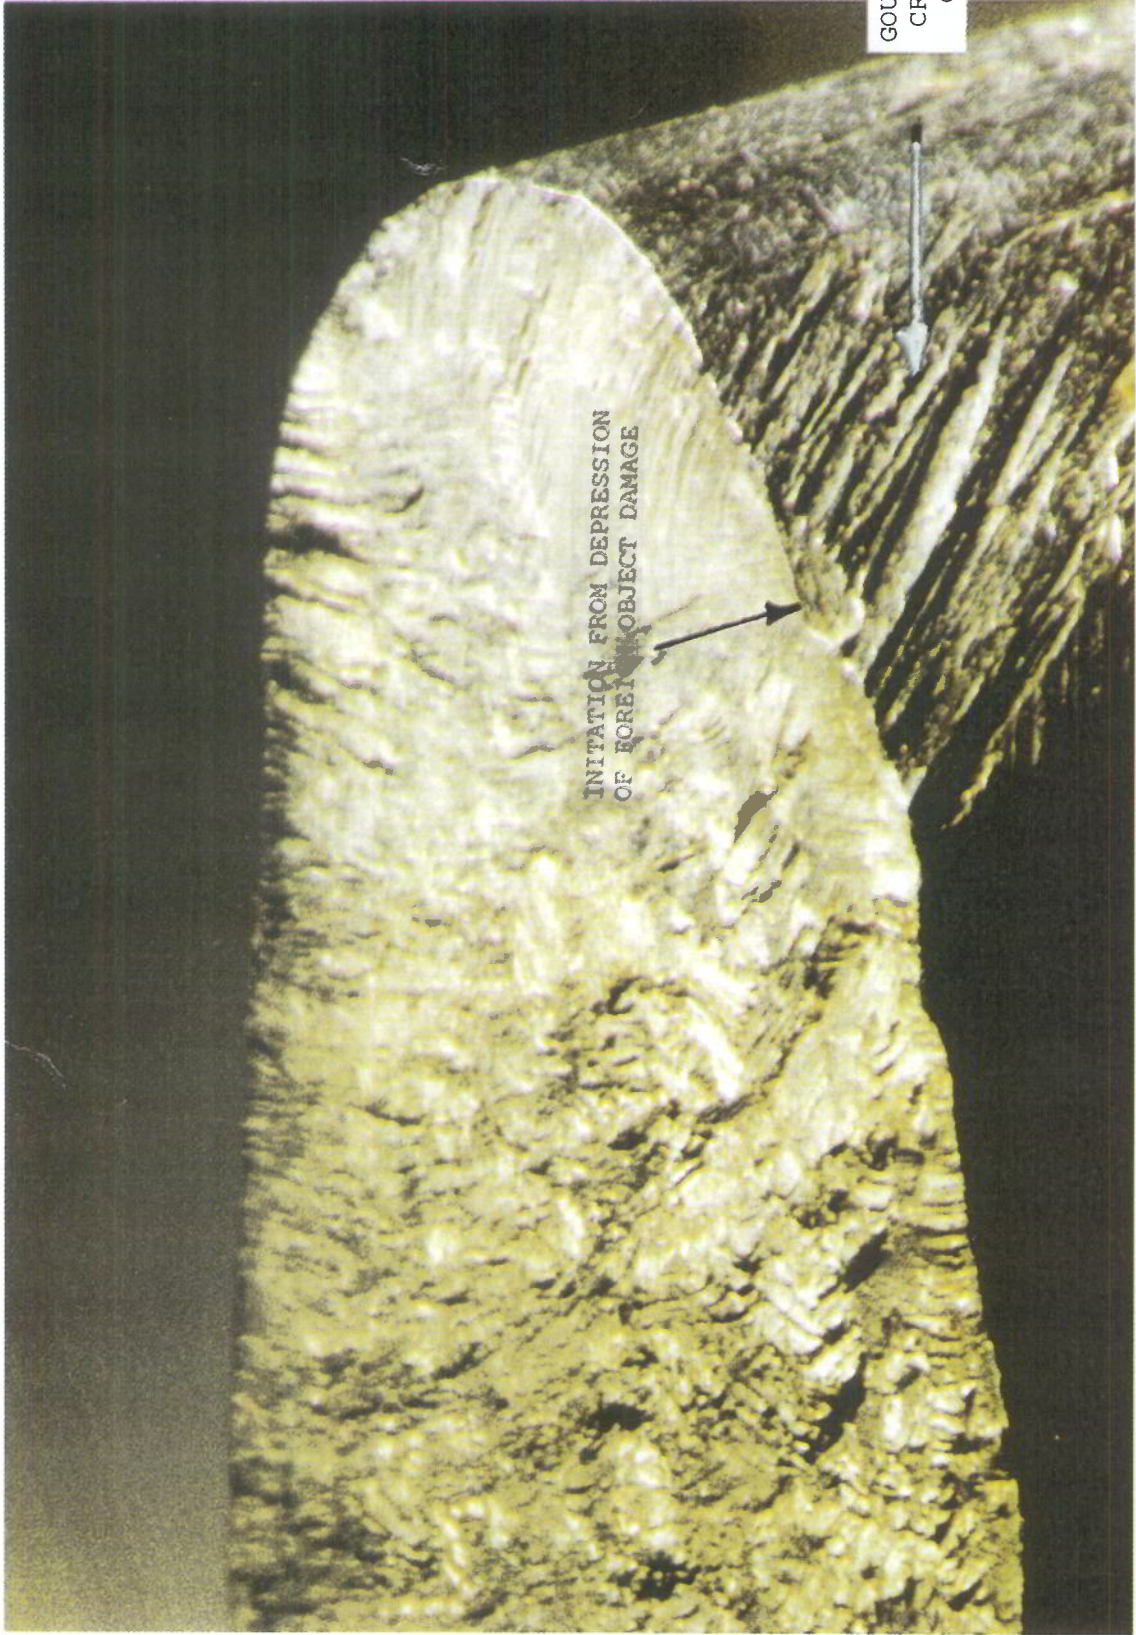
Subsequent metallurgical examination of the propeller blade showed that it had failed as a result of fatigue and that the initiation was at a sharp-edged pit immediately adjacent to the blade's leading edge. The pit in the leading edge had been caused by a foreign object striking the blade whilst it was under power. There were witness marks on the blade leading edge which indicated that an unsuccessful attempt had been made to dress out the associated foreign object damage (Photograph No. 1). Microscopic examination of the failure indicated that the fatigue cracking had initiated from micro-cracking in the pit surface. The micro-cracking had occurred at the time that the foreign object

damage took place and the fatigue progression from the micro cracking was almost immediate. The fracture face showed that the initial progression occurred as a result of a series of 'events', each of which contained many load cycles. It was considered that the events were flights. The start of each event was identifiable by an increased rate of damage which, it was considered, had occurred during the 'ground-to-air' part of each flight. It was estimated that the progression up to the rapid failure was over a period of approximately 50 flights. During the examination it was noted that the leading edge paint had been abraded, rather than eroded, from the outer 12 inches of the blades.

PHOTOGRAPH No. 1 Three quarter view on initiation region showing depression from hard particle and associated gouged region where dressing out had been attempted.
