ACCIDENT

Aircraft Type and Registration:	Piper PA-15, G-ALGA	
No & Type of Engines:	1 Lycoming O-145-B2 piston engine	
Year of Manufacture:	1949	
Date & Time (UTC):	22 July 2006 at 1345 hrs	
Location:	Marshland, Suffolk, (Farm Strip, East of Fenland)	
Type of Flight:	Training	
Persons on Board:	Crew - 1	Passengers - None
Injuries:	Crew - None	Passengers - N/A
Nature of Damage:	Damage to left landing gear and propeller	
Commander's Licence:	Private Pilot's Licence	
Commander's Age:	69 years	
Commander's Flying Experience:	760 hours (of which 30 were on type) Last 90 days - 12 hours Last 28 days - 10 hours	
Information Source	Aircraft Accident Report Form submitted by the pilot

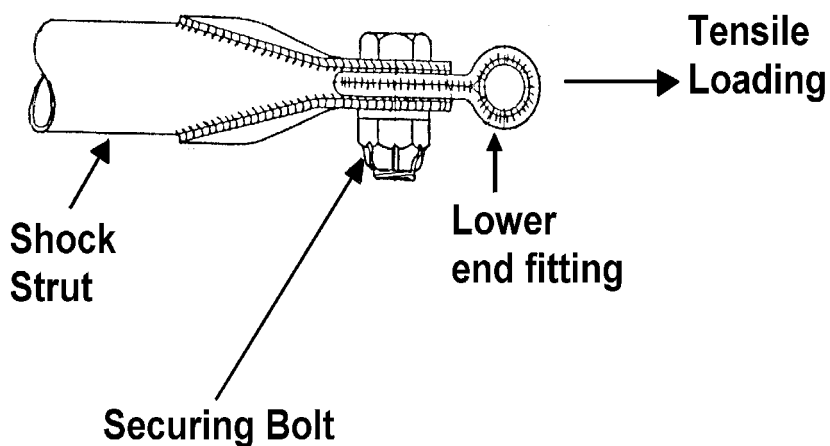
Figure 1

Following a normal landing, with a slight crosswind from the left, the left main landing gear failed at the shock strut end fitting. The aircraft came to a stop resting on the right main landing gear, the tail wheel and the left wing tip. Engineering investigation revealed that the incident was the result of progressive deformation of the end fitting bolt hole, which resulted in it failing in tensile overload.

Examination of the aircraft revealed that the collapse of the left landing gear was caused by the shock strut lower end fitting 'pulling' from the strut. The lower end

fitting, see Figure 1, fits into the strut and is secured by a bolt. While the aircraft is on the ground the fitting is under a tensile load. The hole for the securing bolt had become elongated in the direction of the load before failing in overload. A review of the aircraft log book failed to identify when this component was fitted, but its general condition indicated that it had been installed for a considerable time. The damage to the bolt hole could not have been seen with the fitting attached to the strut and there is no requirement to remove the fitting from the shock strut for inspection.
