**Aircraft type and registration:** Jodel D112 G-BHIM

**Date and time (UTC):** 10 May 1987 at 1915 hrs

**Location:** Near Trefgraig, Gwynedd, North Wales

**Information Source:** AIB Field Investigation

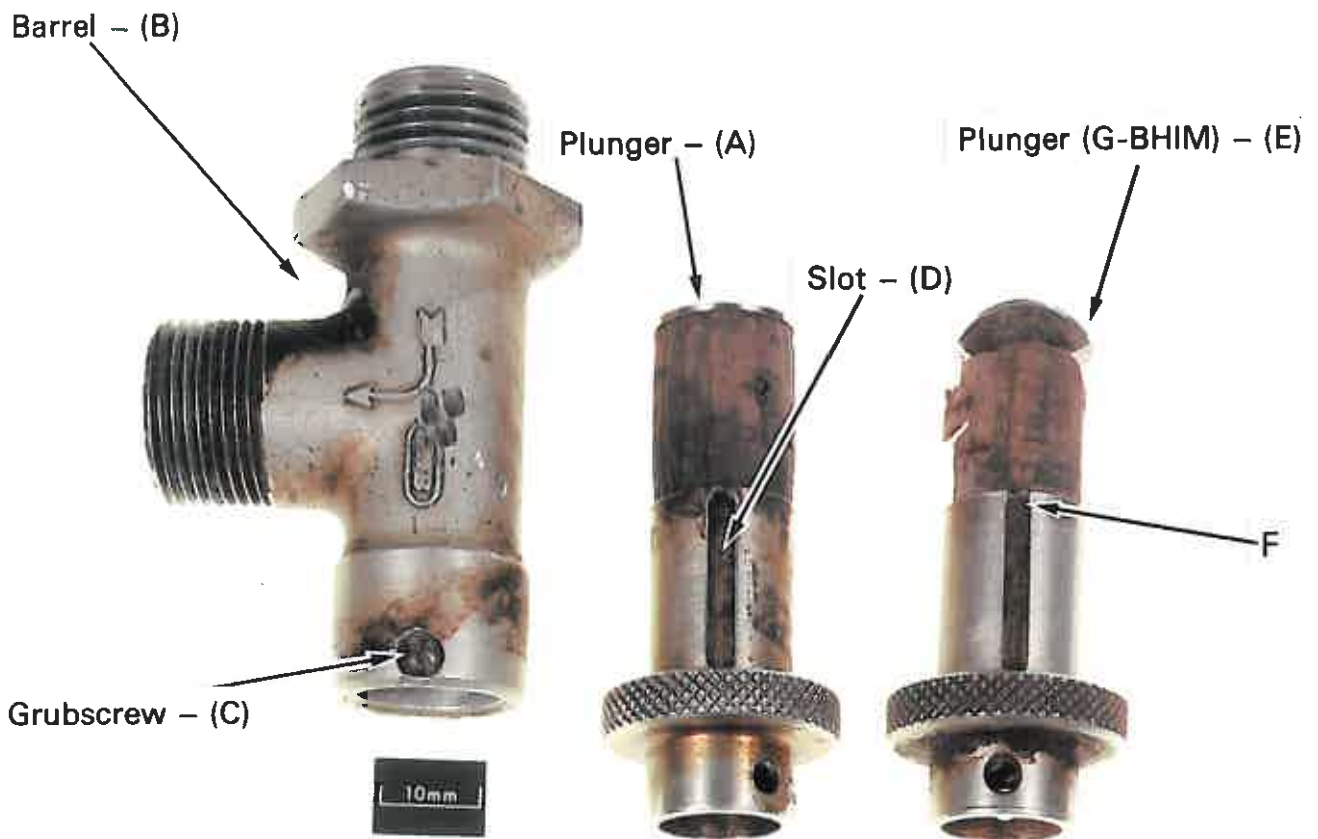
Figure 1 – Fuel Cock (G-BHIM)

The second anomaly concerned the fuel cock (figure 1), originally manufactured by Le Bozec in France, which is located immediately under the fuel tank and is operated by reaching forward under the instrument panel. The operation is that the plunger (A) is moved downwards, within the Barrel (B), to allow fuel to flow to the carburettor: the travel of the plunger is restricted only by a grubscrew (C) located within a slot (D) on the plunger. On G-BHIM, however, the plunger (E) was found separated from its barrel and it was apparent that the top of the slot (F) had been worn away, allowing the plunger to extend further, and the grubscrew to wear a groove along the cork plug. It could not be demonstrated conclusively that the plunger had been displaced from the barrel in flight, rather than in the impact, but the physical evidence suggests that even a light disturbance would have been sufficient to provoke a leakage of fuel.
