AAIB Bulletin No: 2/94

Ref: EW/C93/9/4

Aircraft Type and Registration: AS350B1 Ecureuil, G-PLME

Nature of Damage: Aircraft destroyed, structure partially collapsed vertically on impact with ground

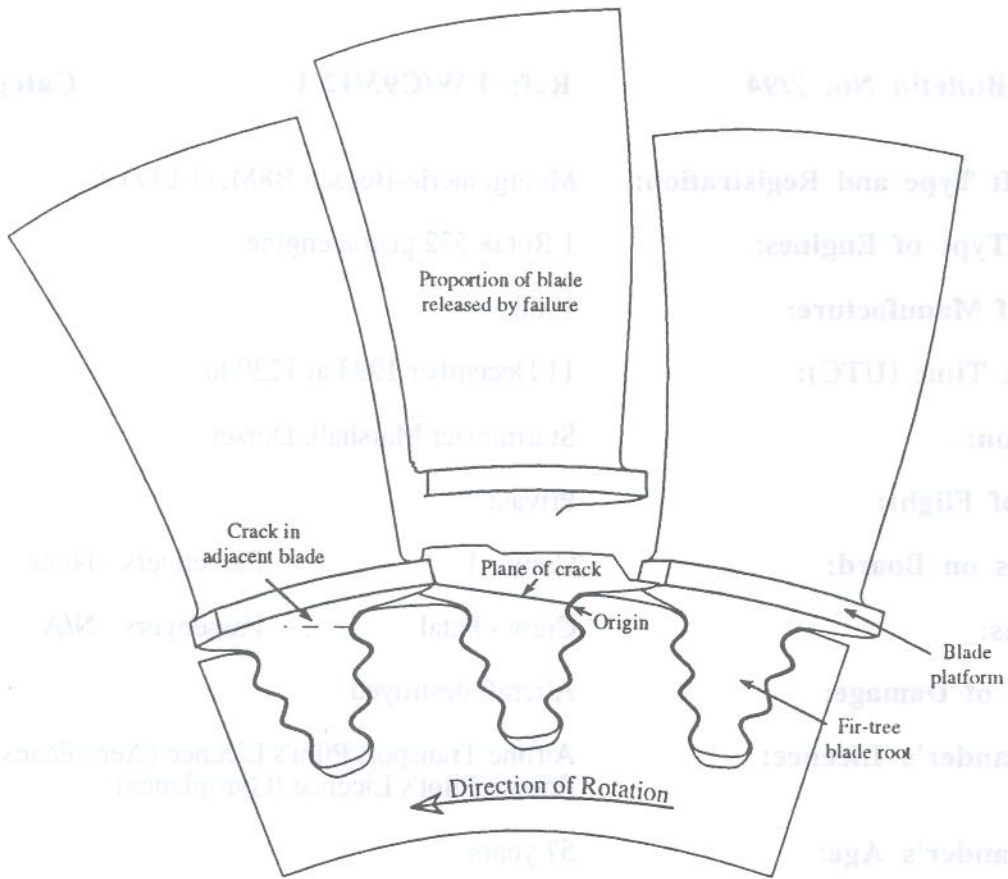
Examination of the fracture of the blade showed that it had failed initially by fatigue from an origin in the trailing edge side of the aft face of the fir-tree root, at the first serration below the platform (see Figs 1 & 2). The failure had progressed by a fatigue mechanism forwards and upwards from this point until it had penetrated the platform, after which the final separation of the blade had occurred by fast rupture through the remainder of the blade section. Examination of the other blades in this turbine assembly showed that a further 7, of the total of 27 blades, had started to crack at the same location on the fir-tree root and an 8th had a crack starting on the 3rd fir-tree root serration. It was also noted during this examination that the injection wheel was cracked. These cracks were not associated with any material defects or deficiencies and the interpretation placed on these findings by the manufacturer was that the engine had experienced a very large number of operating cycles since overhaul and that the turbine blade set had exceeded its safely useable life.

Fig. 1
View on aft side of a segment of Turbine wheel showing fir-tree root

93-60 The CAA, in collaboration with DGAC of France, should review the basis on which Turbomeca has established the current service life of the 2nd Stage Turbine blades of the Arriel 1 engine and consider the need to monitor the consumption of that life by electronic means.
(Issued 21 January 1994)

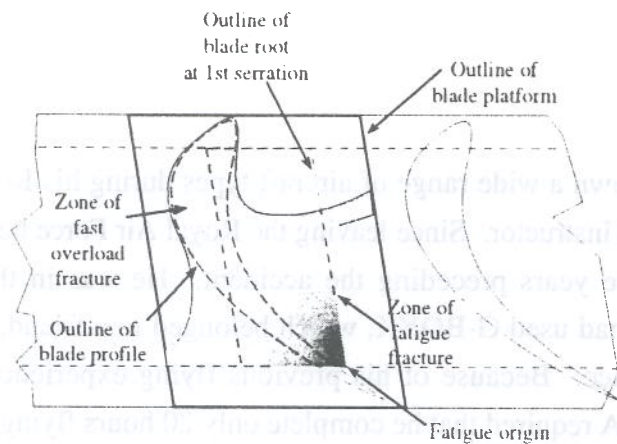
Fig. 2
View looking radially towards the centre of the Turbine wheel showing progression of fatigue from the fir-tree root.
