**SERIOUS INCIDENT**

<b>Aircraft Type and Registration:</b>	Socata TBM 850, N850TV	
<b>No &amp; Type of Engines:</b>	1 P&W Canada PT6A-66 SER turboprop engine	
<b>Year of Manufacture:</b>	2009	
<b>Date &amp; Time (UTC):</b>	12 January 2011 at 1535 hrs	
<b>Location:</b>	Birmingham Airport	
<b>Type of Flight:</b>	Private	
<b>Persons on Board:</b>	Crew - 1	Passengers - 3
<b>Injuries:</b>	Crew - None	Passengers - None
<b>Nature of Damage:</b>	None	
<b>Commander's Licence:</b>	FAA Private Pilot's Licence	
<b>Commander's Age:</b>	51 years	
<b>Commander's Flying Experience:</b>	1,100 hours (of which 180 were on type) Last 90 days - 30 hours Last 28 days - 12 hours	
<b>Information Source:</b>	AAIB Field Investigation

**Synopsis**

Following a loss of communications on approach due to a frequency mis-selection by the pilot, the TBM 850 passed over the top of an aircraft holding on the Birmingham Airport Runway 15 starter extension and landed. No injuries or damage occurred. Four Safety Recommendations are made.

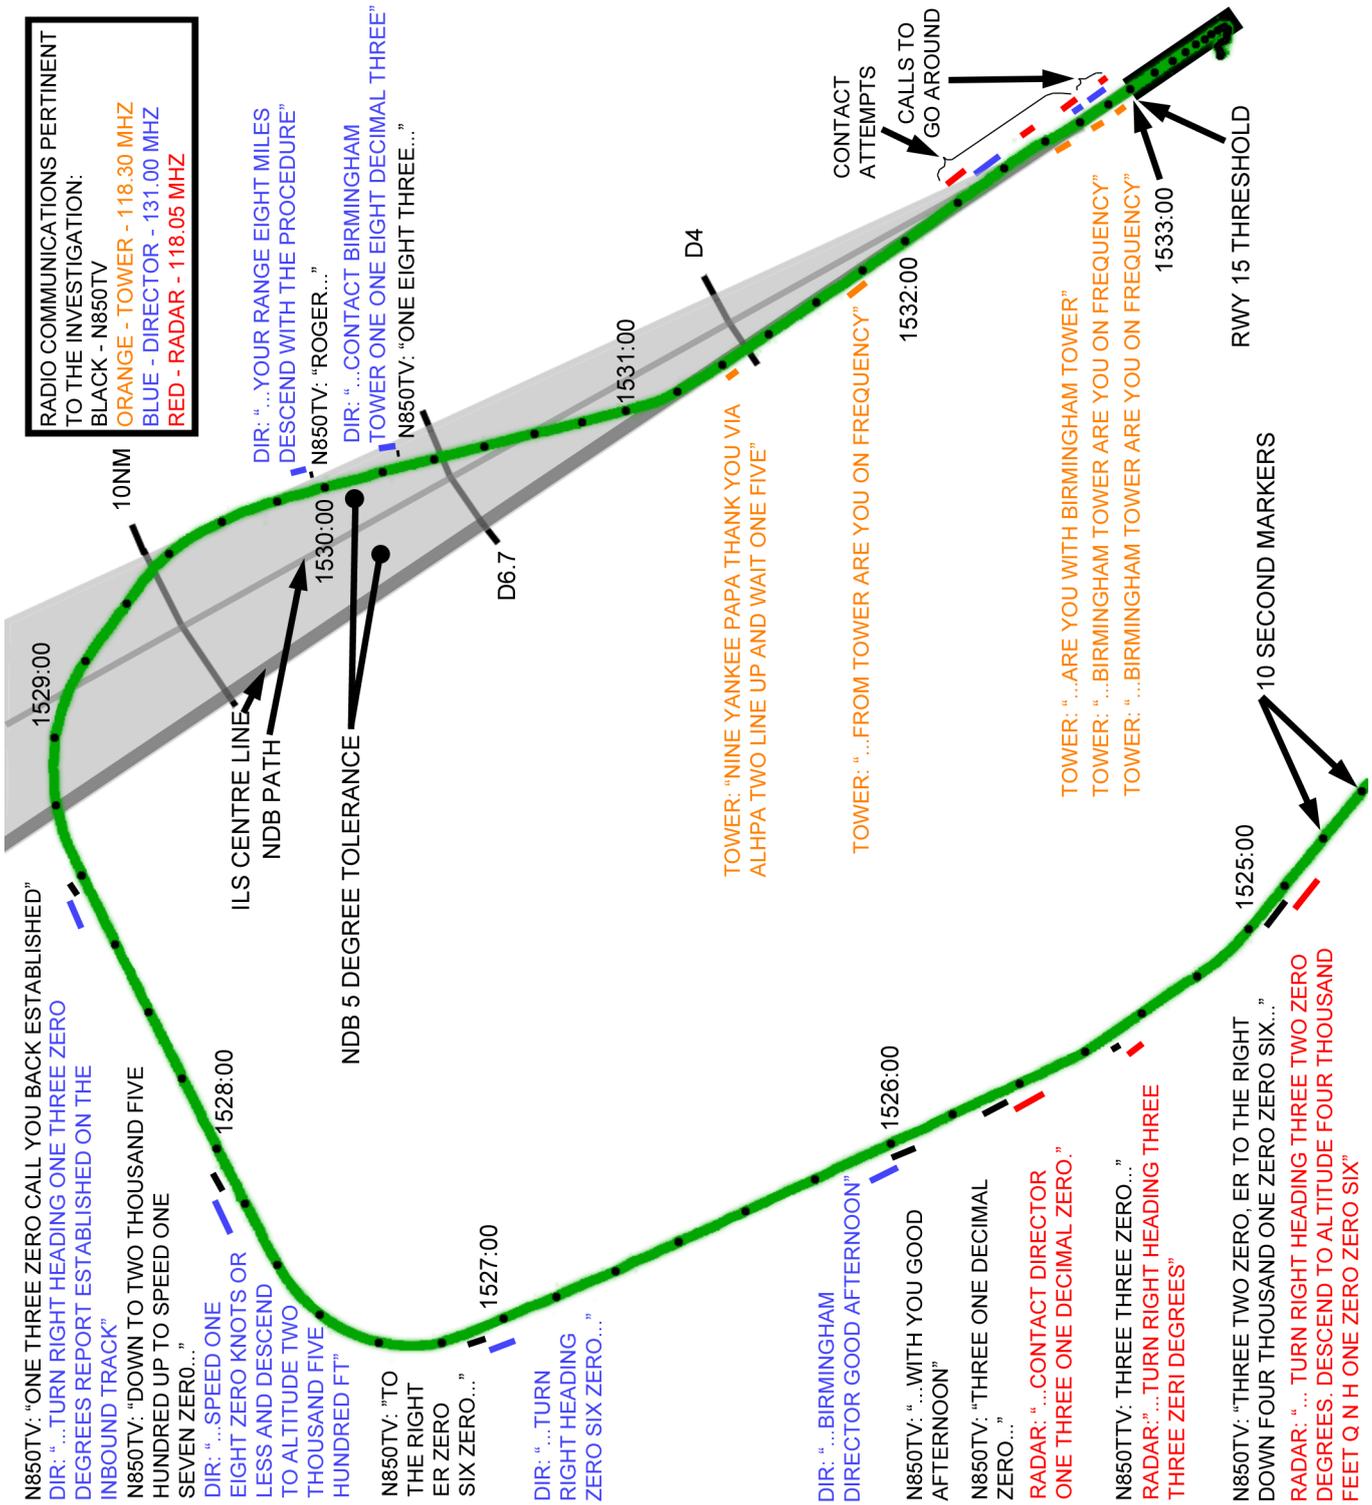
The history of the flight has been derived from interviews with the personnel involved, data recorded on the TBM 850, surface movement radar and air traffic recordings. Figure 1 shows the TBM flightpath and radio communications for the last nine minutes of the flight. Figure 2 shows relevant recorded data for the last four minutes.

Aircraft track and radio communications, with pertinent procedural track information

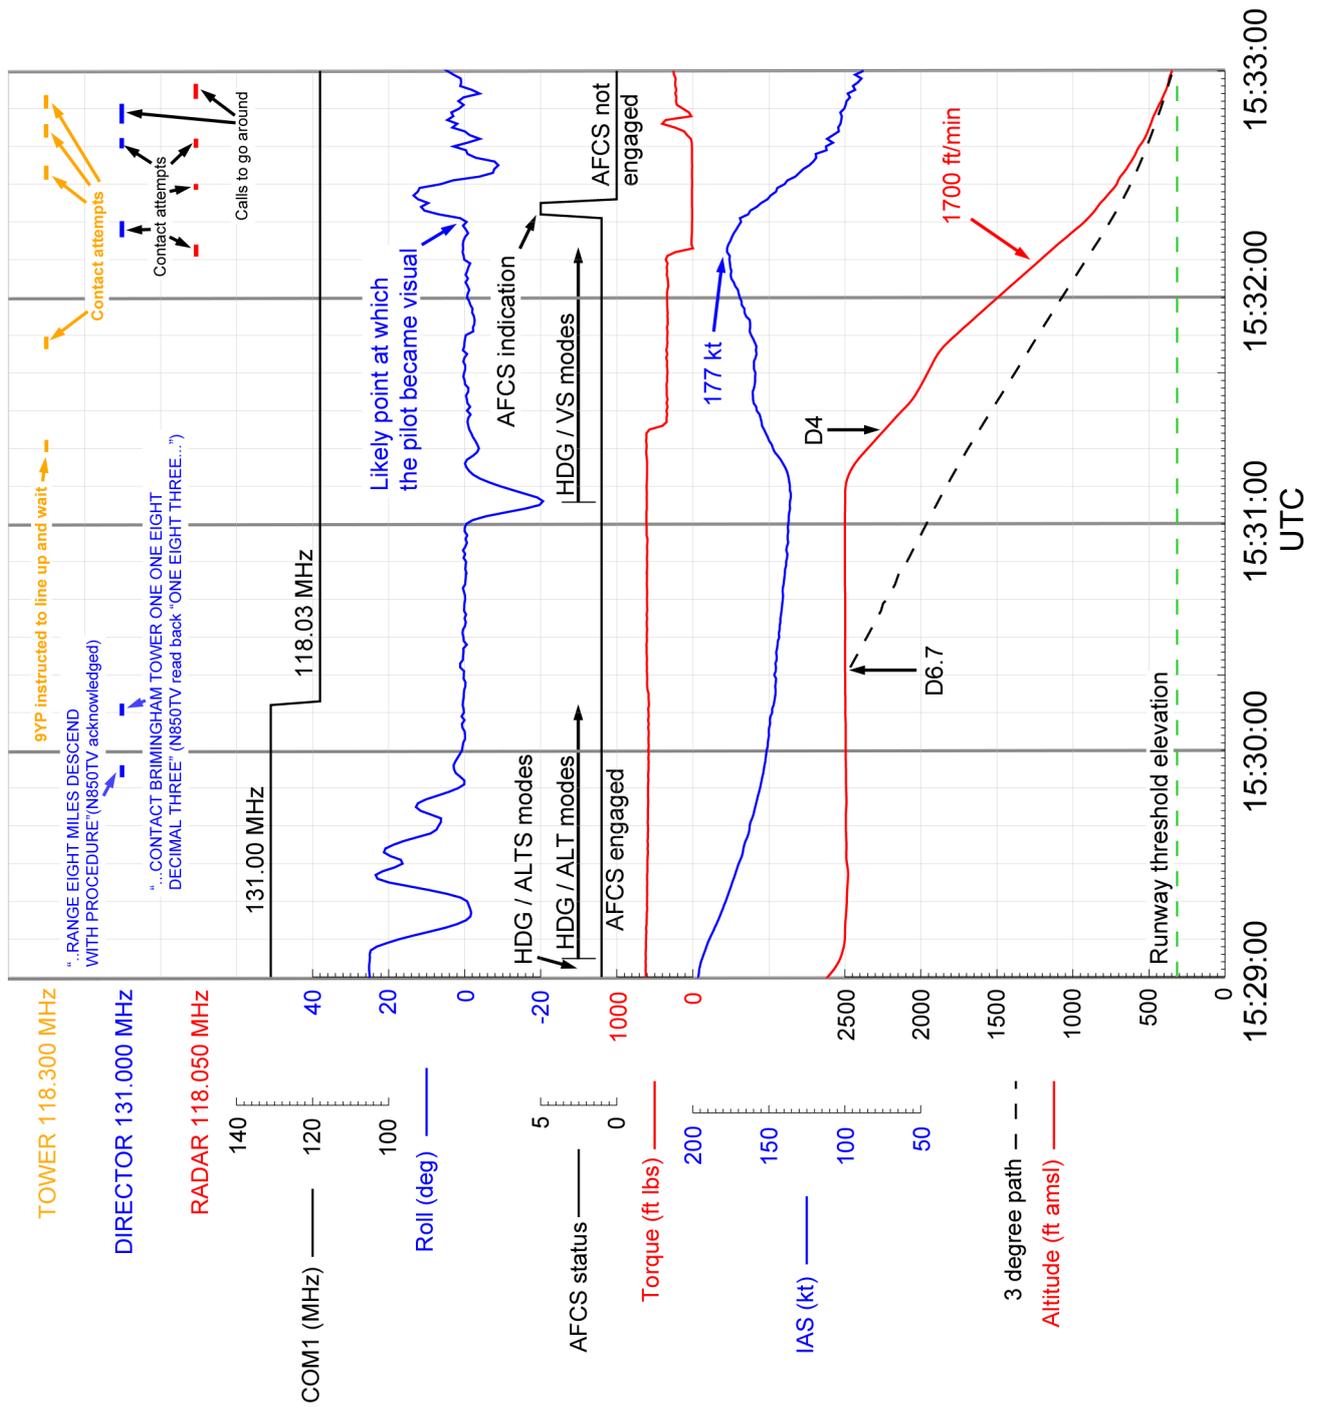
**Figure 2**  
 Pertinent recorded data for the four minutes prior to crossing the runway threshold

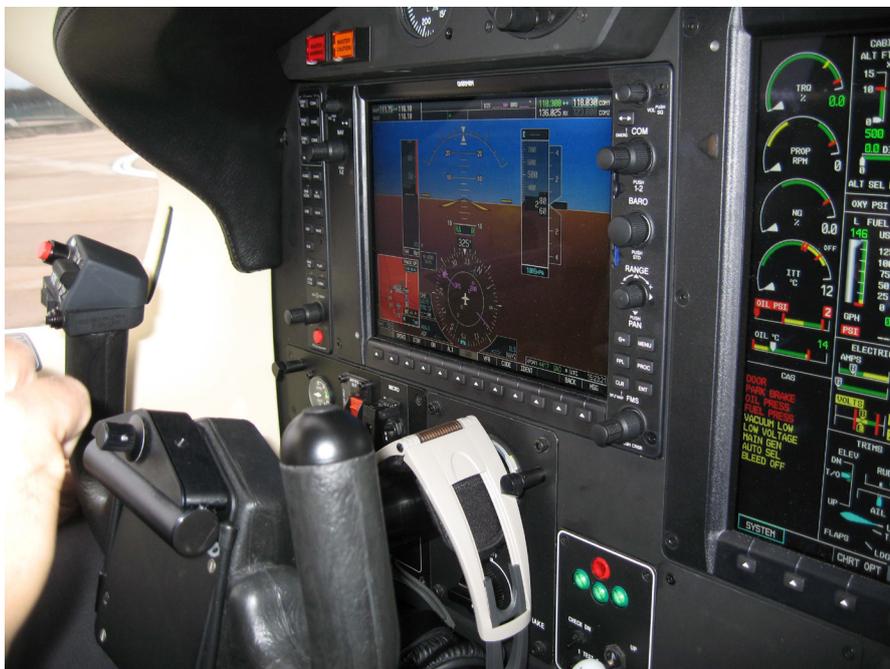
The transponder Mode A code is altered by selecting the XPDR soft key on the PFD, then selecting CODE and entering the required code. The XPDR soft key is the eighth key from the left of the PFD and is therefore located behind the control yoke (shown in Figure 3 below).

**Figure 3**  
Position of transponder controls

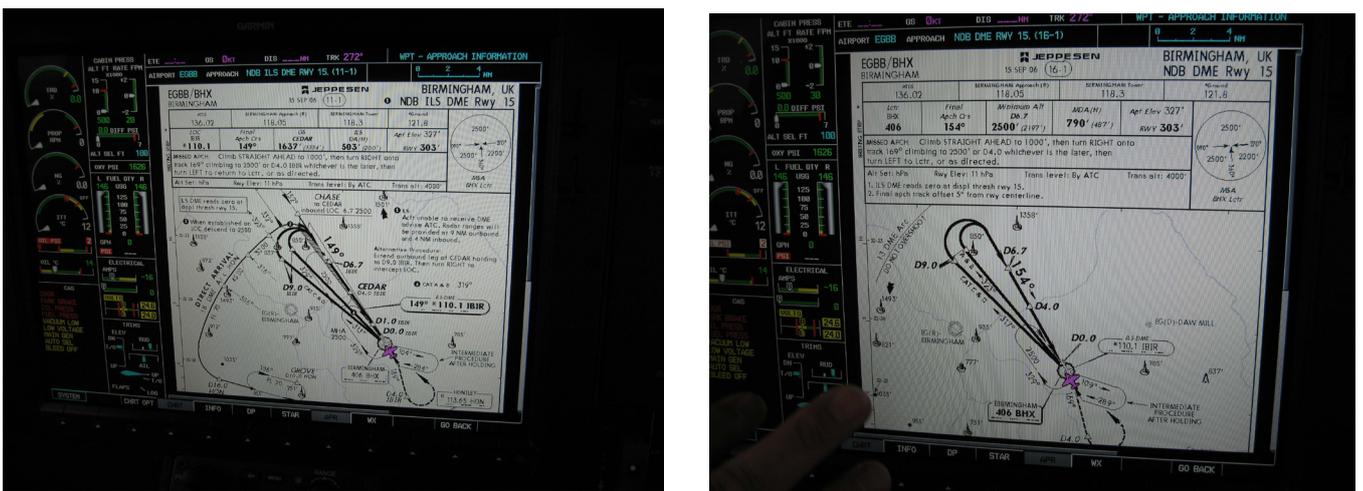
onto the electronic chart as an aid to situational awareness but this is not approved for primary navigation use. The charts are selected by pressing the SHW CHRT soft key then pressing the FMS knob to activate the cursor and entering the airfield identification. The FMS knob is then used to select an approach and a dropdown box with the chart options appears. Turning either FMS knob will scroll through the available charts and enter selects the chart. The electronic menu uses the same identifiers as the paper charts; the ILS for Runway 15 at Birmingham is therefore listed as the NDB ILS DME Rwy 15 (plate number 11-1), while the NDB approach is NDB DME Rwy 15 (plate number 16-1). The chart display can zoom into the chart at a user-set level. The default user-set level set for N850TV displays the top two-thirds of the chart but cuts off the vertical profile at the bottom (see Figure 4 below).

On the day following the incident the pilot was asked to demonstrate selecting the NDB approach chart for Runway 15 on the system. However, the chart he selected for display was the ILS chart for Runway 15.

**Figure 4**  
Presentation of ILS and NDB plate images on G1000

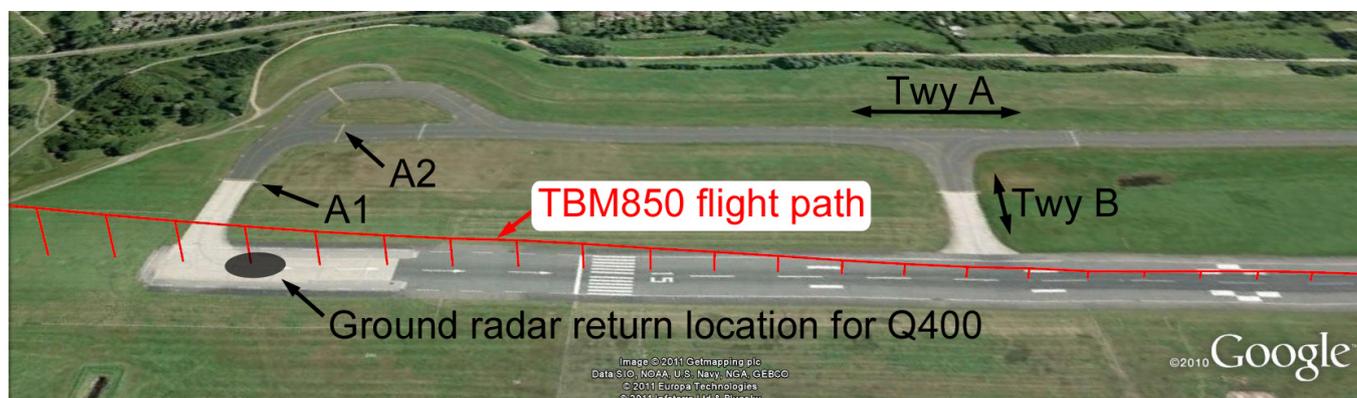
runway is equipped with high intensity approach lights, runway lighting with 15 m spaced centreline lighting, touchdown zone lighting and PAPI set to 3°. Figure 5 below shows the area around the threshold of Runway 15 and identifies the holding points at that end.

**Figure 5**  
Runway 15 threshold
