**AAIB Bulletin No: 8/93**

**Ref: EW/G93/04/17**

**Aircraft Type and Registration:** Piper PA-34-200T Seneca II, G-BORH

**Location:** Shoreham Airport, West Sussex

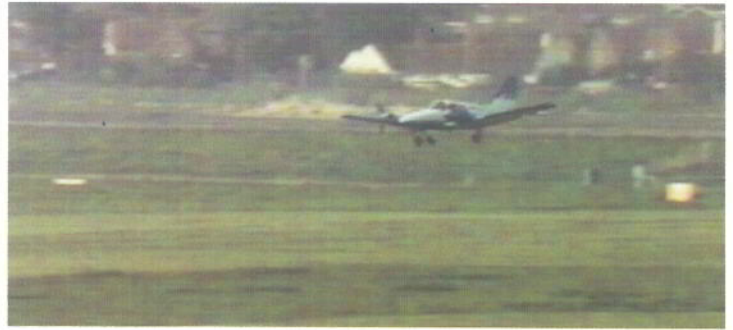
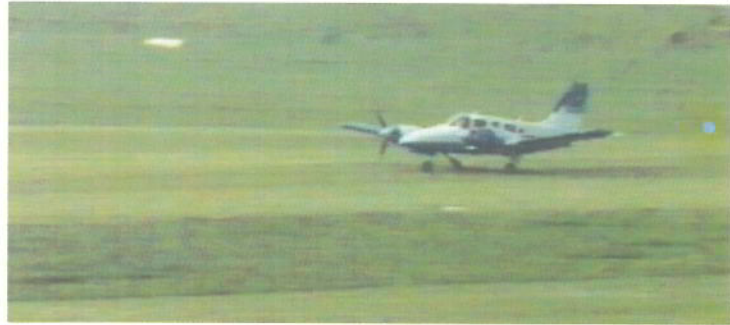
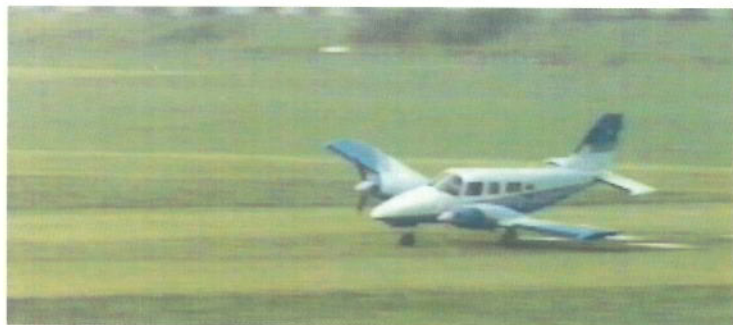
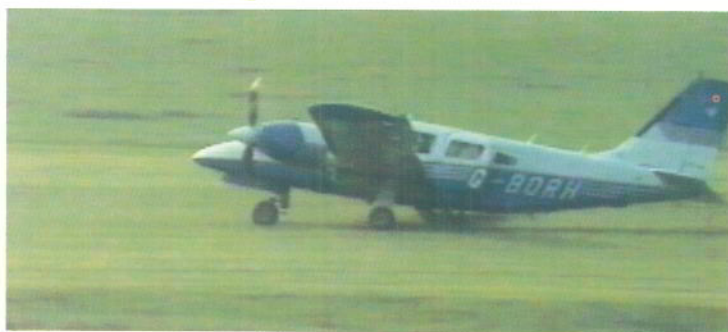
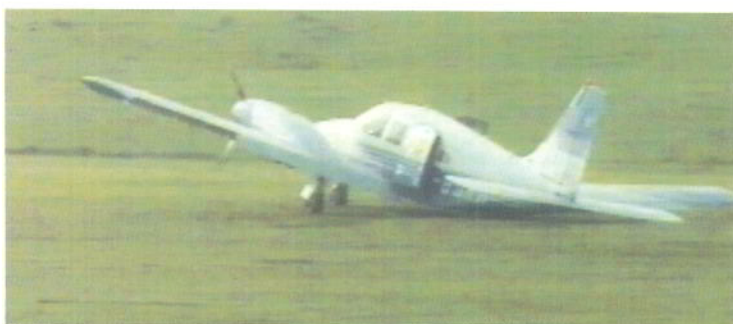
**Figure 1**

Following an uneventful flight from Rouen the aircraft had made an approach to Runway 21 at Shoreham Airport when, following a reported normal touchdown, it suddenly began to veer to the right. Considering that it would be dangerous to continue with the landing, the pilot made the decision to go-around. As the aircraft climbed away, one of the rear passengers informed the pilot that he could see the right main landing gear, which was trailing in the slipstream with hydraulic fluid leaking away. A later flypast of the tower confirmed that there was major damage to the right gear leg and so the pilot elected to burn off fuel to the south of the airfield in order to reduce the fuel quantity to a reasonable minimum. During this two hour period the opportunity was taken to comprehensively brief the passengers, and the emergency services were also alerted by the controller. At 1620 hours the pilot carried out a precautionary approach to Runway 25 (grass) in order to assess the visibility 'into sun', and the wind strength. Ten minutes later, with the right engine stopped and its propeller feathered, the aircraft was landed with the landing gear down at a speed of around 70 kt. During the initial landing roll, the right wing lifted and the left propeller blade tips made contact with the ground. After coming

to rest, the occupants (who were uninjured) were able to make their escape within a few seconds. There was no fire. The landing sequence is shown at Figure 1.

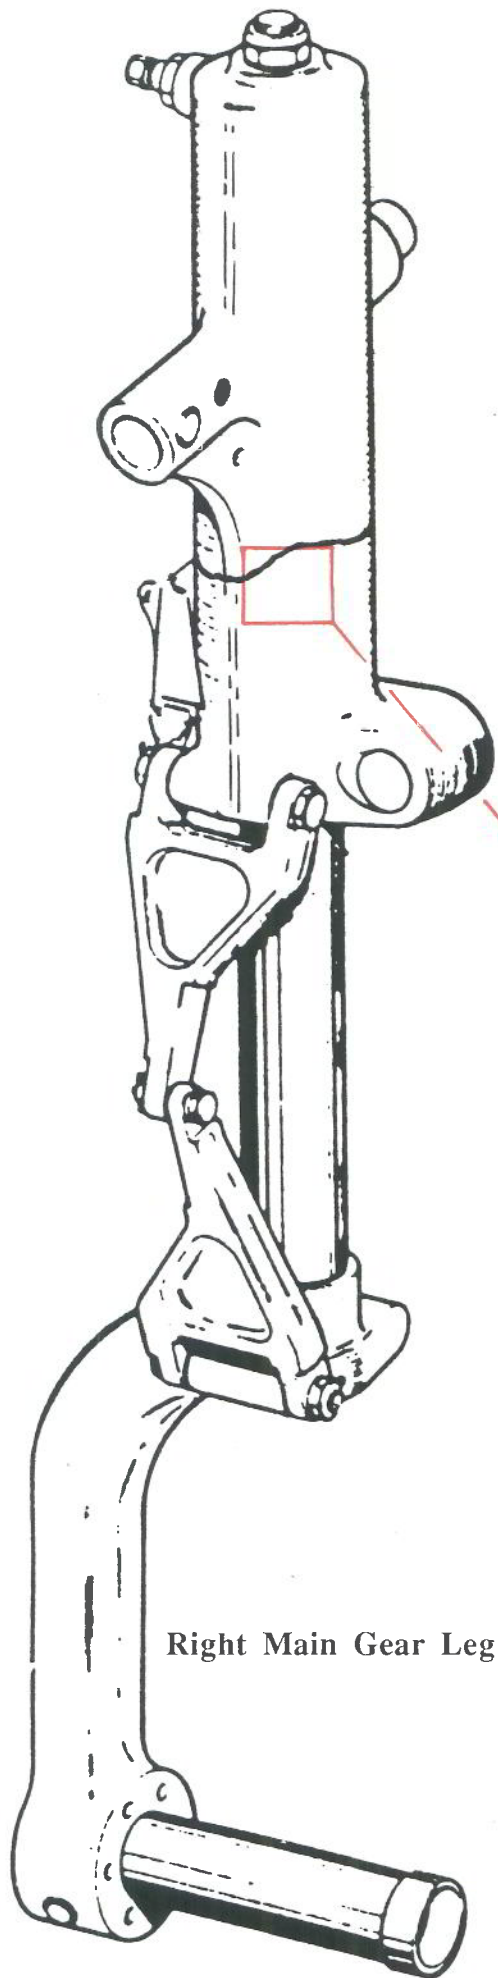
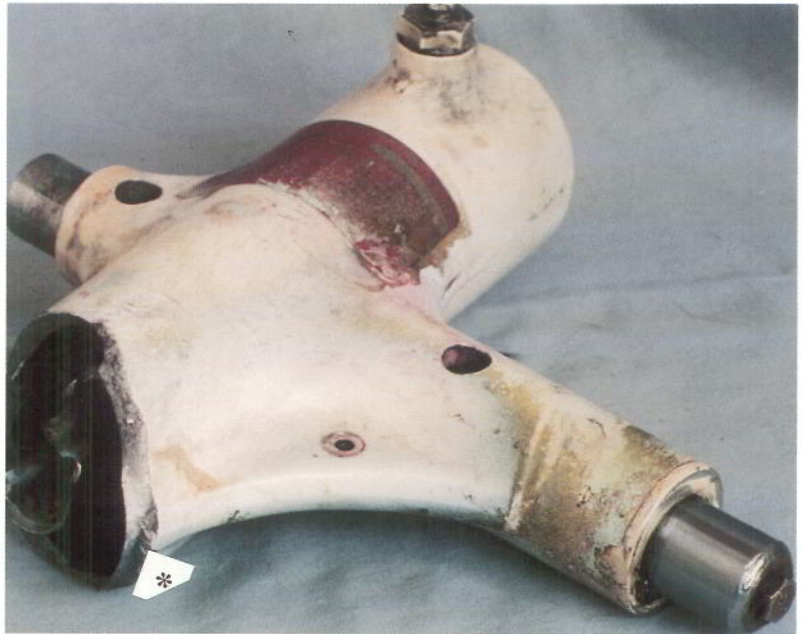
Figure 2

After the aircraft had been recovered to its maintenance organisation on the airfield the failed right main gear was removed and taken for examination by the AAIB. A complete failure had occurred around the lower end of the oleo trunnion assembly housing at a position coincident with the runout of a large fillet between the leg barrel and aft trunnion, as shown in Figure 2. The majority of the fracture face exhibited evidence of an overload type of failure, but in the region where the fillet blended into the barrel, which was coincident with a forging 'flash-line', there were progression bands that were typical of those produced by a high stress, low cycle, tension fatigue mechanism. The paint on the barrel immediately adjacent to the fracture in this area contained a large number of stress-related and smaller cracks. In addition, cracks which appeared to be secondary open cracks in the barrel surface could be seen through the cracked paint, which is illustrated in Figure 3. The relative location of the cracks in the paint showed that the leg, at some time, had been subjected to an abnormally high level of forward flexing. Hardness and conductivity measurements on the material of the housing indicated that it had been fully heat-treated and was materially satisfactory.

Fracture Location  
Asterix denotes Fatigue/Stress Corrosion Area  
Note dye stains on paint  
and under washer area

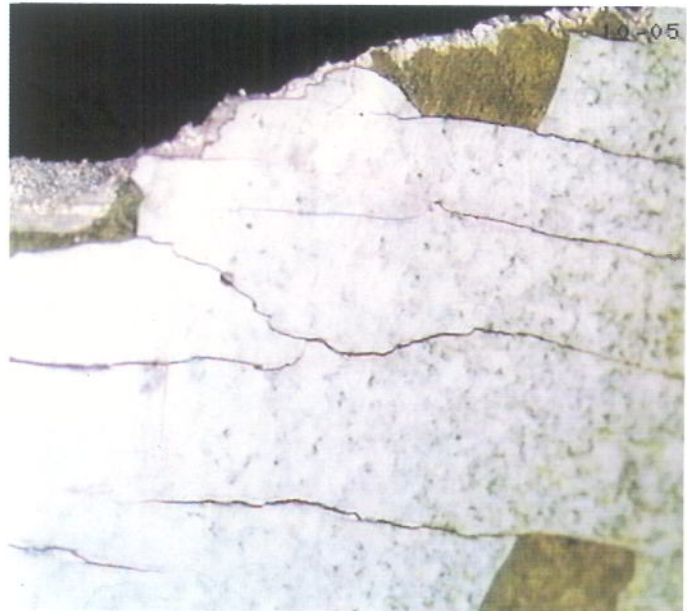
Figure 3

Stress Cracks in Paint

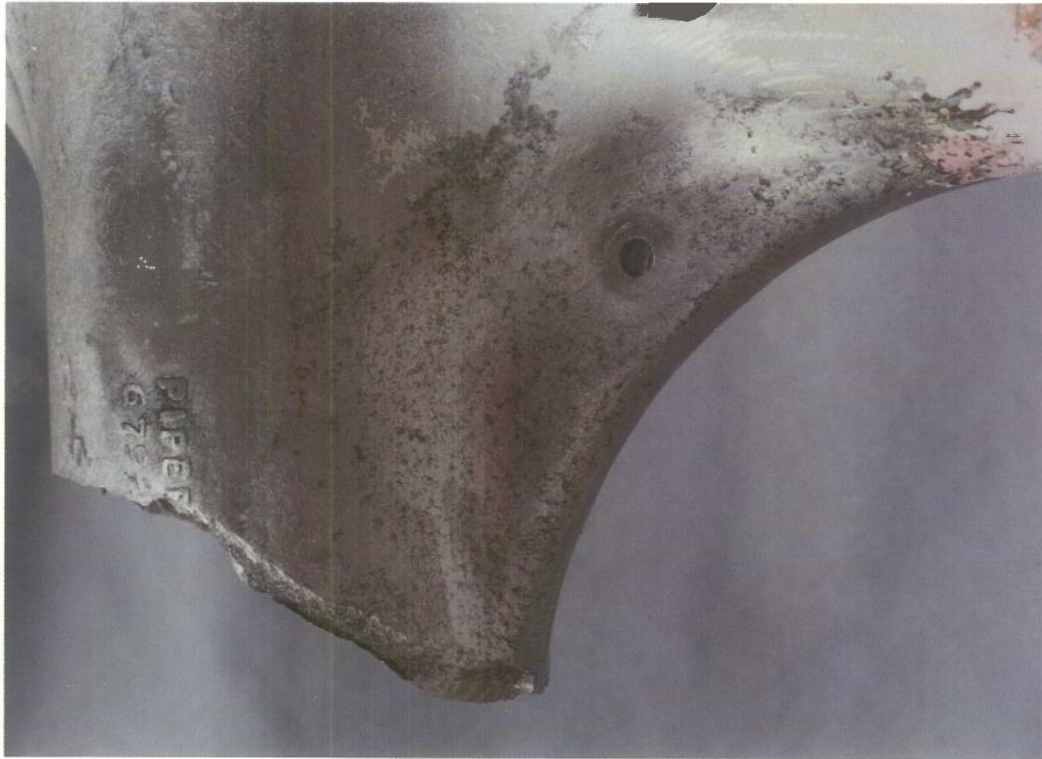
Figure 4

In view of previous instances of such failures on PA-34 aircraft, the subject portion of the leg was stripped of paint and examined generally for corrosion and cracks. Extensive corrosion was present on part of the barrel wall and on one face of the fillet, as shown in Figure 4. This appeared to be a region from which paint had previously been removed, presumably in accordance with Service Bulletin 747A (see later), and coincided generally with the area of stress-cracking in the paint. The total area of fatigue damage on the fracture surface contained at least three positions where cracking from a tension fatigue mechanism had initiated. This area had also been attacked by corrosion, with associated pitting. From its appearance, this fracture had progressed over a considerable time (Figure 5). A section of material from this area, close to the fracture initiation site, was removed and prepared so that the associated cracks could be examined. This showed that these cracks were typical of those produced by a slow stress-corrosion mechanism. Figure 6 shows one example where a fatigue crack had started to develop from the inner end of a stress corrosion crack, but had not progressed to failure.

General Surface Corrosion Revealed Below Paint on Face of Fillet

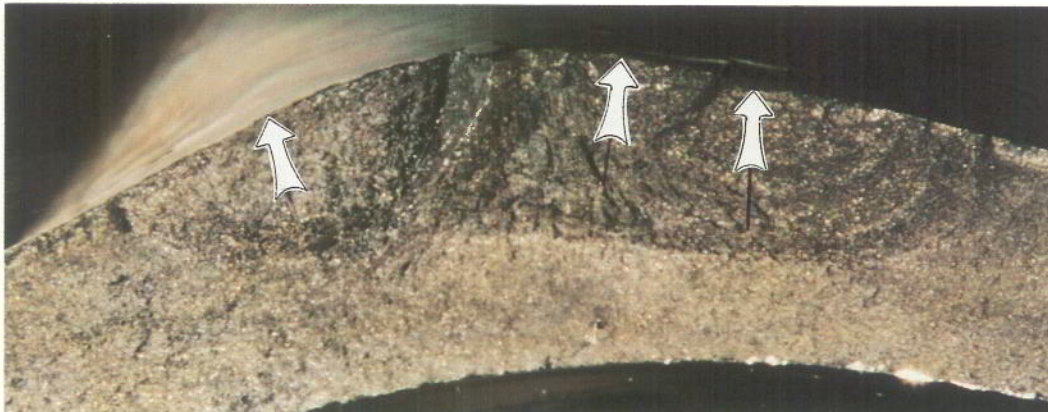
Figure 5

Detail of Fatigue Area Showing Multiple Crack Origins and Corrosion Staining of Crack Surface

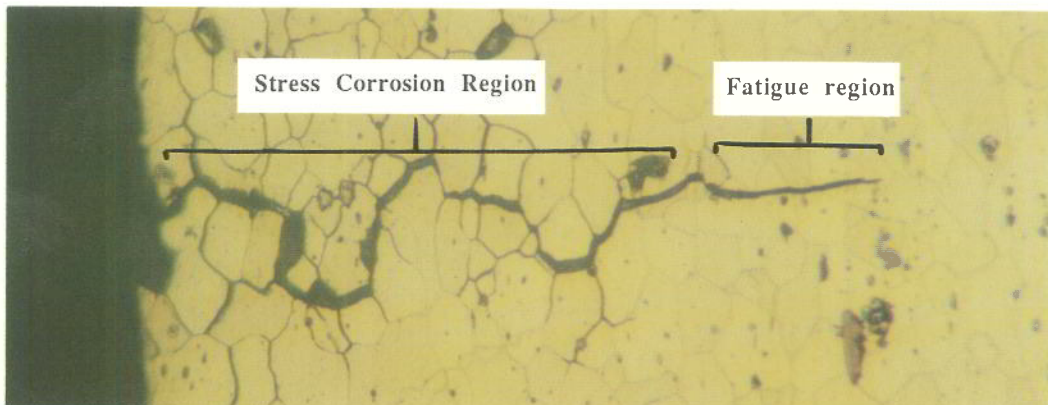
Figure 6

Micro Section of Typical Stress Corrosion Crack (Intergranular) Running to a Fatigue Crack (Transgranular)
