## ACCIDENT

<b>Aircraft Type and Registration:</b>	Piper PA-28-181 Cherokee Archer II, G-OODW
<b>No &amp; Type of Engines:</b>	1 Lycoming O-360-A4M piston engine
<b>Year of Manufacture:</b>	1984 (Serial no: 28-8490031)
<b>Date &amp; Time (UTC):</b>	10 October 2013 at 1400 hrs
<b>Location:</b>	Turweston Aerodrome, Northamptonshire
<b>Type of Flight:</b>	Private
<b>Persons on Board:</b>	Crew - 1                  Passengers - None
<b>Injuries:</b>	Crew - None              Passengers - N/A
<b>Nature of Damage:</b>	Damage to the left wing
<b>Commander's Licence:</b>	Private Pilot's Licence
<b>Commander's Age:</b>	66 years
<b>Commander's Flying Experience:</b>	400 hours (of which 50 were on type) Last 90 days - 10 hours Last 28 days - 4 hours
<b>Information Source:</b>	Aircraft Accident Report Form submitted by the pilot

## Synopsis

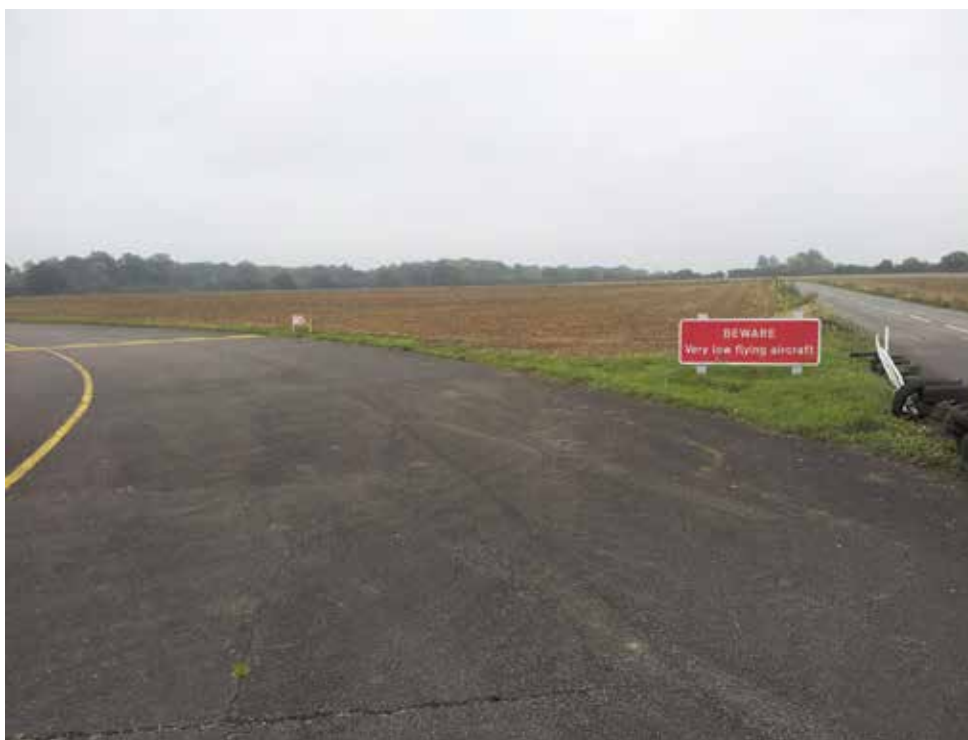
**Figure 1**

Holding Point C, the taxiway and the warning sign

The pilot manoeuvred the aircraft to the left (east) of the centreline to ensure enough room to turn right back to the holding point, to carry out a power check. During the turn, the pilot felt a “small bump” as the left wing contacted the warning sign and passed over it. From his position in the cockpit, he could only see a small dent in the left wing but did not connect it with the bump. Having performed the power check, the pilot took off and returned to Fairoaks.

The pilot had not been aware of the full extent of the damage, which was not visible from the cockpit, before departing from Turweston. He concluded that he had not seen the warning sign due to its end on aspect when he taxied off the runway and possibly because he was looking to the right, into the turn. On reflection, having felt a bump and seen a dent

The warning sign was not subject to a taxiway sign requirement but was erected to warn vehicle drivers on the adjacent access road that they may hear or see low flying aircraft approaching or departing from the runway. Civil Aviation Publication (CAP) 168, *Licensing of Aerodromes*, sets out the requirements for taxiway signs. Had the sign been a requirement, it would have had to be 12.5 m from the taxiway centreline, as opposed to 9.3 m, as measured, and no higher than 0.36 m. The operator has carried out a review of the location of the warning sign and has elected to move it further away from the taxiway.
