No: 1/92

Ref: EW/C91/10/2

**Aircraft Type and Registration:** Bell 214ST, G-BKJD  
**No & Type of Engines:** 2 General Electric CT7-2A turboshaft engines  
**Year of Manufacture:** 1982  
**Date & Time (UTC):** 2 October 1991 at 1010 hrs  
**Location:** 81 nm east of Aberdeen  
**Type of Flight:** Public Transport  
**Persons on Board:** Crew - 2                      Passengers - 4  
**Injuries:** Crew - None                      Passengers - None  
**Nature of Damage:** Failed tail rotor counterweight bearing journal  
**Commander's Licence:** Airline Transport Pilot's Licence  
**Commander's Age:** 43 years  
**Commander's Flying Experience:** 8,600 hours (of which 1,000 were on type)  
**Information Source:** AAIB investigation of failed parts submitted by operator

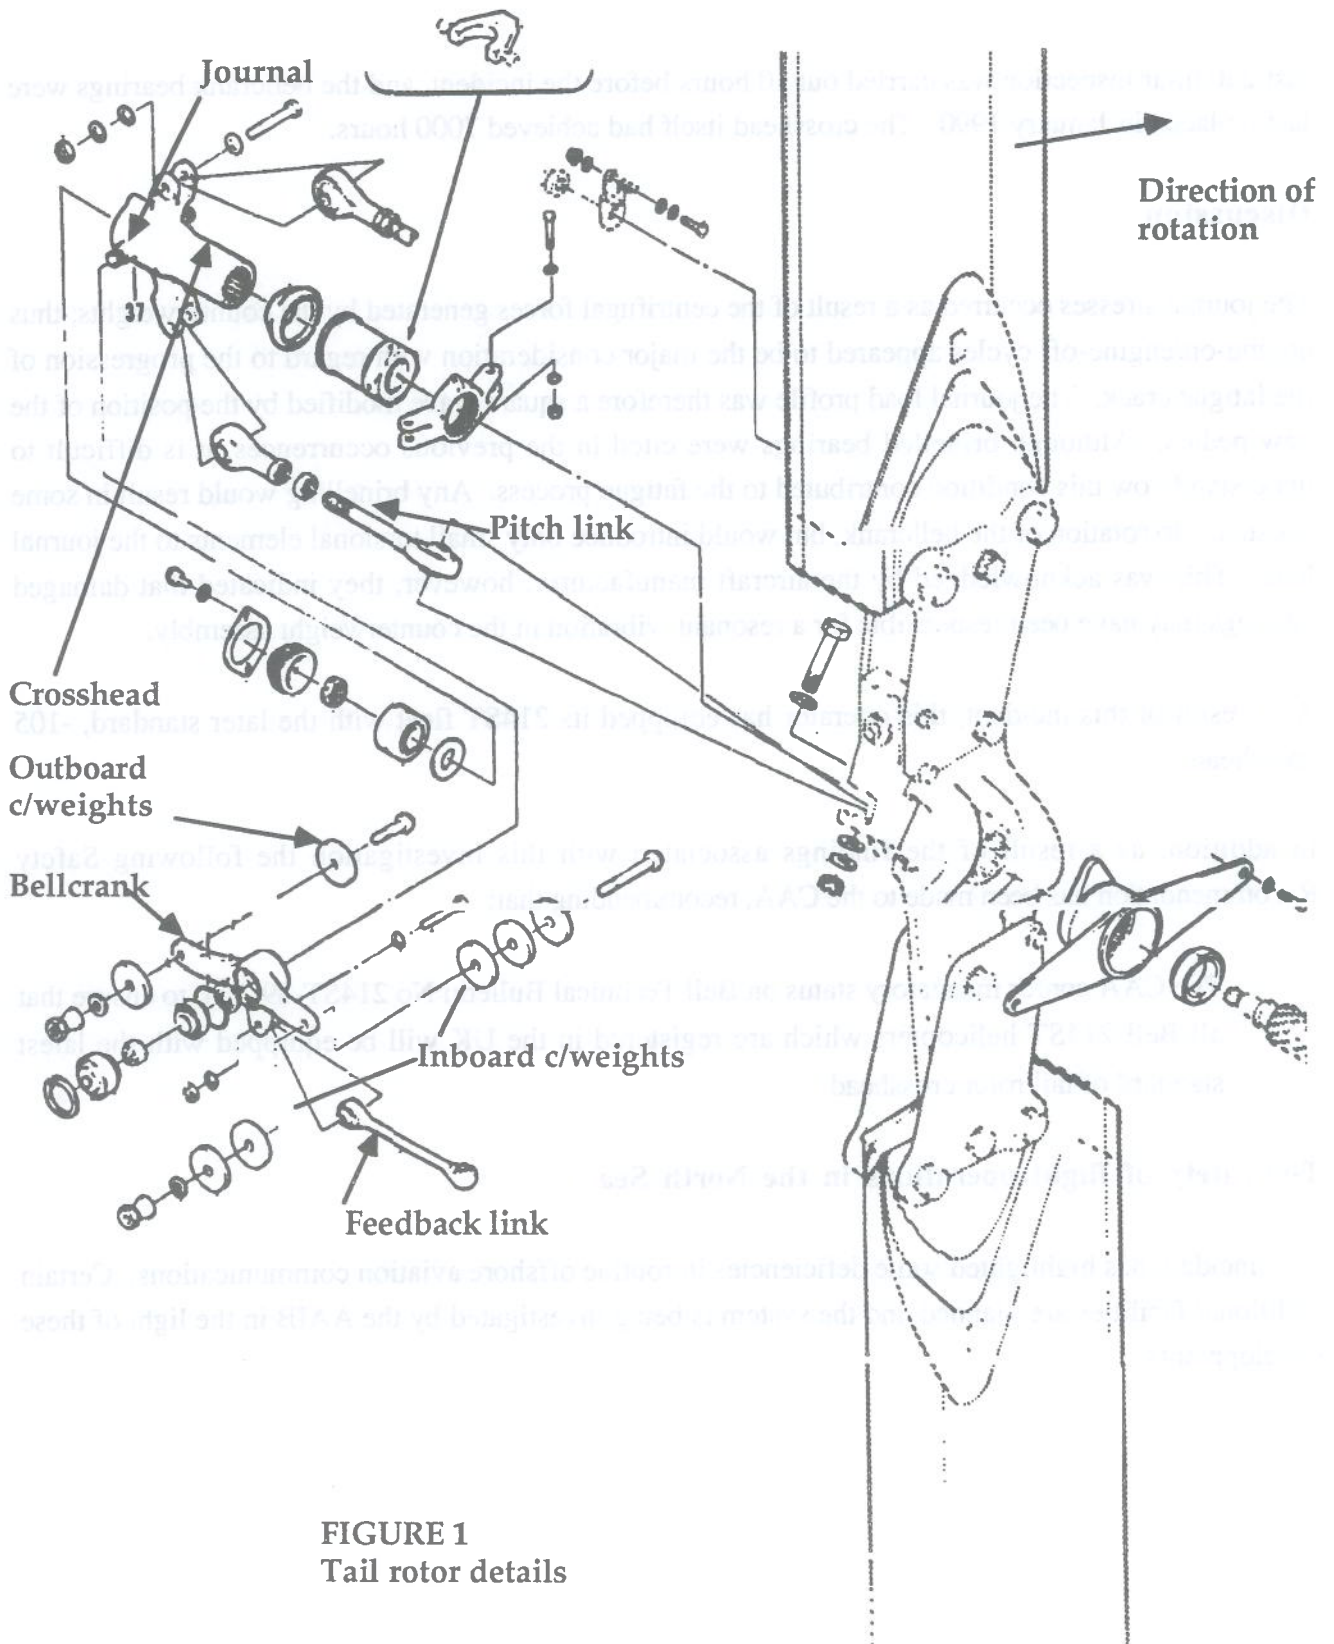
**FIGURE 1**  
Tail rotor details

Subsequent inspection revealed that one of the two tail rotor counterbalance weight bellcrank assemblies was missing from the helicopter and that in separating it had struck the blade grips and the blade surface of one of the tail rotor blades. A complete replacement tail rotor assembly and gearbox were despatched from Aberdeen and fitted to the helicopter. Following test running, the helicopter was flown back to Aberdeen later in the day. The only other damage apparent was a broken left hand life-raft deployment handle cover, which was made of Perspex and roof-mounted behind the crew. Particularly severe vibration had been observed in the area of the roof console.

The failure concerned the tail rotor crosshead, P/N 214-010-806-101, which is splined onto the tail rotor shaft. The tail rotor pitch change links are attached to lugs on the crosshead, which moves axially on the shaft under the action of the yaw control servo. The two counterweight bellcranks are mounted on lugs, or journals, positioned at 90° relative to the pitch link lugs. The relevant components are shown on the diagram at Figure 1. The failure had occurred in the machined undercut at the base of one of the journals. Photographs of the crosshead are shown at Figure 2.

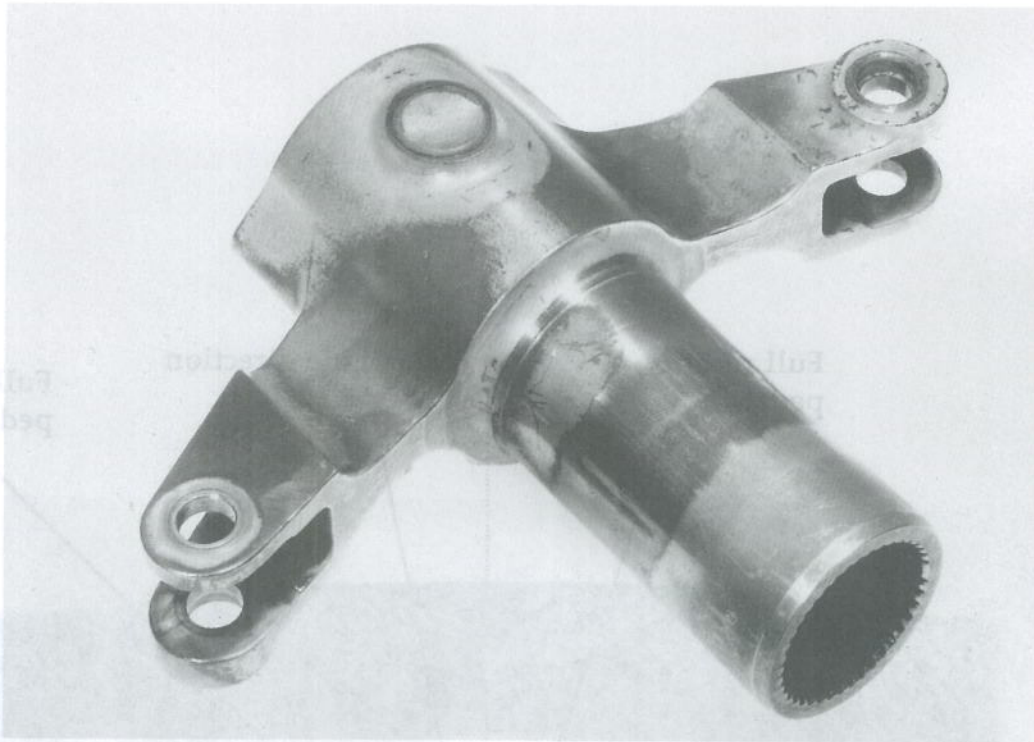
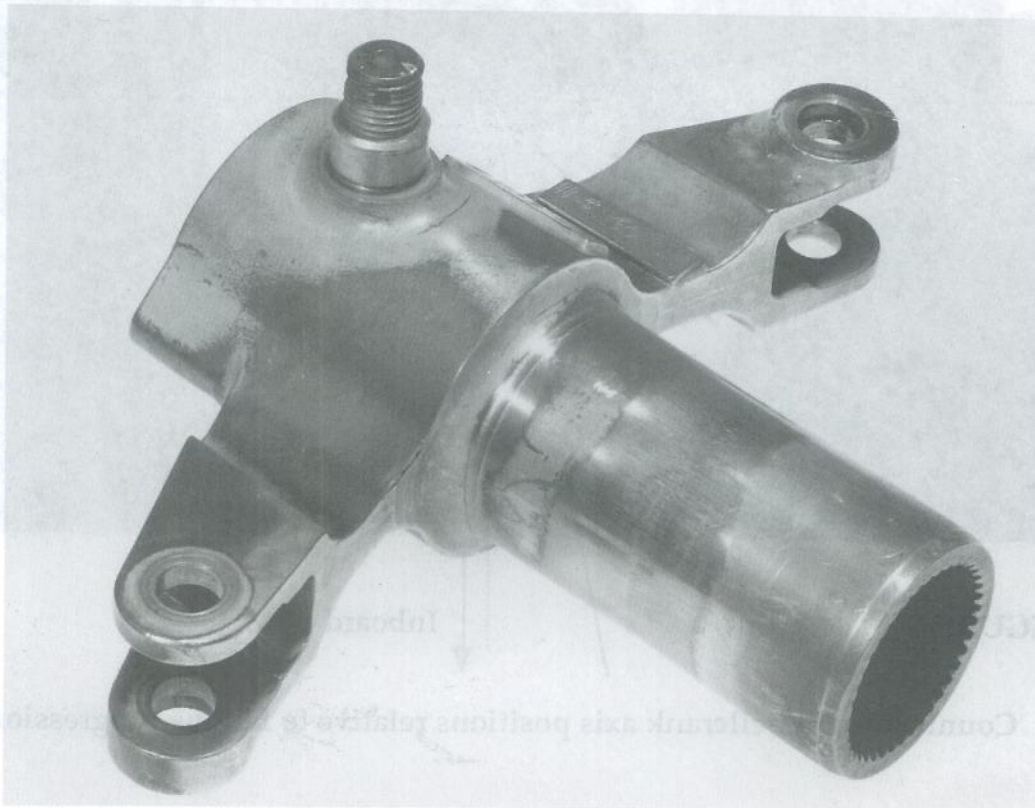
**FIGURE 2** Views of crosshead showing failed and intact journals

The fracture surface was examined by the Materials and Structures Department of the Royal Aerospace Establishment, Farnborough. It was found that the fracture area consisted of a 50% division between fatigue and fast fracture, with fatigue origins within the inboard arc of the fracture, emanating from 'grooves' in the undercut at the base of the journal. Although it initially appeared that these grooves

were machining marks, it was later found that they were in the plating material, and hence would not have been directly responsible for the fatigue initiation. Fatigue striations are invariably difficult to discern in this type of material, but were visible under a scanning electron microscope, and were parallel to the line that divided the two parts of the fracture. Figure 3 shows a view of the fracture face, with superimposed lines indicating the approximate counterweight bellcrank axis position for the yaw pedal positions. Note that the fatigue direction is consistent with the bellcrank being close to the mid position. The maximum centrifugal force generated by the counterweights (and hence the maximum tensile/bending stress in the journal) occurs at maximum radius of rotation, *ie* full left pedal, with the minimum occurring when the bellcrank is aligned with the rotor axis. It therefore appeared that the fatigue progressed with the bellcrank close to a typical cruise position, although the initiation may have occurred towards the position of highest stress. Dye penetrant and magnetic particle inspections revealed no cracks in the intact journal.

The metallurgical examination also revealed a degree of porosity in the microstructure which, although typical of a cast alloy, would have tended to reduce the fatigue life. However, none of the voids was associated with the fatigue origin. In addition, it was observed that the undercut area had not been shot-peened which, although not required for this component, would have improved the fatigue resistance. Finally, some fretting marks were observed on the casting at the base of the undercut. This was attributed to flexing of the journal as the crack progressed, causing relative movement between the shoulder of the bellcrank bearing and the casting. It was noted that this feature could also have been caused as a result of a loose bellcrank retaining nut. This item should be torqued to 175 inch pounds; thus any loss of torque would result in some loss of preload in the journal, with an attendant increase in susceptibility to fatigue.

As a result of this incident, this operator has equipped its 214ST fleet with the later standard, -105 crosshead.

The CAA confer mandatory status on Bell Technical Bulletin No 214ST-89-104, to ensure that all Bell 214ST helicopters which are registered in the UK will be equipped with the latest standard of tail rotor crosshead.

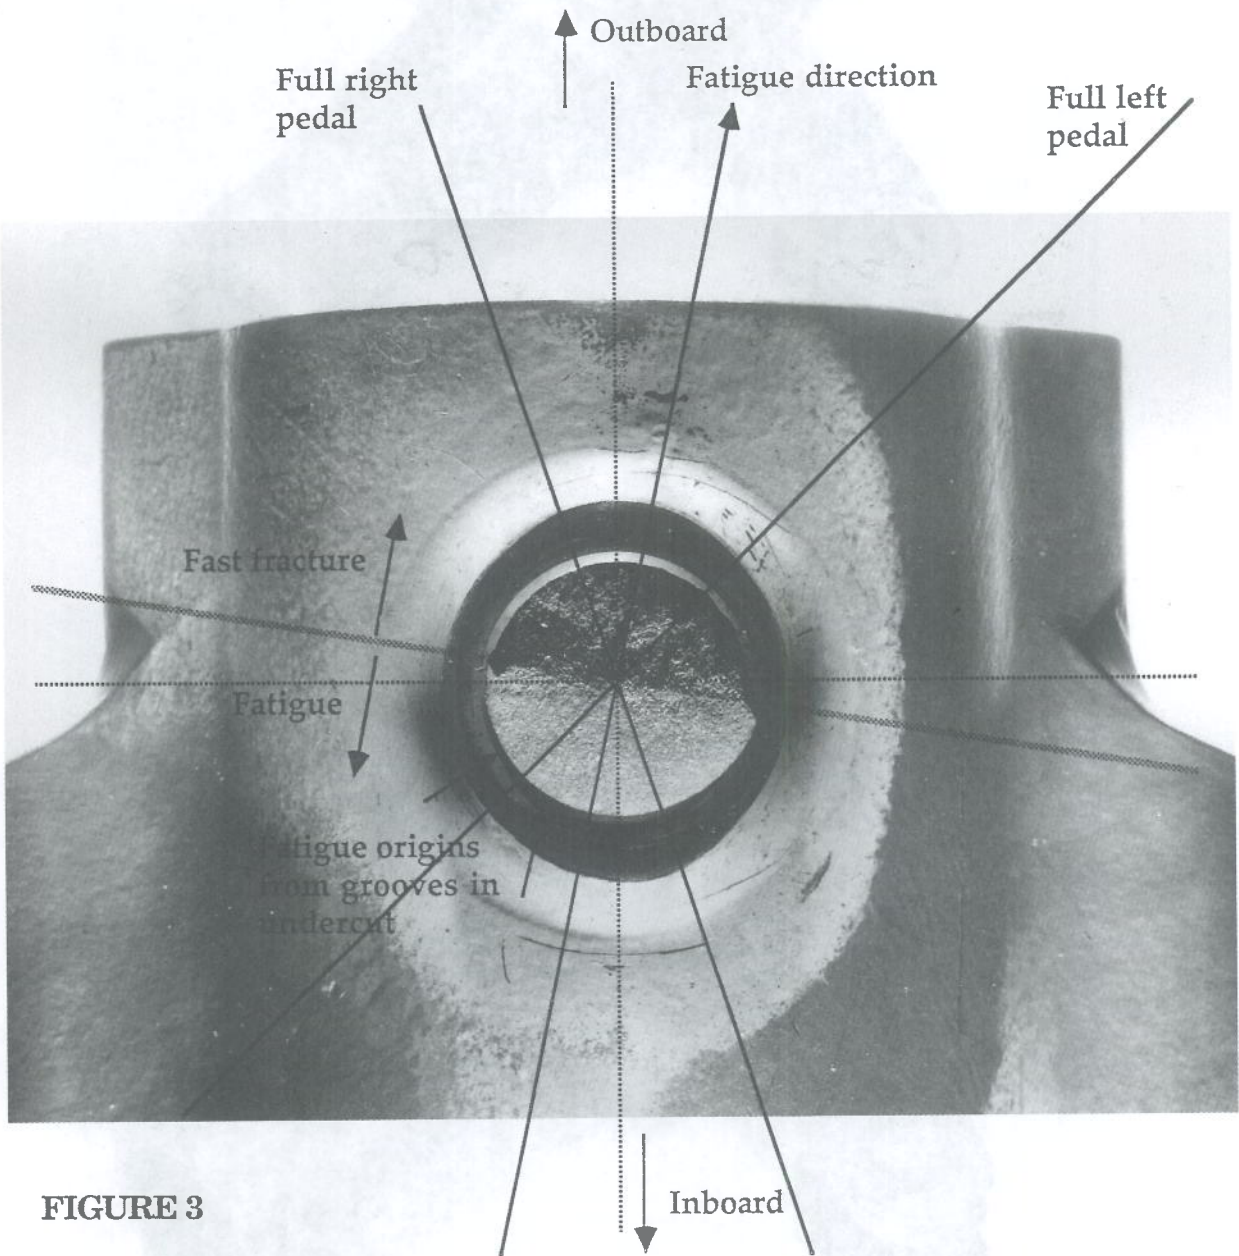
**FIGURE 3**

The journal stresses occurred as a result of the centrifugal forces generated by the counterweights; thus engine-on/engine-off cycles appeared to be the major consideration with regard to the progression of the fatigue crack. The journal load profile was therefore a square wave modified by the position of the yaw pedals. Although brinelled bearings were cited in the previous occurrences, it is difficult to understand how this condition contributed to the fatigue process. Any brinelling would result in some resistance to rotation of the bellcrank, but would introduce only small torsional elements to the journal load. This was acknowledged by the aircraft manufacturer: however, they indicated that damaged bearings may have been responsible for a resonant vibration in the counterweight assembly.

Counterweight bellcrank axis positions relative to fatigue progression
