**Air Accidents Investigation Branch**

**Report on the serious incident to  
BAe 146-200, registration EI-CZO  
at London City Airport  
on 20 February 2007**

**Air Accidents Investigation Branch****Aircraft Accident Report No: 5/2009 (EW/C2007/02/06)**

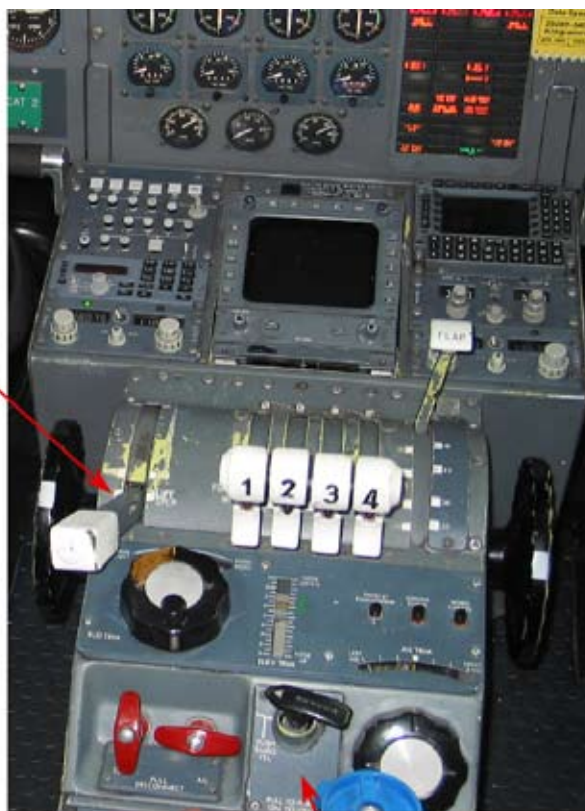
**Figure 4**

The aircraft examination revealed no defects that could explain the reason for the lift spoilers not deploying on landing. However, tests on the airbrake/lift spoiler lever did show that it was very easy to move the lever forward from 'lift-spoiler' to the full 'airbrake' position, due to the lack of friction in the mechanism. Indeed, during the aircraft tests it was noted that just nudging the lever whilst in the lift spoiler detent, caused the deployed lift spoilers to retract. With this lack of resistive force, it is possible that a lever that has already been placed in the lift-spoiler position by the pilot in the left seat, could be nudged or vibrated out of the selection, thereby stowing the deployed spoilers.

It is recommended that the European Aviation Safety Agency should mandate BAe Systems Service Bulletin 27-73-00889 for the BAe 146 series of aircraft, which increases the operating force in the forward direction from zero to 12 lb, of the lift spoiler/airbrake selector lever, to prevent the lever moving forward under the influence of vibration or being inadvertently nudged forward during the landing roll. (**Safety Recommendation 2008-062**)

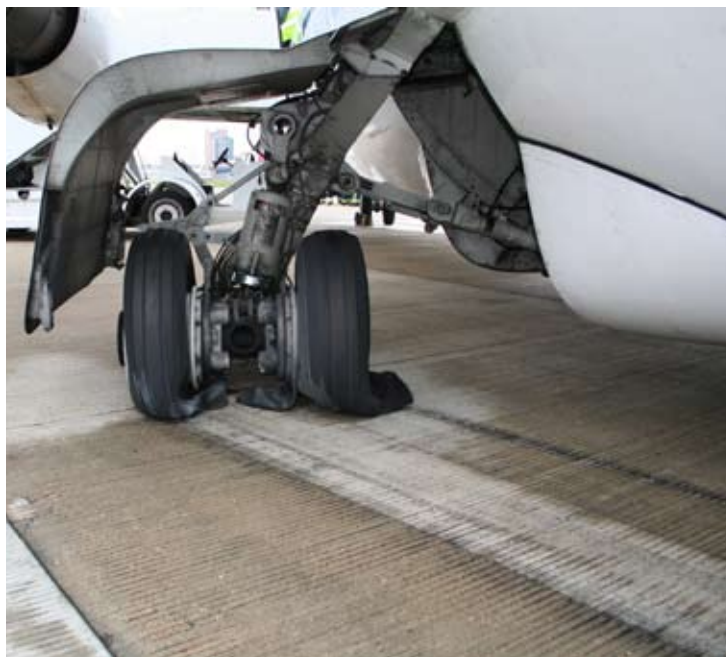
**Figure 8**

The four main wheel tyres had been worn through by surface friction until they deflated. The main wheel hubs were also damaged.

Damage to left Main Landing Gear tyres; right similar

17. Skid marks on the runway surface indicated that all four main wheels had locked up over the last 473 m of the ground roll.
18. The locked main wheels caused all four tyres to be worn through by friction with the surface and to deflate.

20. The flight crew was not aware of the tyre failures.
21. The lift spoiler surfaces did not deploy at any time during the ground roll.
22. Subsequent examination of the aircraft failed to find any defects within the lift spoiler or wheel braking systems.
