Air Accidents Investigation Branch

**Report on the serious incident to
BAe 146-200, registration EI-CZO
at London City Airport
on 20 February 2007**

Air Accidents Investigation Branch**Aircraft Accident Report No: 5/2009 (EW/C2007/02/06)**

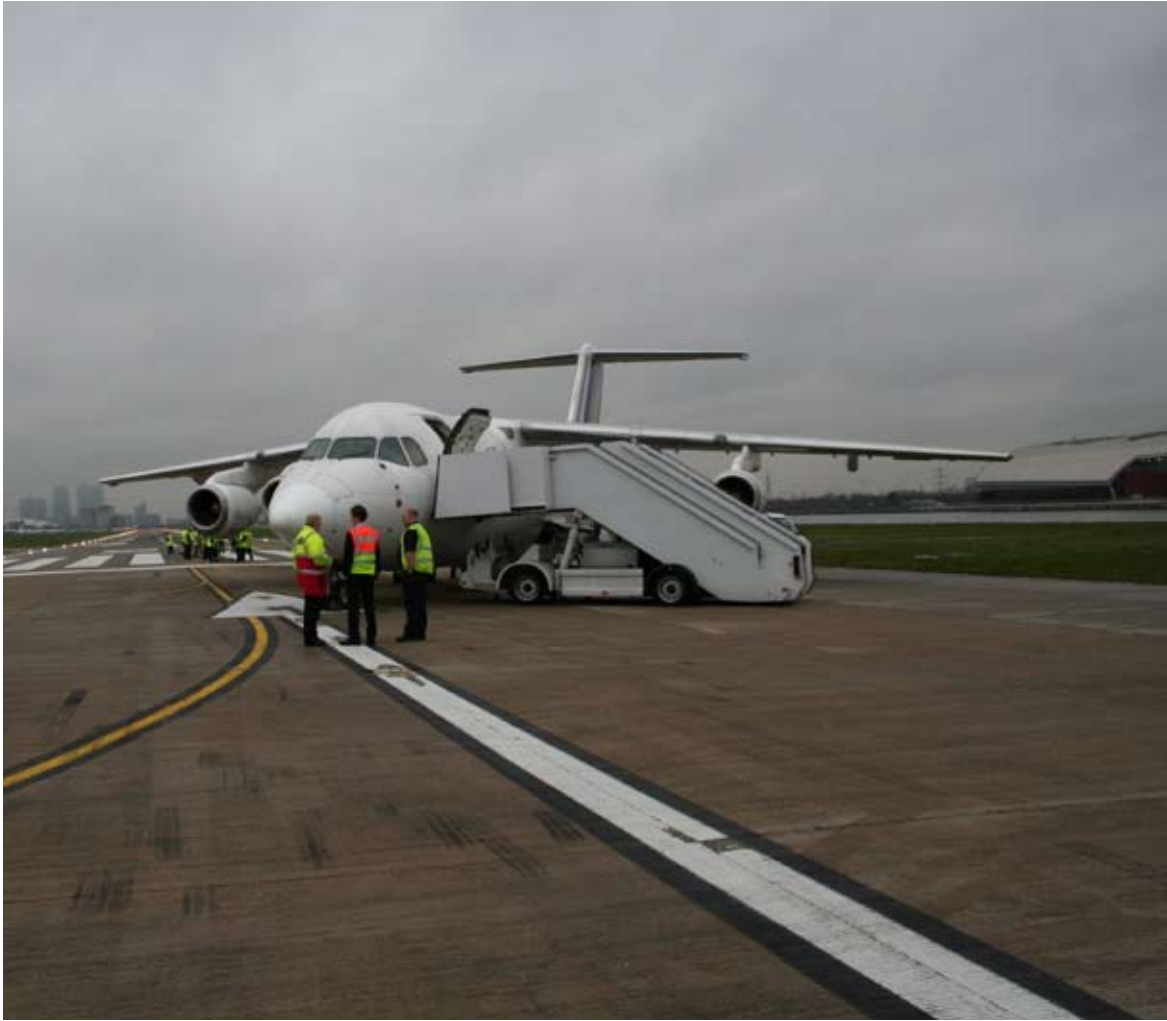
Stopped position of EI-CZO

The aircraft came to rest on the paved surface but with its nose some 50 m beyond the end of the LDA, and approximately 160 m from the dock edge. It had turned through approximately 30° over the last part of the ground roll, onto a heading of 130°. During the final part of the roll, all four main landing gear wheels locked and the tyres were worn down by friction with the surface until they burst. The flight crew were not aware of the tyre failures.

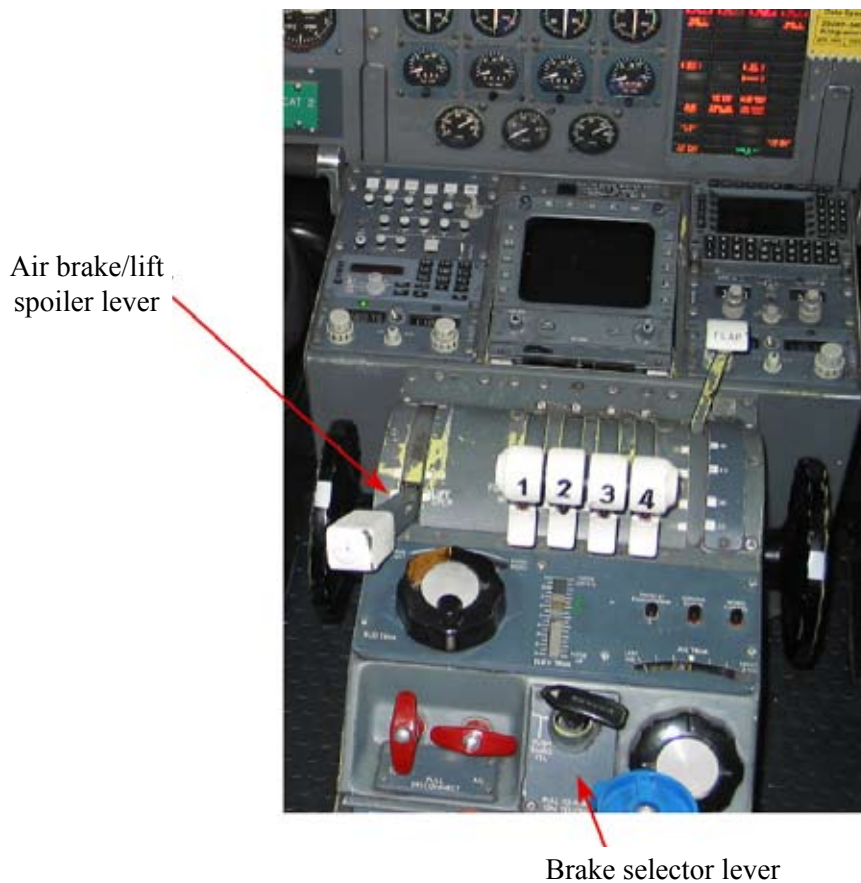
Close to zero force is required to move the lever from 'LIFT SPOILER' back to 'AIRBRAKE'.⁴

Figure 4
Airbrake/lift spoiler lever location

The aircraft examination revealed no defects that could explain the reason for the lift spoilers not deploying on landing. However, tests on the airbrake/lift spoiler lever did show that it was very easy to move the lever forward from 'lift-spoiler' to the full 'airbrake' position, due to the lack of friction in the mechanism. Indeed, during the aircraft tests it was noted that just nudging the lever whilst in the lift spoiler detent, caused the deployed lift spoilers to retract. With this lack of resistive force, it is possible that a lever that has already been placed in the lift-spoiler position by the pilot in the left seat, could be nudged or vibrated out of the selection, thereby stowing the deployed spoilers.

It is recommended that the European Aviation Safety Agency should mandate BAe Systems Service Bulletin 27-73-00889 for the BAe 146 series of aircraft, which increases the operating force in the forward direction from zero to 12 lb, of the lift spoiler/airbrake selector lever, to prevent the lever moving forward under the influence of vibration or being inadvertently nudged forward during the landing roll. (**Safety Recommendation 2008-062**)

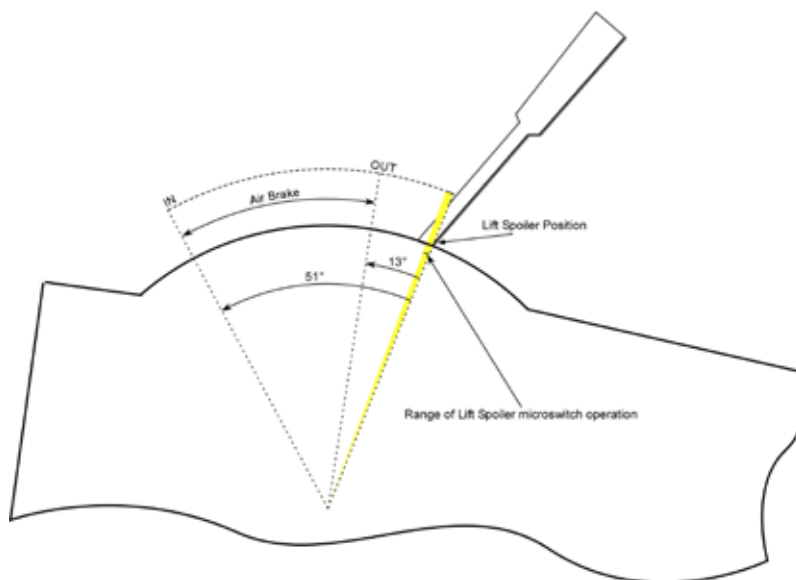
Figure 5
Airbrake/lift spoiler lever location and range of movement

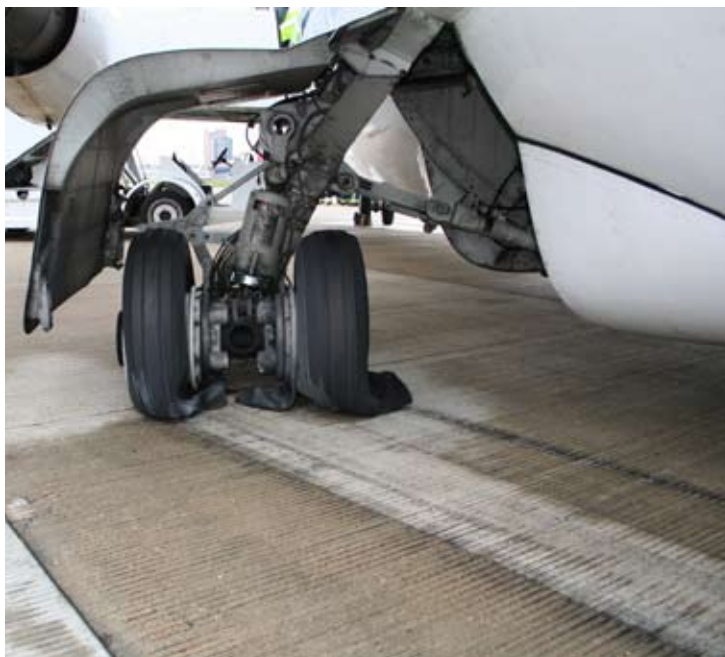
Figure 8

The four main wheel tyres had been worn through by surface friction until they deflated. The main wheel hubs were also damaged.

The aircraft came to rest in the undershoot area of Runway 28, 161 m short of the dock edge. Based on witness evidence, it touched down at the end of Runway 10 touchdown zone and, on this basis, the aircraft travelled 554 m prior to the start of the skid marks. These were evident for each of the four main wheel tyres over a distance of 473 m. Toward the end of the skid, the aircraft tracked to the left of the runway centreline, but with the aircraft heading to the right, before coming to a halt on a heading of 130° . During the skid, the four main wheel tyres had been worn through, causing all to deflate, and all the tyre carcasses to start to roll over the rims of their wheel hubs.

Damage to left Main Landing Gear tyres; right similar

The operator replaced the aircraft wheels, tyres and brakes to allow the aircraft to be towed from the runway to a safe area for further investigation. Full functional and visual checks of the hydraulic, flap, normal brake, emergency brake and anti-skid systems, were satisfactory. Later, a high-speed taxi test to assess braking action was carried out, with satisfactory results. Calibration of the aircraft's airspeed indicators showed both to be within the limits given in the maintenance manual.

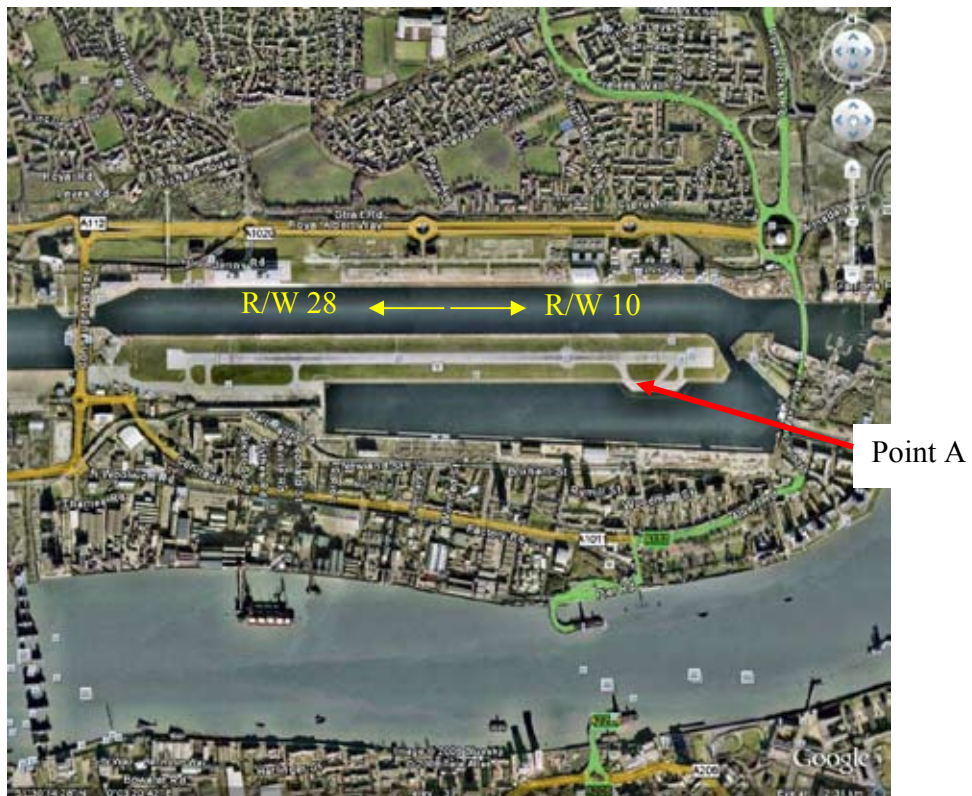
Figure 10

The overrun area for Runway 10 at LCY is 192 m, and the Runway End Safety Area (RESA) is 132 m. The RESA therefore forms the majority of the overrun area and exceeds the ICAO recommended length of 120 m for a code two instrument runway. Runway 10 overrun area does not include an arrestor bed; although, the paved surface is grooved. Beyond this area is a small water channel linking the two main water-filled areas of the old dock, located either side of the runway, Figure 10. Overshooting the paved surface or departing the runway to the side would, therefore, carry a significant risk of an aircraft entering the water, possibly in a damaged condition.

Photograph illustrating the nature of the undershoot and overrun areas, and the proximity of the water-filled docks to Runway 10/28

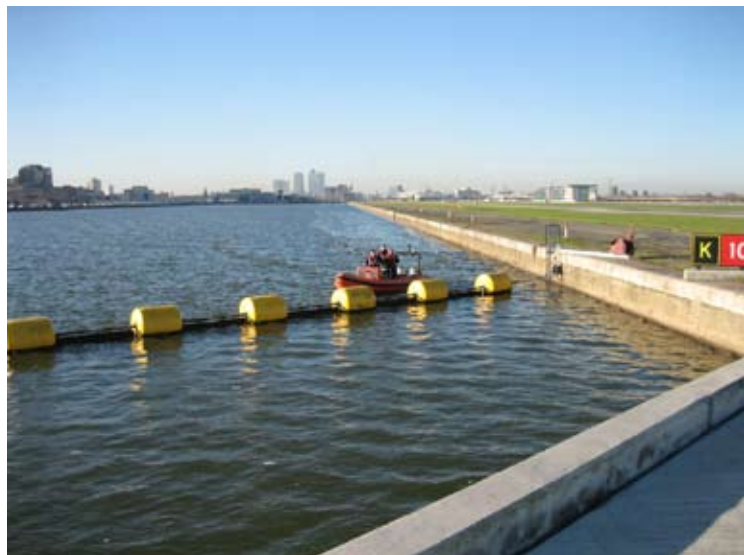
Figure 11

The London City Airport Fire and Rescue Service (AFRS) operates three rapid intervention rigid inflatable boats (RIBS), Figure 11, two of which are on standby at any one time, and which are capable of deploying buoyancy aids. Two towable slide rafts can be used in conjunction with the RIBS, which are capable of seating up to 60 persons. Both RIBS are positioned on the south side of the runway at a location which ensures the minimum of delay in their deployment by the AFRS.

Photograph taken from point A in Figure 10, looking west, showing one of the rapid intervention boats, and illustrating the proximity of the southern 'old' dock to the taxiway and runway
