AIRCRAFT ACCIDENT REPORT 5/2009

**Report on the serious incident to
BAe 146-200, registration EI-CZO
at London City Airport
on 20 February 2007**

Air Accidents Investigation Branch**Aircraft Accident Report No: 5/2009 (EW/C2007/02/06)**

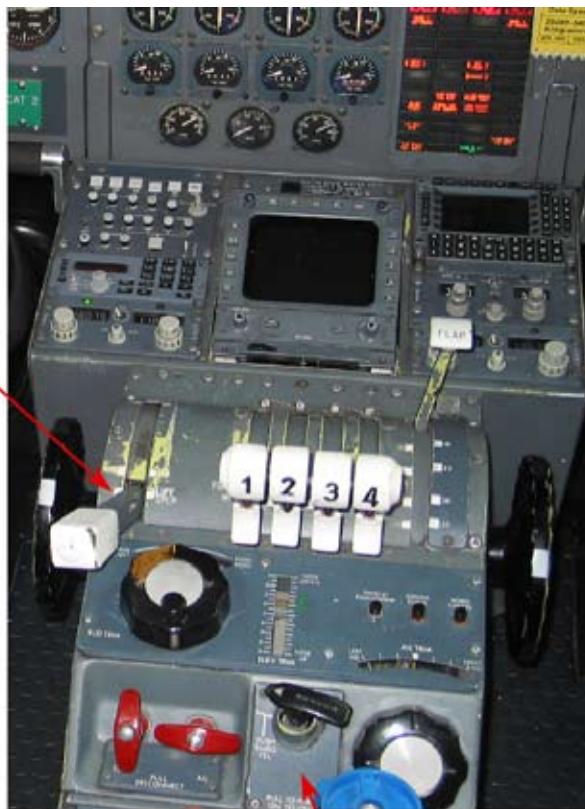
Figure 4

Airbrake/lift spoiler lever location

The aircraft examination revealed no defects that could explain the reason for the lift spoilers not deploying on landing. However, tests on the airbrake/lift spoiler lever did show that it was very easy to move the lever forward from 'lift-spoiler' to the full 'airbrake' position, due to the lack of friction in the mechanism. Indeed, during the aircraft tests it was noted that just nudging the lever whilst in the lift spoiler detent, caused the deployed lift spoilers to retract. With this lack of resistive force, it is possible that a lever that has already been placed in the lift-spoiler position by the pilot in the left seat, could be nudged or vibrated out of the selection, thereby stowing the deployed spoilers.

It is recommended that the European Aviation Safety Agency should mandate BAe Systems Service Bulletin 27-73-00889 for the BAe 146 series of aircraft, which increases the operating force in the forward direction from zero to 12 lb, of the lift spoiler/airbrake selector lever, to prevent the lever moving forward under the influence of vibration or being inadvertently nudged forward during the landing roll. (**Safety Recommendation 2008-062**)

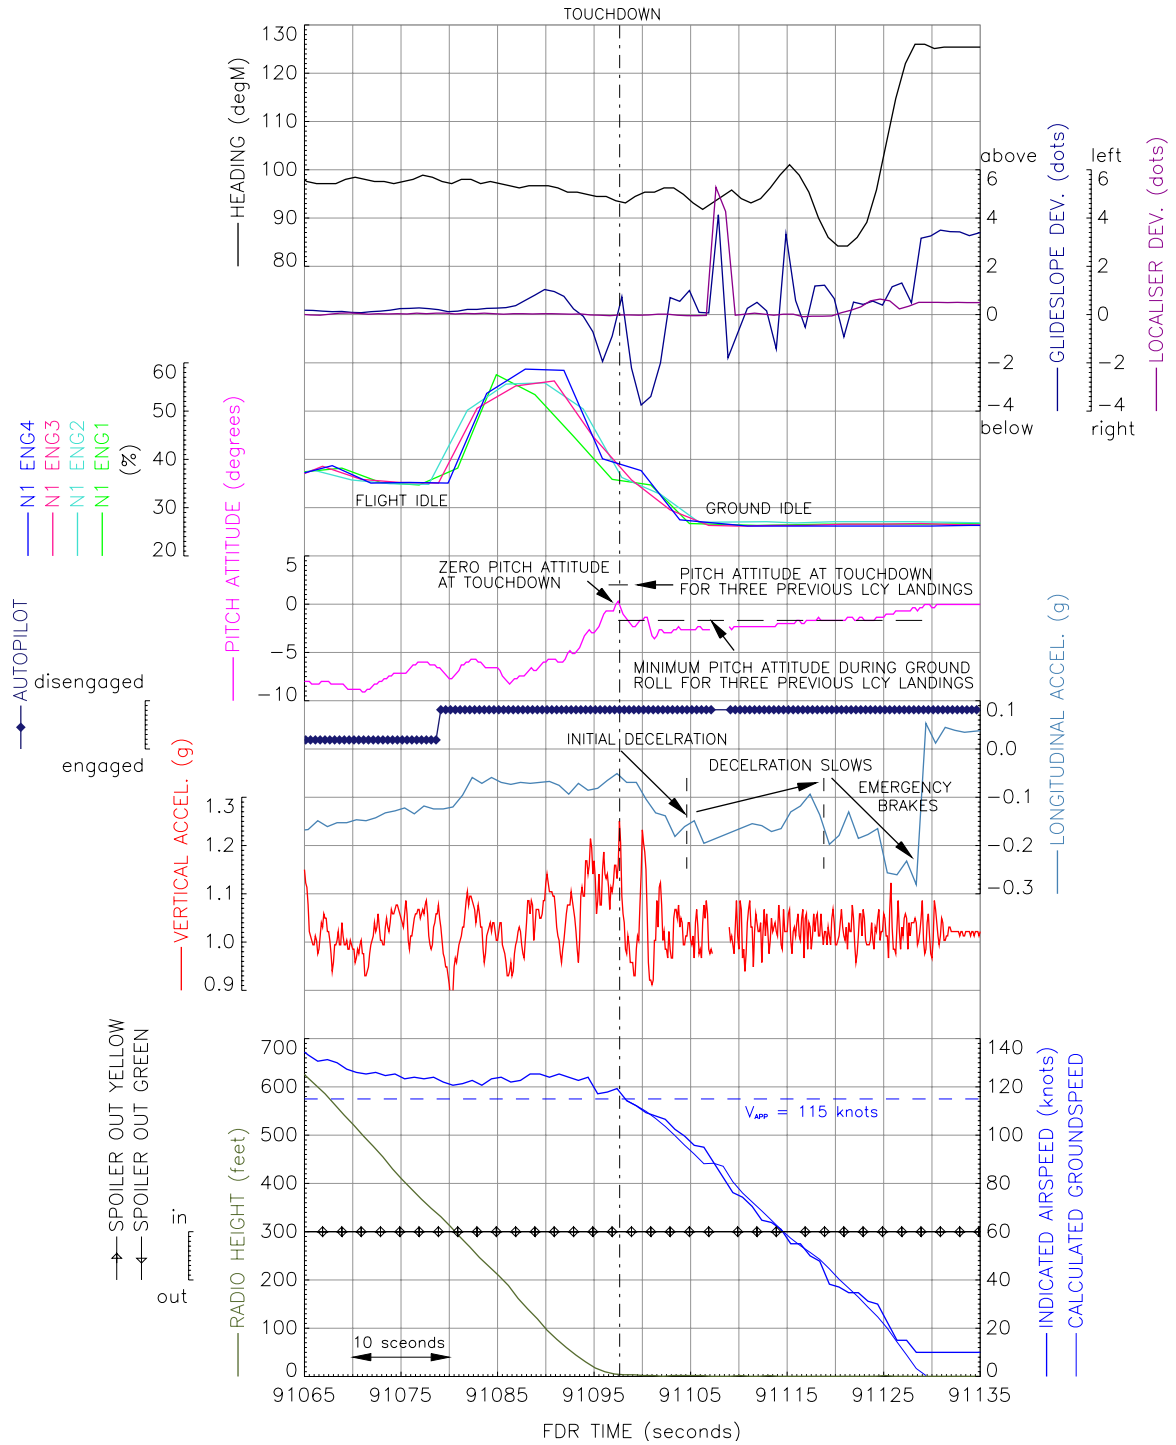
Figure 7
Salient FDR Parameters

At 380 ft agl, with the airspeed at 124 kt (ie, $V_{APP} +9$), the autopilot disengaged while the engine thrust increased. The thrust reached between 55% and 59% N_1 eight seconds later, as EI-CZO passed through 200 ft agl, before reducing back to about fight idle just before touchdown⁵. As the thrust decreased, the pitch attitude increased (at a rate of no more than 1°/second) until touchdown.

From initial touchdown, the aircraft slowed to a halt over a period of 31 seconds during which it veered to the left and right with increasing amplitude, until finally veering off to the right on a heading of 126°M. Three distinct phases of deceleration were noted:

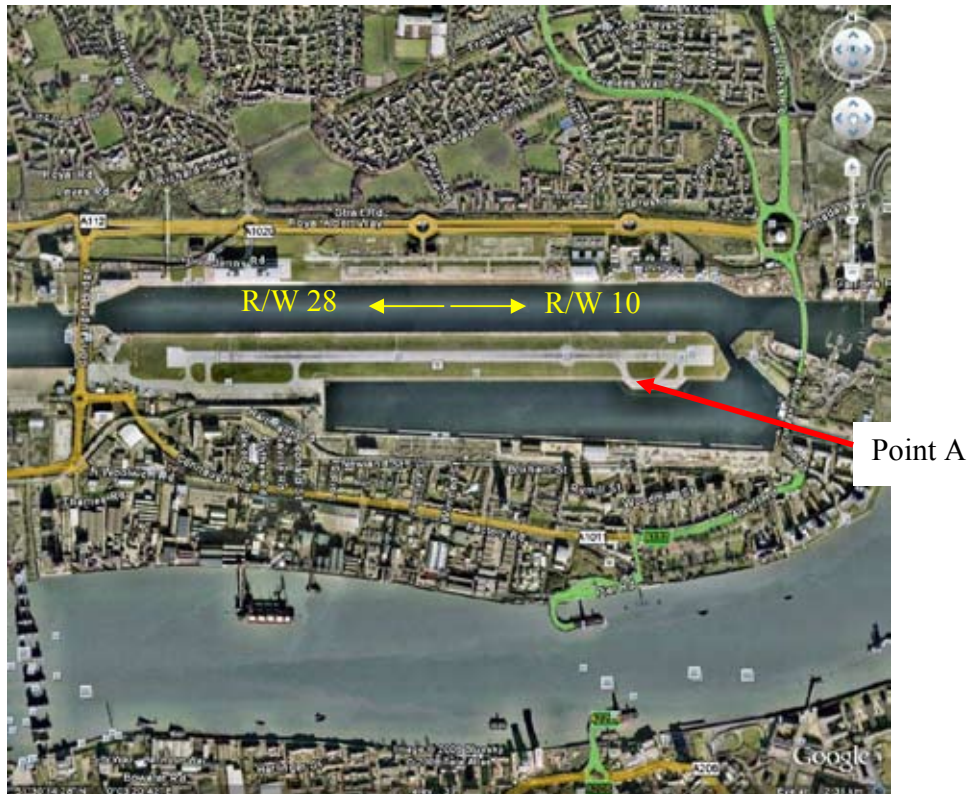
Figure 10

The overrun area for Runway 10 at LCY is 192 m, and the Runway End Safety Area (RESA) is 132 m. The RESA therefore forms the majority of the overrun area and exceeds the ICAO recommended length of 120 m for a code two instrument runway. Runway 10 overrun area does not include an arrestor bed; although, the paved surface is grooved. Beyond this area is a small water channel linking the two main water-filled areas of the old dock, located either side of the runway, Figure 10. Overshooting the paved surface or departing the runway to the side would, therefore, carry a significant risk of an aircraft entering the water, possibly in a damaged condition.

Photograph illustrating the nature of the undershoot and overrun areas, and the proximity of the water-filled docks to Runway 10/28

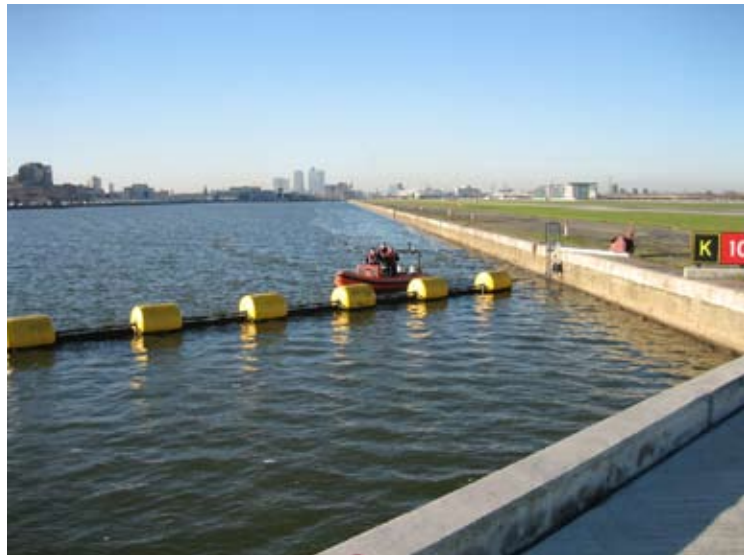
Figure 11

The London City Airport Fire and Rescue Service (AFRS) operates three rapid intervention rigid inflatable boats (RIBS), Figure 11, two of which are on standby at any one time, and which are capable of deploying buoyancy aids. Two towable slide rafts can be used in conjunction with the RIBS, which are capable of seating up to 60 persons. Both RIBS are positioned on the south side of the runway at a location which ensures the minimum of delay in their deployment by the AFRS.

Photograph taken from point A in Figure 10, looking west, showing one of the rapid intervention boats, and illustrating the proximity of the southern 'old' dock to the taxiway and runway
