Aircraft Type and Registration:	Grob G115E Tutor, G-BYXJ	
No & Type of Engines:	1 Lycoming AEIO-360-B1F piston engine	
Year of Manufacture:	2001	
Date & Time (UTC):	29 June 2004 at 1650 hrs	
Location:	4.5 nm Southwest of Salisbury, Wiltshire	
Type of Flight:	Training	
Persons on Board:	Crew - 2	Passengers - None
Injuries:	Crew - Nil	Passengers - N/A
Nature of Damage:	One propeller blade, part of propeller hub and canopy detached; substantial damage to engine and airframe	
Commander's Licence:	Royal Air Force Qualified Flying Instructor	
Commander's Age:	28 years	
Commander's Flying Experience:	1,450 hours (of which 215 were on type) Last 90 days - 60 hours Last 28 days - 20 hours	
Information Source:	AAIB Field Investigation

Synopsis

The aircraft was completing an aerobatic manoeuvre when one of the propeller blades separated from the hub. Despite severe vibration, the pilot was able to shut down the engine quickly and perform a successful forced landing in a field. There were no injuries to either crew member.

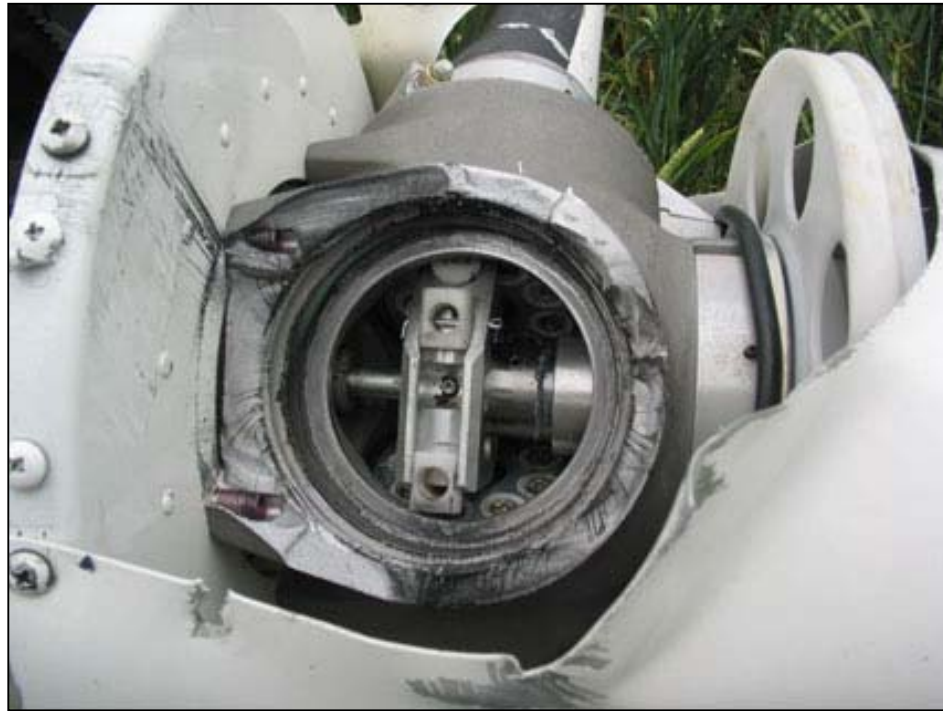
Figure 1

The aircraft had landed in a cornfield and was intact, except for the canopy, the No 1 propeller blade and a section of the propeller hub, which were missing. It was evident that the No 1 propeller blade had detached due to a fracture of the blade socket of the aluminium alloy hub (Figure 1). The fracture, which appeared to originate in the threads inside the blade socket, allowed the outer part of the blade socket and the blade retaining nut to separate from the hub, thus releasing the propeller blade. The departing blade was struck by the following (No 3) blade, causing the detachment of a large portion of the latter (Figure 2).

The cause of the propeller failure was a fracture of the No 1 blade socket due to extensive fatigue crack propagation culminating in an overload failure that allowed the No 1 blade to detach from the hub. The presence of fatigue origins on opposite sides of the blade socket, with similar crack propagation rates on either side, suggests that the propeller blade had been subjected to cyclic stresses possibly related to vibration. The presence of a small fatigue crack in the No 2 blade socket, in a similar location to one of the crack origins of the No 1 socket, suggests that the No 2 blade may have been similarly affected.

Propeller hub showing fractured No 1 blade socket

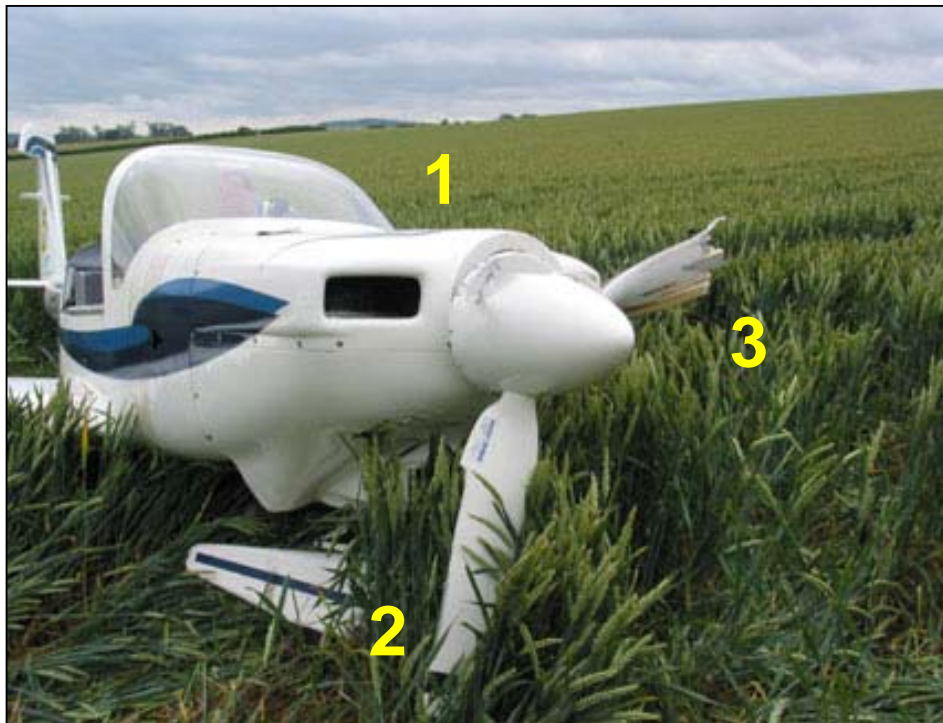
Figure 2

General view of propeller damage (blade locations numbered)

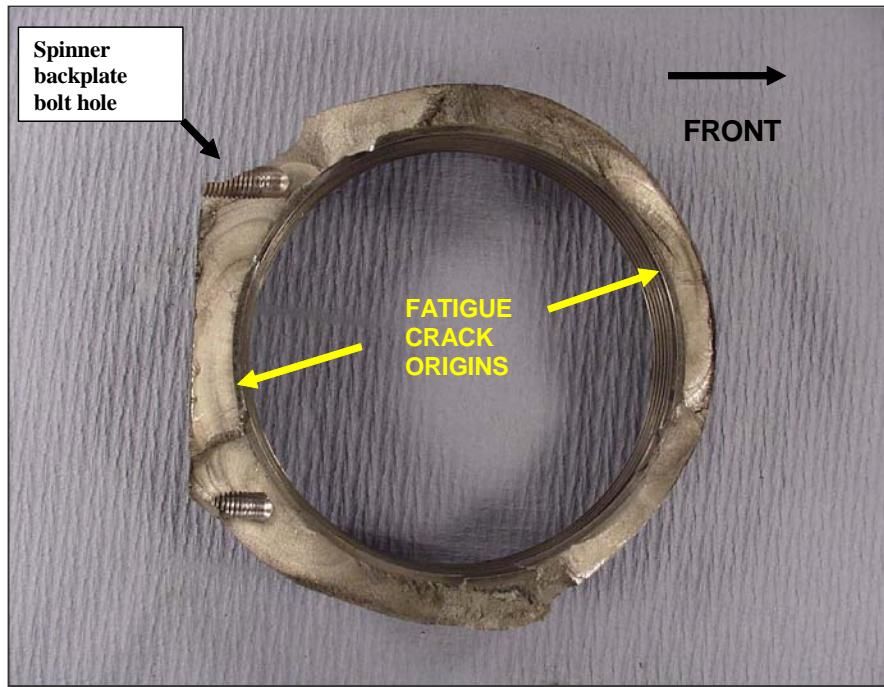
Figure 5

Examination of the fracture surface on the No 1 blade socket showed that it had fractured due to the initiation and growth of high-cycle fatigue cracks, on opposite sides of the blade socket (Figure 5). The centres of the primary crack initiation zones were displaced about 20 degrees clockwise (looking down on the blade socket) from the fore/aft axis of the hub. The cracks originated in the first or second threads from the bottom of the threaded portion of the socket, corresponding to the most highly loaded threads. A notable feature was that the initial direction of propagation, near the crack origins, was in an axial direction upwards, with the cracks undercutting the tooth of the thread. This appeared to be the result of bending loads applied to the blade socket threads by the blade retaining nut (see Figure 7 showing a similar crack in No 2 blade socket). The fatigue cracks then turned outwards in a predominantly radial direction, before propagating circumferentially around the blade socket until failure, with relatively small regions of overload.

Measurements of the fatigue striation spacing on the fracture surface of the No 1 blade socket with the aid of a scanning electron microscope gave an estimate of 225,000 cycles from crack initiation to failure of the blade socket. This figure is considered to be conservative and does not in any case include the number of stress cycles required to initiate the cracking. It was not possible to estimate the length of time taken to form crack initiation to failure without a better understanding of the mode and frequency of the blade vibration, but this could not be determined from the available evidence.

The high cycle fatigue failure observed in hub G22, with primary crack origins located on opposite sides of the blade socket and with similar rates of crack propagation in each location (Figure 5), is indicative of the blade socket having been subjected to cyclic stresses. The direction of the applied forces on the blade to produce such stresses is predominantly in the fore and aft direction.

View on underside of separated portion of No 1 blade socket of Hub G22 showing locations of fatigue crack origins

It is recommended that Hoffmann Propeller GmbH & Co KG introduce suitable maintenance procedures, or a suitable technical solution, for the type HO-V343K-V/183GY propeller on the Grob G115E, to ensure that the preload of the propeller blade retaining nut is maintained at an acceptable level.

It is recommended that Hoffmann Propeller GmbH & Co KG introduce adequate, high confidence level, non-destructive test (NDT) procedures, that will detect cracks in the threads of the type HO-V343K-V/183GY propeller blade sockets during overhaul and whilst in operational service on Grob G 115E aircraft.

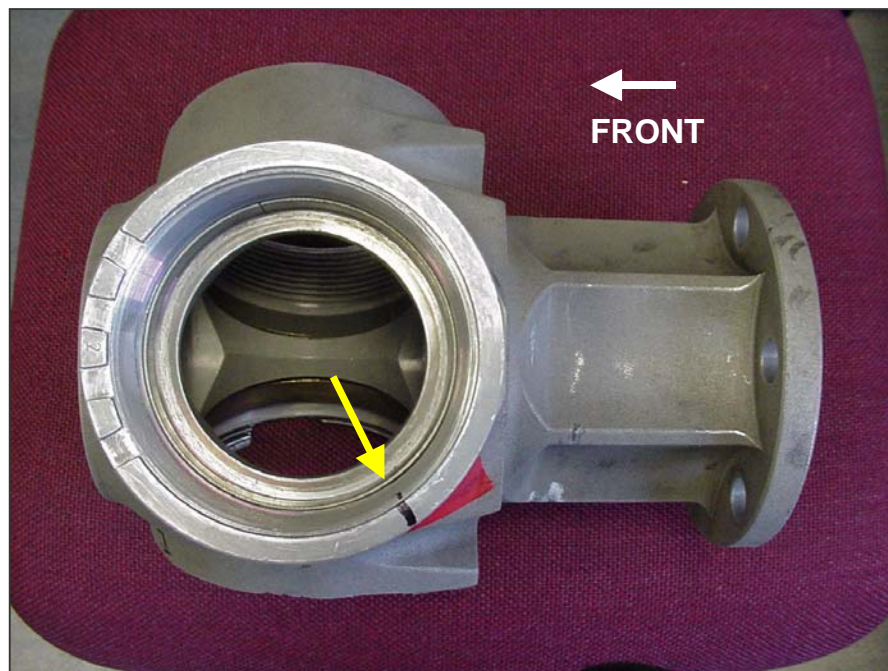
Figure 6

When the threads in the No 2 and No 3 blade sockets were inspected using the 2 MHz eddy current procedure specified in Service Bulletin 61-10-03 SB E 15, a large defect indication was found in the No 2 blade socket. Visual inspection using an optical microscope at low power confirmed the presence of an approximately 8 mm long crack at the base of the thrust flank of the first full thread in the bottom of the socket. This was in a similar circumferential location to one of the secondary fatigue crack origins in the No 1 blade socket (Figure 6). A section taken through the crack revealed that the direction of propagation was axial, undercutting the tooth of the thread (Figure 7). The depth of the crack into the material was approximately 2 mm. When the crack was opened up to allow the surface to be viewed, evidence of fatigue propagation was seen.

The fact that the crack in the No 2 blade socket of hub G22 exhibited similar characteristics to the cracks in the failed No 1 socket, in that it was located at the base of the thrust flank of the bottom thread and was propagating in fatigue, suggests that a similar failure mechanism may have been at play in the No 2 socket.

Circumferential location of crack in bottom thread of Hub G22 No 2 blade socket

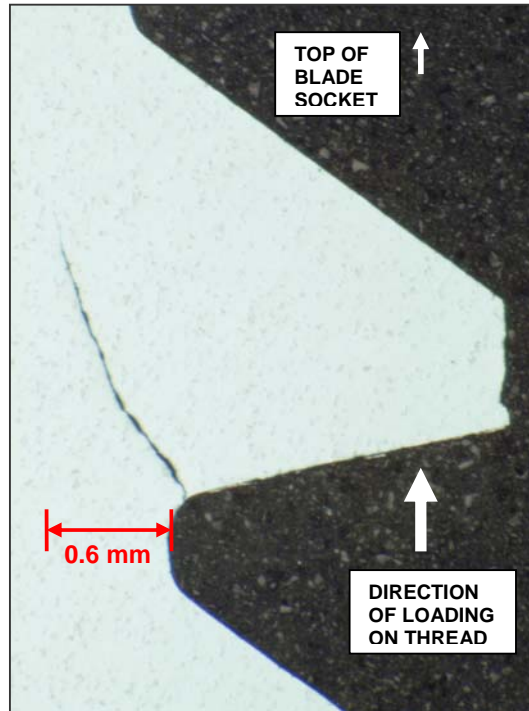
Figure 7

Fatigue crack in bottom thread of Hub G22 No 2 blade socket
(Crack penetration depth approximately 2mm; crack detected using 2 MHz eddy current procedure)

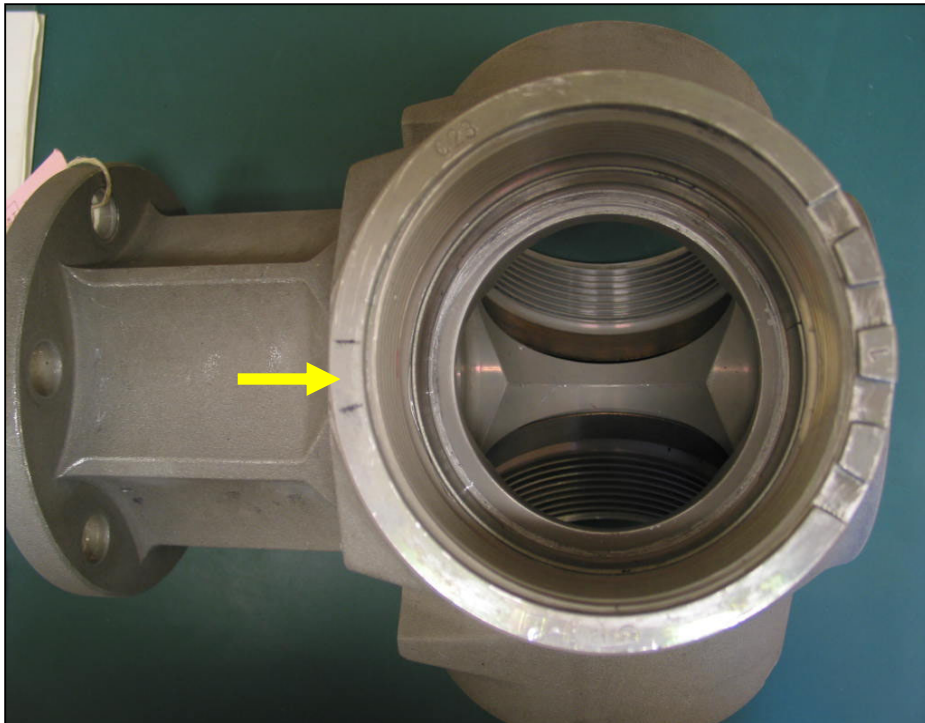
Figure 8

Hub G23, that had failed the initial eddy current crack check on the fleet, was sent to the AAIB for initial examination before being returned to the propeller manufacturer for further investigation. Examination, under a low power microscope, revealed a crack indication in the bottom thread in the region of the eddy current defect indication in the No 1 socket. The crack indication was located towards the rear of the blade socket and near the base of the thrust-bearing flank of the bottom thread (Figures 8 & 9). The external appearance and general location of the crack indication were similar to that of the crack found in the No 2 socket of hub G22.

Circumferential location of crack indication in bottom thread of No1 blade socket - Hub G23

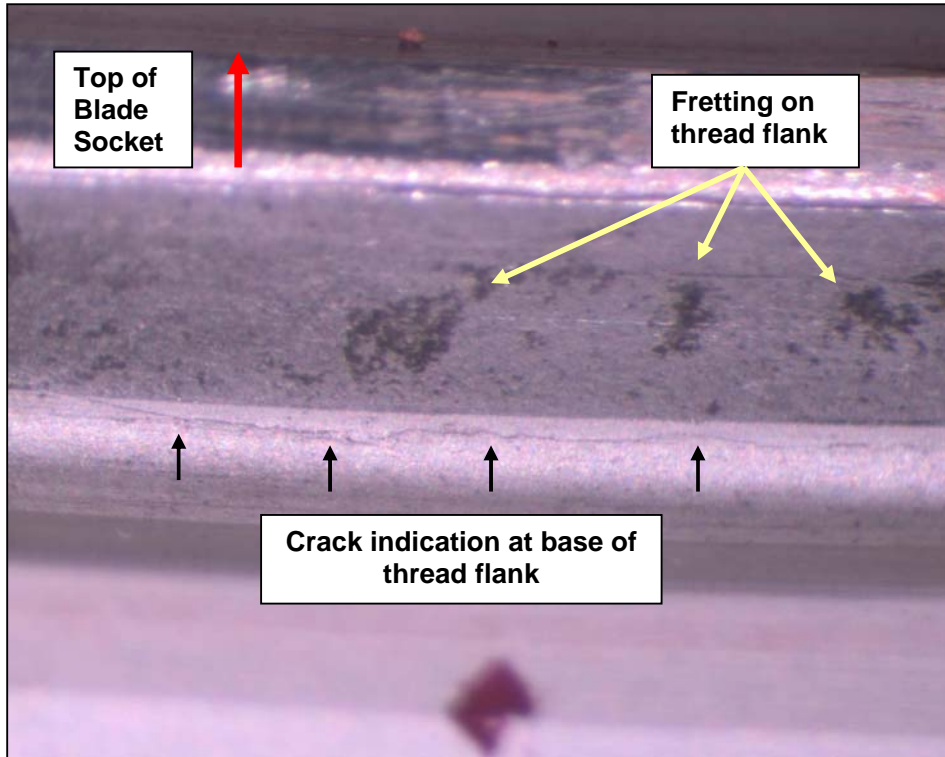
Figure 9

Visual appearance of crack indication - Hub G23
