SERIOUS INCIDENT

Aircraft Type and Registration:	Britten-Norman Islander BN-2B-26, VP-MNT	
No & Type of Engines:	2 Lycoming O-540 piston engines	
Year of Manufacture:	1987 (Serial no: 2186)	
Date & Time (UTC):	16 October 2012 at 1340 hrs	
Location:	John A Osborne Airport, Montserrat	
Type of Flight:	Commercial Air Transport (Passenger)	
Persons on Board:	Crew - 1	Passengers - 6
Injuries:	Crew - None	Passengers - None
Nature of Damage:	None	
Commander's Licence:	Federal Aviation Administration Commercial Pilots Licence with Air Safety Support International validation	
Commander's Age:	31 years	
Commander's Flying Experience:	700 hours (of which 348 were on type) Last 90 days - 92 hours Last 28 days - 31 hours	
Information Source:	AAIB Field Investigation

Synopsis

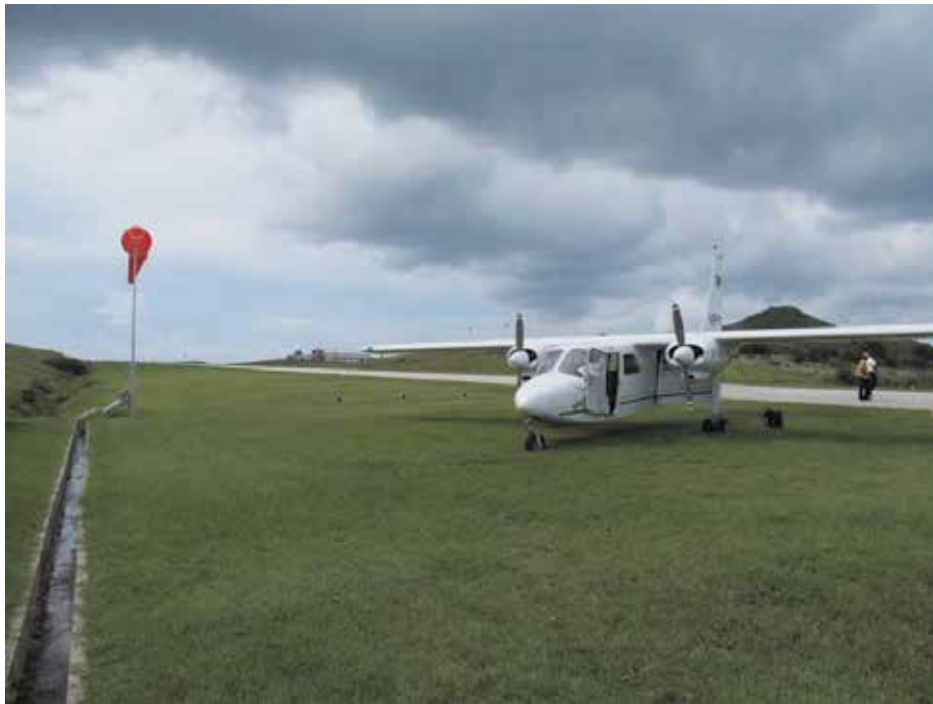
Figure 1

The pilot then perceived that the aircraft would not stop before the end of the runway. So he elected to manoeuvre it off the runway to avoid running over the cliff beyond the runway end. He turned the aircraft to the right onto the grass south of the runway stop-end (Figure 1).

The aircraft at rest after the runway excursion

The aircraft had come to rest south of the Runway 10 stop end. There were two sets of skid marks on the runway which transitioned to wheel tracks at the runway edge, ending at the main wheels of the aircraft.

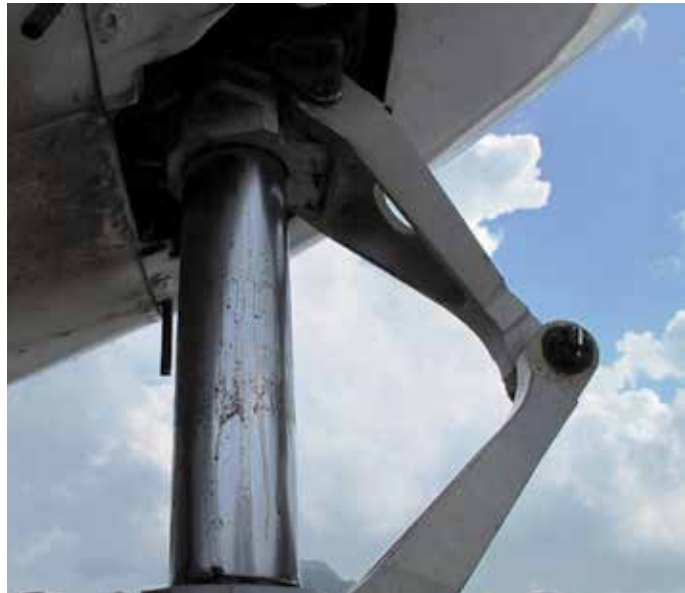
Figure 2

The tyres were examined for wear or flat spots and appeared to be satisfactory. The nose of the aircraft was supported on a trestle and the nose landing gear examined for play; none was apparent. Hydraulic fluid had leaked from the oleo assembly onto the 'Fescolized' portion² of the nose landing gear strut, as shown in Figure 2. It was not possible to determine if the leak had resulted from the incident but there was no evidence that the fluid had been blown back by airflow as might occur in flight. The operator's engineer, who had conducted checks on the aircraft that morning, recalled that there was no evidence

The nose landing gear oleo

of such a leak during his checks. The aircraft brakes operated satisfactorily when checked.

The engineering investigation did not identify any malfunctions or abnormalities to account for the nosewheel shimmy. The seals in the nosewheel oleo appeared normal. The fluid evident on the nosewheel oleo may have been an artefact of the shimmy, if the motion between the piston and cylinder disrupted the sealing of the oleo to the extent that fluid escaped.

The operator decided to replace the nose landing gear assembly, but facilities for that task were not available on Montserrat. Following taxi trials, during which the aircraft behaved normally, it was flown to the operator's contracted maintenance facility where the work was carried out. The pilot who flew the aircraft to the maintenance facility reported that it behaved normally, with no shimmy apparent. The maintenance organisation did not report any abnormality discovered during the component change.
