INCIDENT

Aircraft Type and Registration:	Fokker F28 Mark 0100, G-BXWE	
No & Type of Engines:	2 Rolls-Royce Tay 650-15	
Year of Manufacture:	1991	
Date & Time (UTC):	14 August 2004 at 1940 hrs	
Location:	London Heathrow Airport, London	
Type of Flight:	Public Transport (Passenger)	
Persons on Board:	Crew - None	Passengers - None
Injuries:	Crew - None	Passengers - N/A
Nature of Damage:	None	
Commander's Licence:	Airline Transport Pilot's Licence	
Commander's Age:	Not known	
Commander's Flying Experience:	Not known	
Information Source:	AAIB Field Investigation

Synopsis

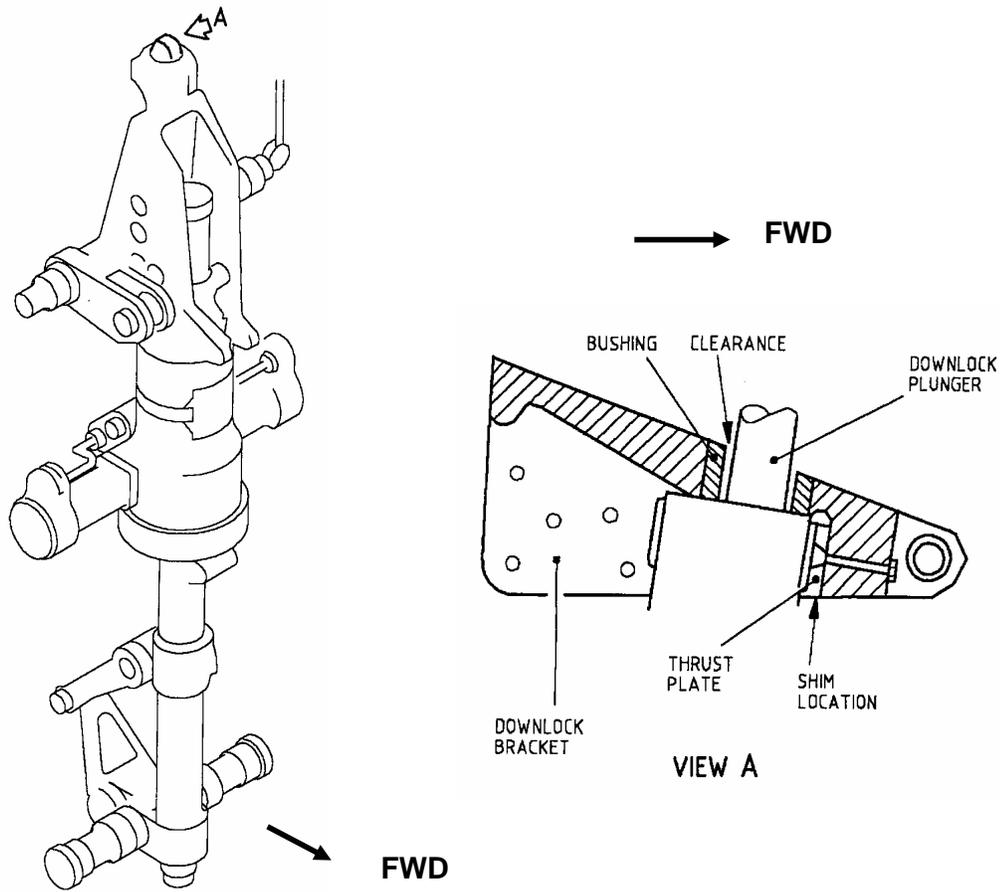
Figure 2

The nose landing gear on the Fokker F28 Mark 0100 is of the forward-retracting type. The gear is locked in the down position by a spring-loaded plunger mounted on the top of the leg (see Figure 2). During gear extension, the plunger contacts a ramp on the downlock bracket, which compresses the plunger into its housing against the force of the spring. When the gear is in the fully down position, the plunger lines up with a hole at the base of the ramp and extends under spring pressure, thus locking the leg in position. The extension of the plunger triggers the nose gear down and locked proximity sensors to illuminate the green gear indication light in the cockpit.

The downlock bracket is shimmed, to ensure that the downlock plunger is located centrally in the hole when the gear is down. If the clearance is incorrect, the downlock plunger may be prevented from fully extending due to the excessive friction caused by the plunger being forced against the sides of the hole. If the plunger is not fully extended, the down and locked proximity sensors may not be triggered.

The aircraft was subsequently on a Base Maintenance check between 19 and 28 September 2004, during which the downlock plunger clearance was rechecked after further consultation with the aircraft manufacturer. On this occasion, the clearance was found to be outside the Aircraft Maintenance Manual (AMM) limits of 0.003 to 0.020 inch and the shimming was adjusted to increase the clearance to bring it within limits. According to the aircraft manufacturer, too small a clearance increases the chances of the downlock plunger not fully engaging, due to the increased friction on the plunger caused by the misalignment.

On reviewing the AMM procedure for checking the downlock plunger clearance, the airline's Engineering Quality Department noted that the procedure was ambiguous, in that it did not make it clear that it is necessary to apply a rearward force on the nose landing gear when checking the downlock plunger clearance. Failing to do so will result in an incorrect measurement being obtained.

The nose landing gear on G-BXWE was replaced in June 2003, following a towing incident. It is thought that the downlock plunger clearance may not have been correctly rigged after the nose gear was installed, because of the ambiguity in the AMM procedure. This might also explain why no anomalies were found during troubleshooting after this event and the previous event in September 2003. In-service wear tends to increase the downlock plunger clearance and thus too small a clearance could only have resulted from incorrect maintenance procedures.

Nose Landing Gear Downlock Mechanism

In response to the airline's recommendation, the aircraft manufacturer has agreed to amend AMM subtask 32-21-01-220-024-A00 and task 32-21-01-200-836-A to include a step to clarify that a second person is required to apply a rearward force to the nose gear when measuring the downlock plunger clearance, in order to obtain an accurate measurement.
