**ACCIDENT**

<b>Aircraft Type and Registration:</b>	Agusta A109A II, N2NR	
<b>No &amp; Type of Engines:</b>	2 Allison 250-C20 SER turboshaft engines	
<b>Year of Manufacture:</b>	1986	
<b>Date &amp; Time (UTC):</b>	23 October 2010 at 1448 hrs	
<b>Location:</b>	Shanlieve, Mourne Mountains, Northern Ireland	
<b>Type of Flight:</b>	Private	
<b>Persons on Board:</b>	Crew - 1	Passengers - 2
<b>Injuries:</b>	Crew - 1 (Fatal)	Passengers - 2 (Fatal)
<b>Nature of Damage:</b>	Aircraft destroyed	
<b>Commander's Licence:</b>	Airline Transport Pilot's Licence	
<b>Commander's Age:</b>	63 years	
<b>Commander's Flying Experience:</b>	12,733 hours (of which 1,634 were on type) Last 90 days - 50 hours Last 28 days - 21 hours	
<b>Information Source:</b>	AAIB Field Investigation

**Synopsis**

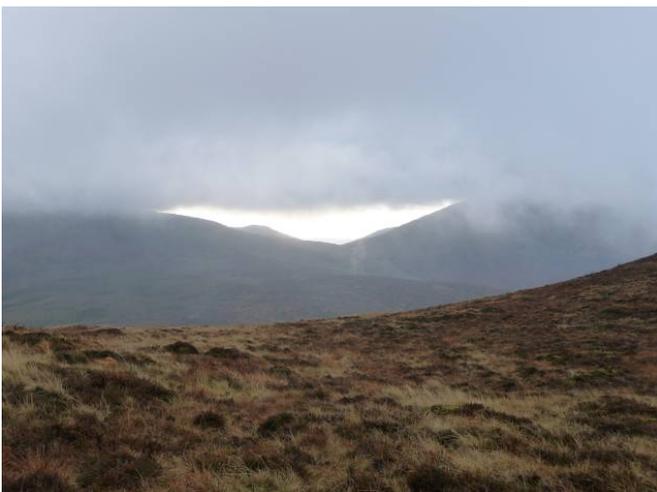
**Figure 1**

From the photographs, the cloudbase at that time was later estimated at 1,600 ft to 1,700 ft. As he continued, the cloudbase descended, with visibility in the cloud reduced to approximately 150 metres. He descended from Slievemoughanmore into the saddle of Windy Gap (elevation 1,377 ft) and could not recall being clear of the cloud at that height. He arrived at the summit of Shanlieve with the visibility still about 150 metres and at about 1415 hrs he descended towards Pierces Castle. He was approximately 300 metres north of Pierces Castle when he heard a helicopter pass overhead, followed by the sound of an impact. He did not see the helicopter but notified the police using his mobile telephone and commenced a search. He met up with the three other walkers, who had been on Castle Bog and had also heard the helicopter pass overhead. They eventually located the accident site in the cloud.

View from Cock Mountain, looking southeast towards the coast at 1138 hrs

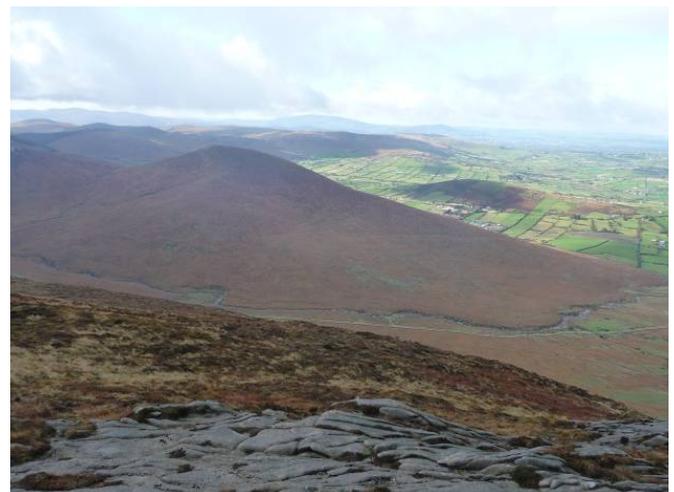
**Figure 2**

View from Cock Mountain at 1138 hrs, looking west towards the direction from which N2NR approached at about 1445 hrs

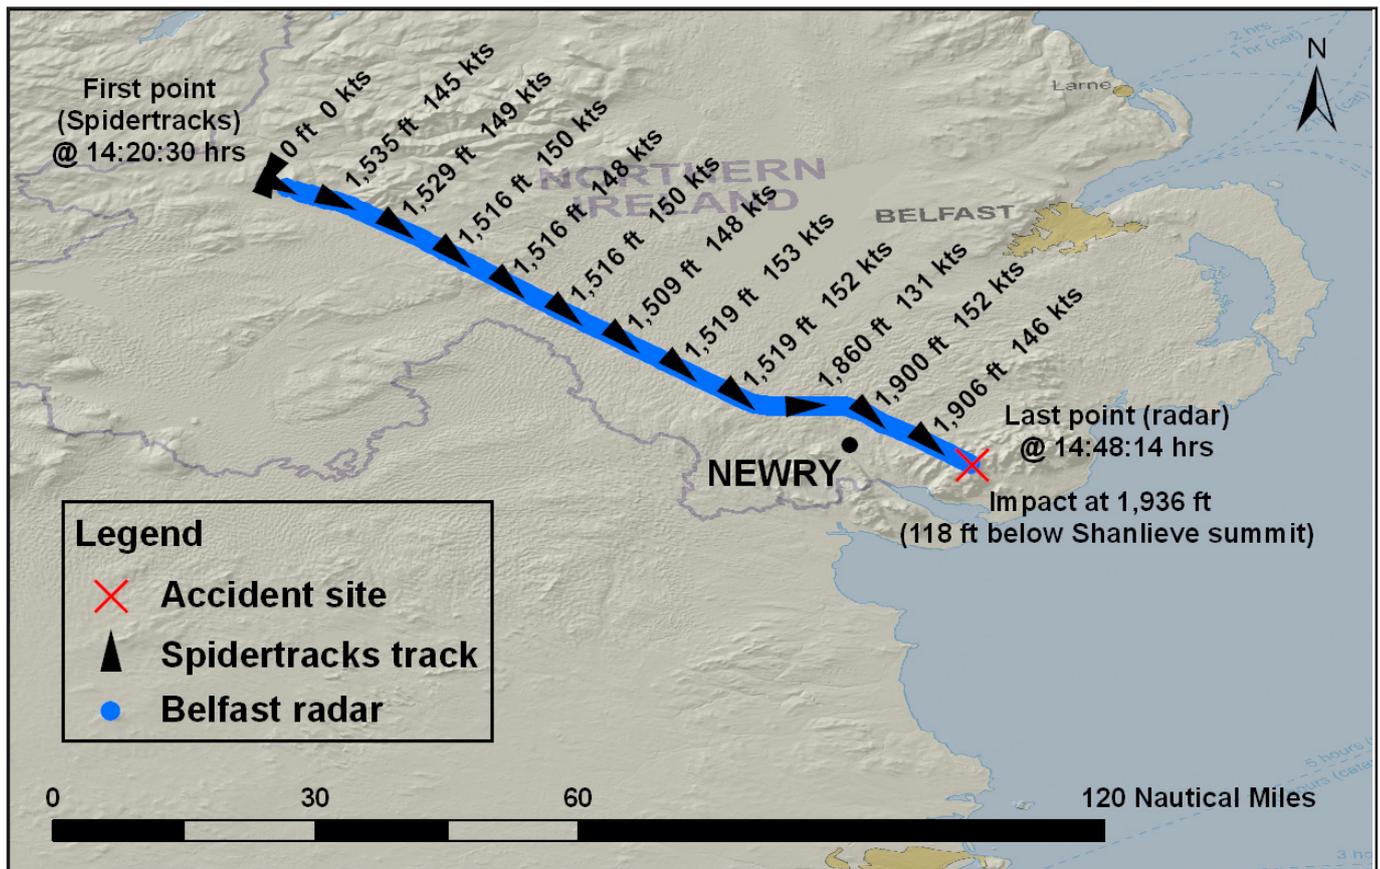
**Figure 3**

Accident track of N2NR from radar and GPS sources  
(showing height amsl & groundspeed, at two-minute intervals)

The initial track, towards Newry, was flown at 1,630 ft<sup>1</sup> (based on 1007 mb) with a groundspeed of about 150 kt. At 1440:45 hrs, approximately 8 nm from Newry, the helicopter started a turn left through 40° onto an easterly track. The helicopter also climbed to 2,030 ft (based on 1007 mb) during which the groundspeed reduced to 130 kt before returning to

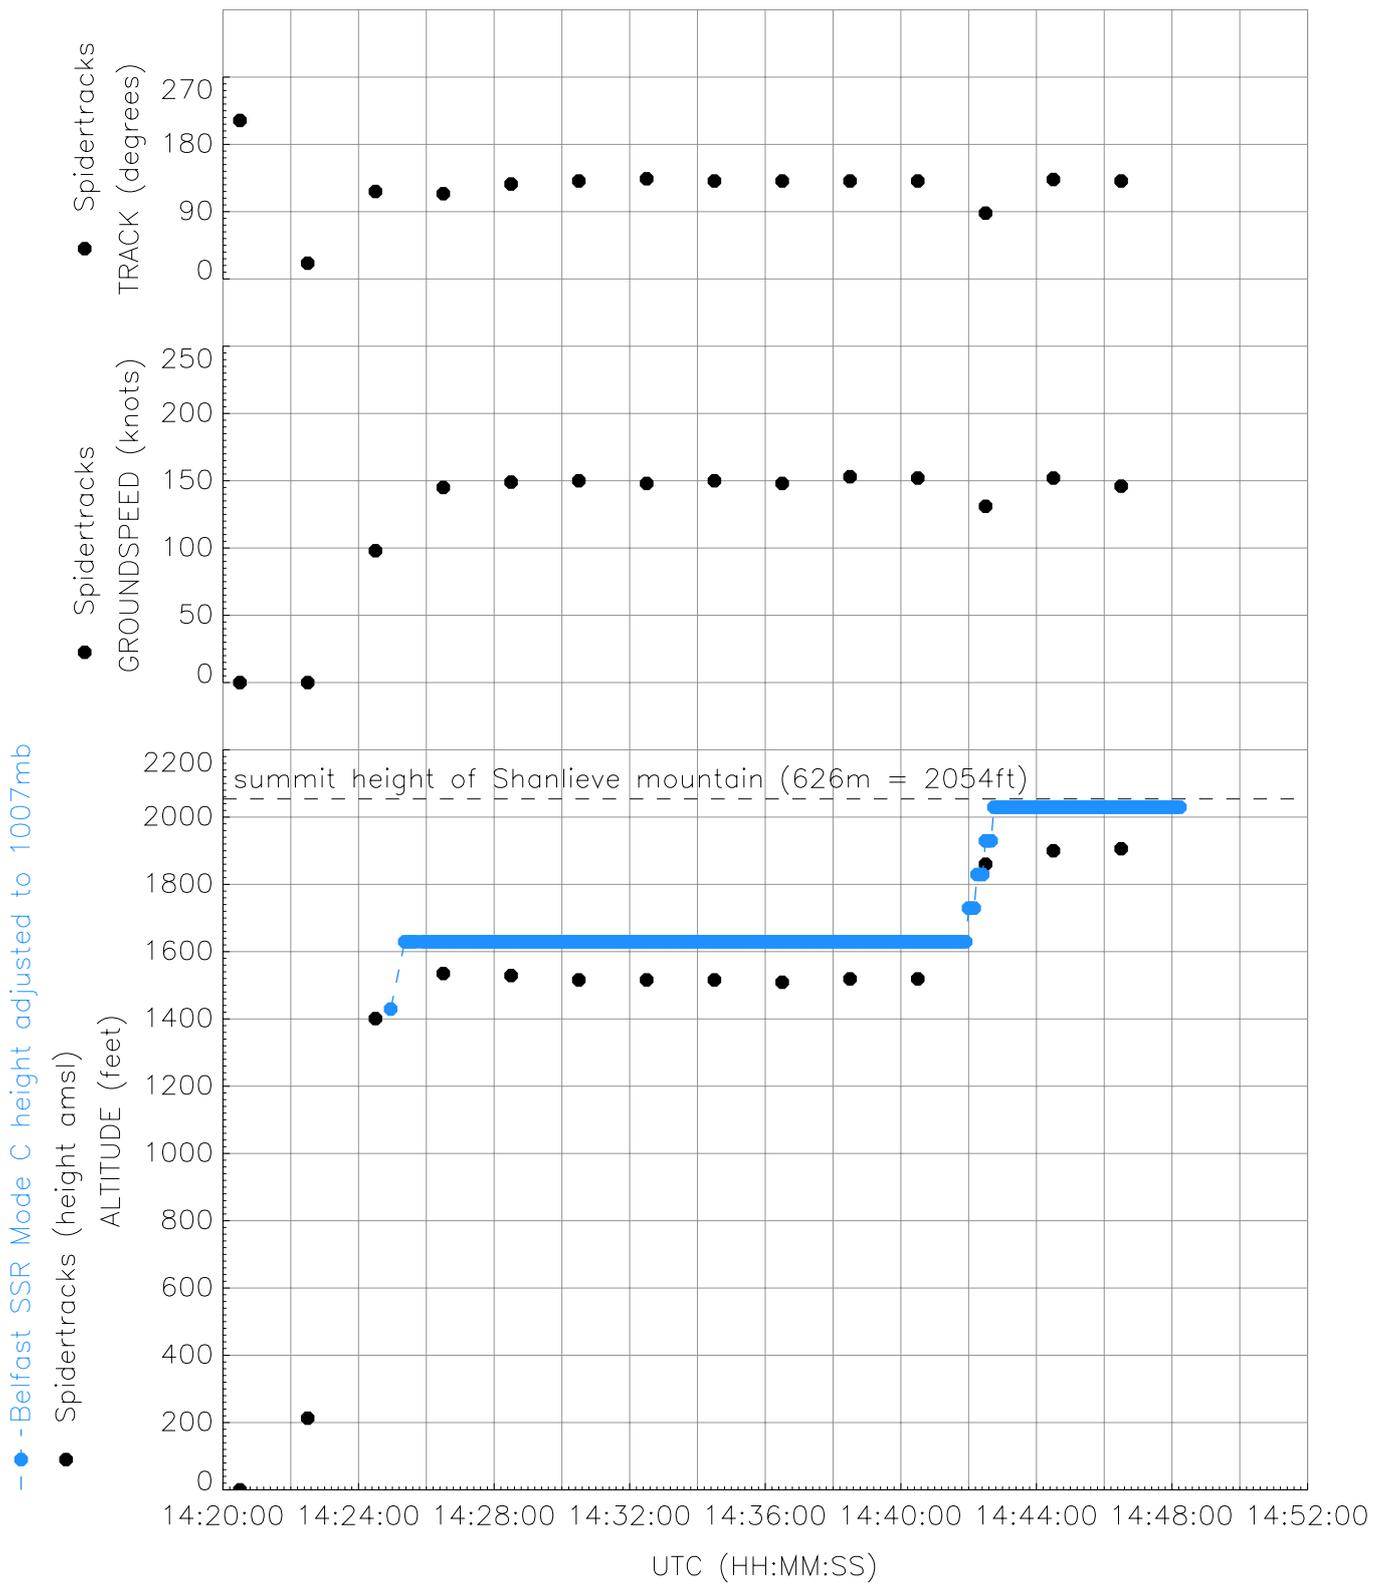
**Figure 4**

Recorded data from the Spidertracks GPS during the accident flight, with Mode C pressure altitude, corrected to 1007mb

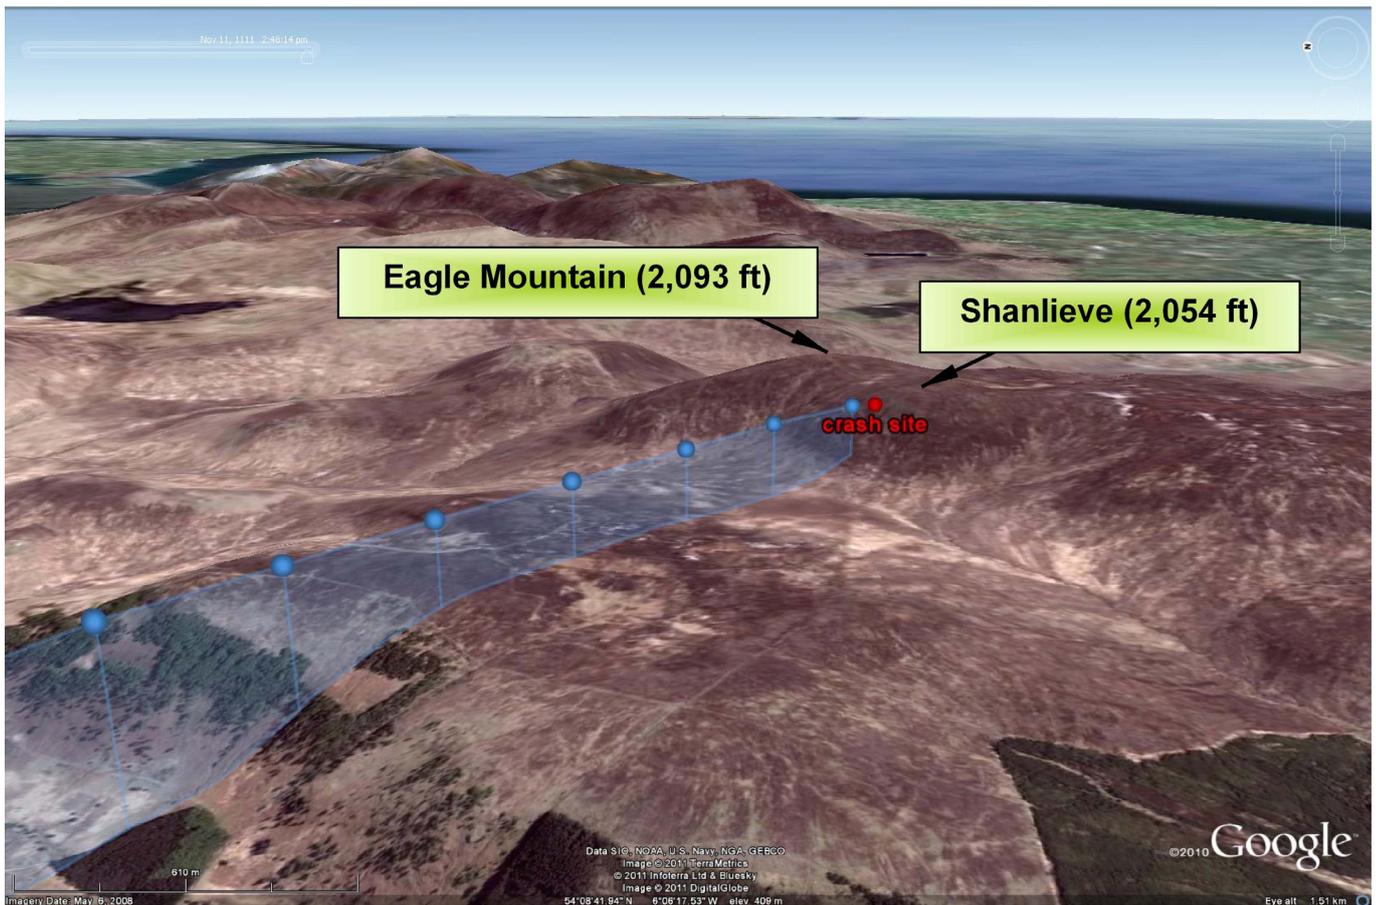
**Figure 5**

Final portion of the accident track, based on radar data, and crash site

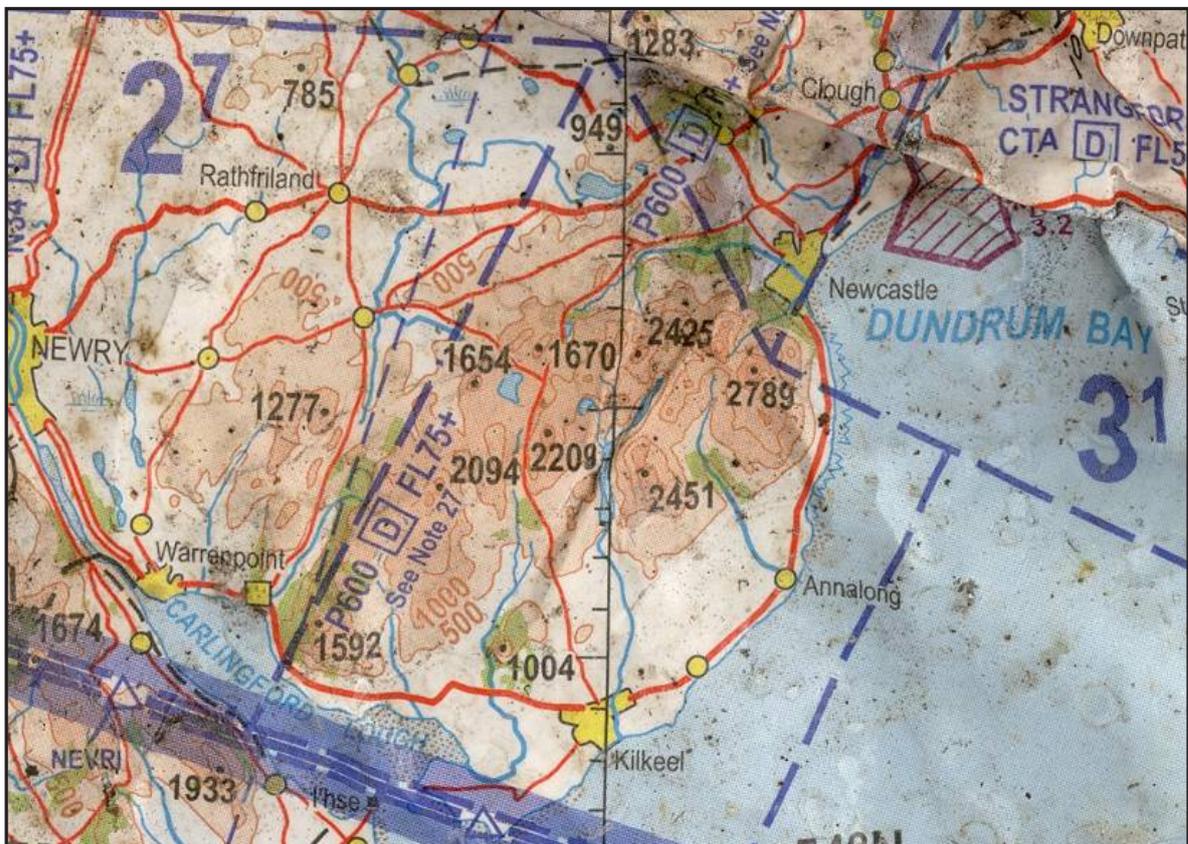
**Figure 6**

The pilot's 1:500 000 map showing terrain colouring and spot heights with Maximum Elevation Figures

At this range, and with the rising ground leading up to Castle Bog and the upper slopes and ridge of Shanlieve visible, the Northern England and Northern Ireland chart (Figure 6) can be related to the terrain ahead. This shows a spot height of 1,277 ft, rising initially to 2,094 ft and 2,209 ft on the projected track. With the upper heights of the terrain obscured by cloud, from and including Castle Bog, use of the chart becomes more difficult. As the distance to Shanlieve reduces, and the helicopter passes over the Altataggart mountain area as shown in Figure 11, the Shanlieve ridge becomes the dominant feature (Figure 12). From 2,000 ft, the area of Castle Bog is some 600 ft below and, providing the helicopter position is accurately known and the spot heights have been checked, the pilot would be aware that there is higher ground still ahead.

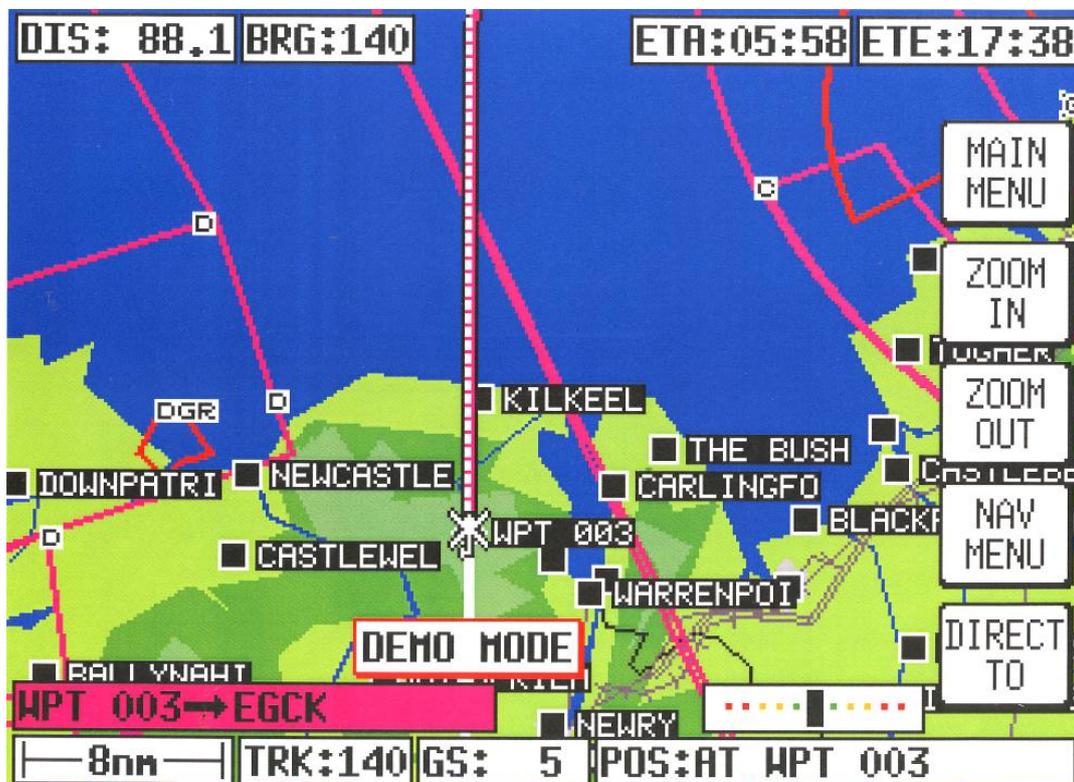
The two 'screen prints', Figures 7 and 9, are examples of the information provided. Figure 7 shows the helicopter at the point of the first left turn with a 30 nm scale set and a direct track to Caernarfon selected. Figure 9 shows the position of the helicopter immediately prior to impact with an 8 nm scale selected. It should be noted from both screen prints that the area of the Mourne Mountains is depicted using two shades of green. The shaded areas do not contain any spot heights, or the brown colour representing the terrain between 2,000 ft

Skymap IIIC screen print on 8 nm range, showing no terrain above 2,000 ft, immediately prior to the impact with Shanlieve

Spot heights were not displayed on the Skymap and the green colour coding would not have indicated that there was ground above 2,000 ft. If the spot heights on the projected track of the helicopter were not noted, and the Skymap were used for navigation, then with the upper slopes and Castle Bog obscured it could have been possible for the pilot to believe that he had overflown the high ground.

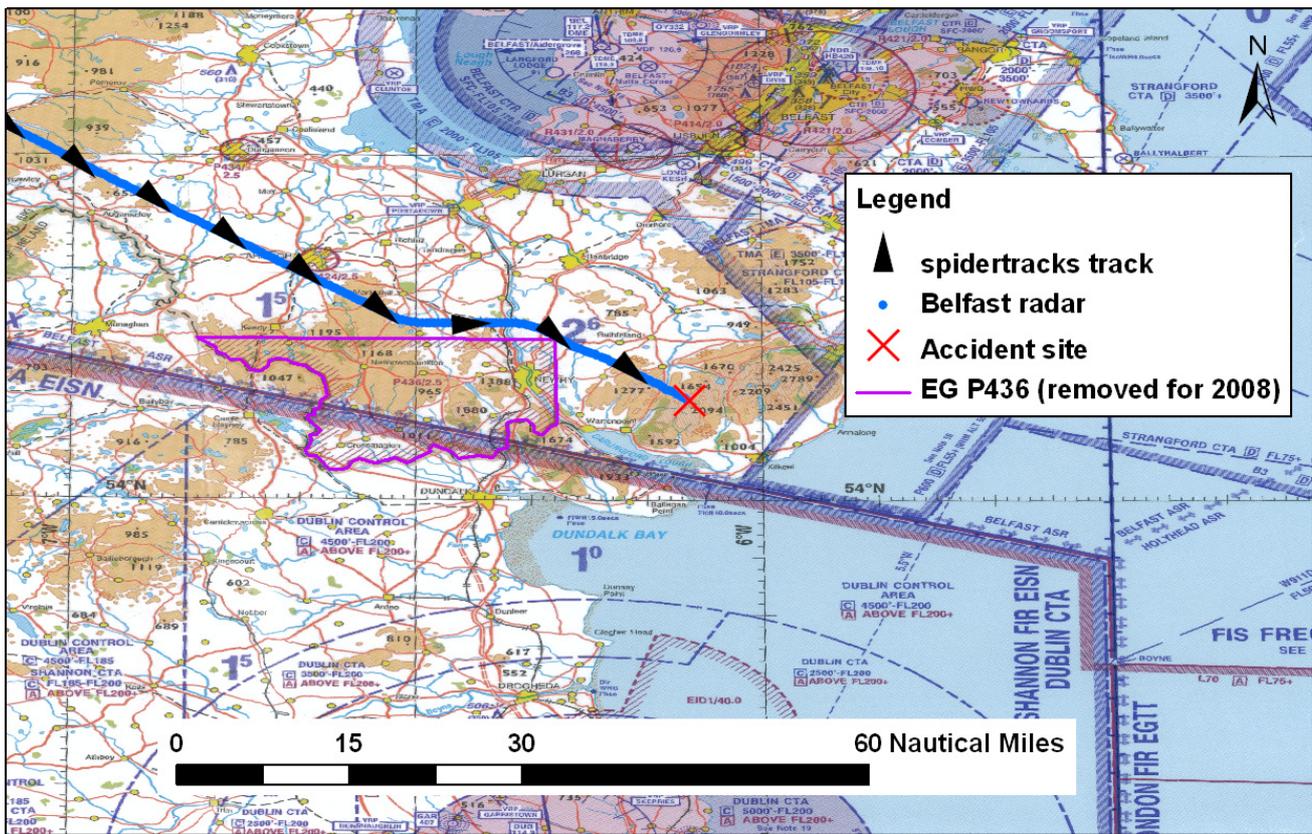
**Figure 10**

Prohibited Area EG P436 was removed for the 2008 air navigation chart and was not included in the Skymap IIC database, or on the pilot’s chart. It was, however, displayed in the flight planning area at St Angelo airport and, as noted above, was probably included in each of the Garmin GNS 430 navigation displays. Figure 10, below, plots the aircraft track in relation to EG P436 and the airspace boundaries.

The former Prohibited Area EG P436 and the Dublin CTA boundary

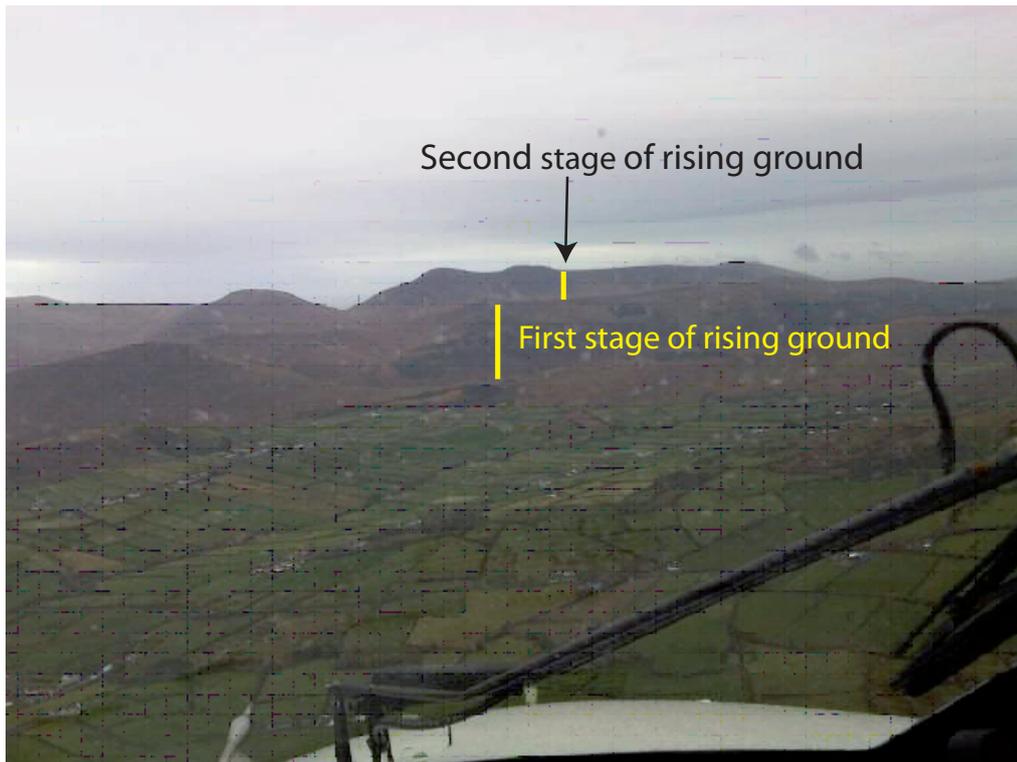
**Figure 11**

When approaching the mountains from the northwest (Figures 11 and 12), the ground rises up in two stages. The first stage is from the Shankys river valley to the summits of Altataggart mountain (1,377 ft) and Tievedockaragh (1,551 ft). At the top is the relatively level area of Castle Bog (1,410 ft). The second stage is the steeply rising ground to the ridge formed by Eagle Mountain (2,093 ft) and Shanlieve (2,054 ft). At the northern end of the ridge, which was to the left in the direction of flight, the saddle of Windy Gap has its lowest point at 1,377 ft before rising up to the summit of Slievemoughanmore (1,833 ft). Figure 11 shows the terrain described taken from a distance of 3 nm and

The first and second stages of rising ground, seen from a distance of 3 nm in the direction of flight

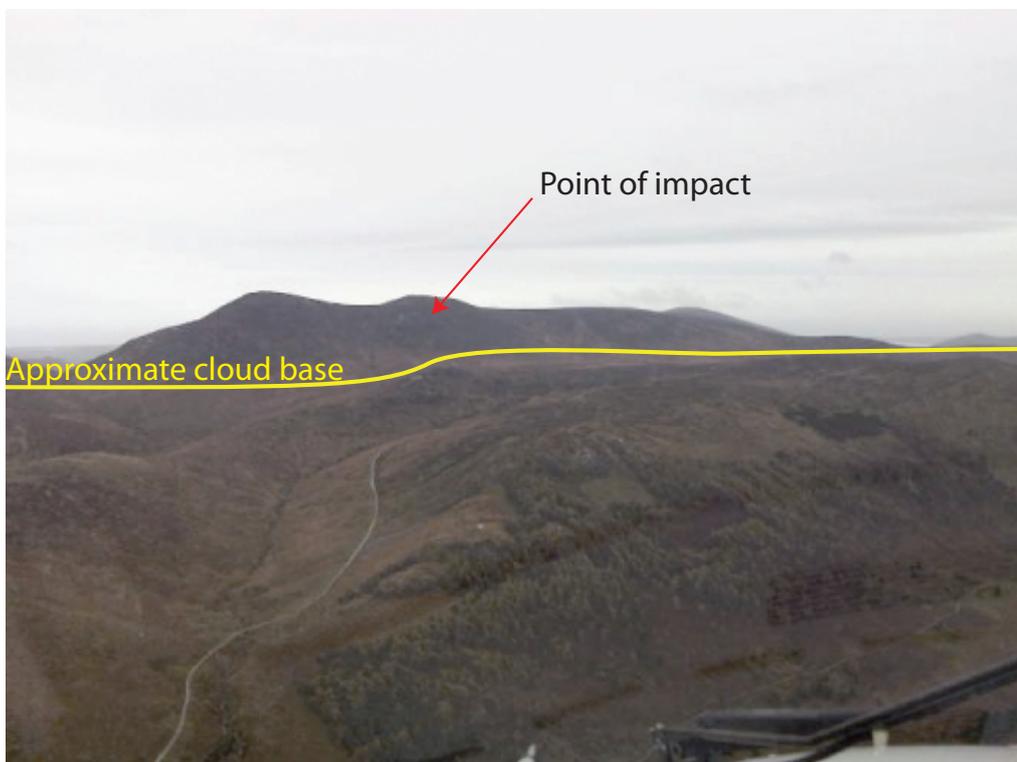
**Figure 12**

The hill walker witnesses were in cloud and it is not known how extensive the cloud cover was or whether any of the upper slopes or ridge were visible to the pilot; there may have been layers of cloud producing a false impression of the upper limits of the terrain. Whilst the terrain was clearly visible during the flight trial, if the upper slopes were obscured by cloud and the height of the terrain was known, it would have been apparent that it would not be possible to continue on the final

The Shanlieve ridge, showing the point of impact and the approximate cloudbase described by the witnesses

heading. An alternative route around the mountains would have been necessary.
