AAIB Bulletin No: 11/93

Ref: EW/G93/08/40

Aircraft Type and Registration: Piper PA-32-301 Saratoga, G-TOGA

Information Source: Aircraft Accident Report Form submitted by the pilot and AAIB phone enquiries, engine examination and test

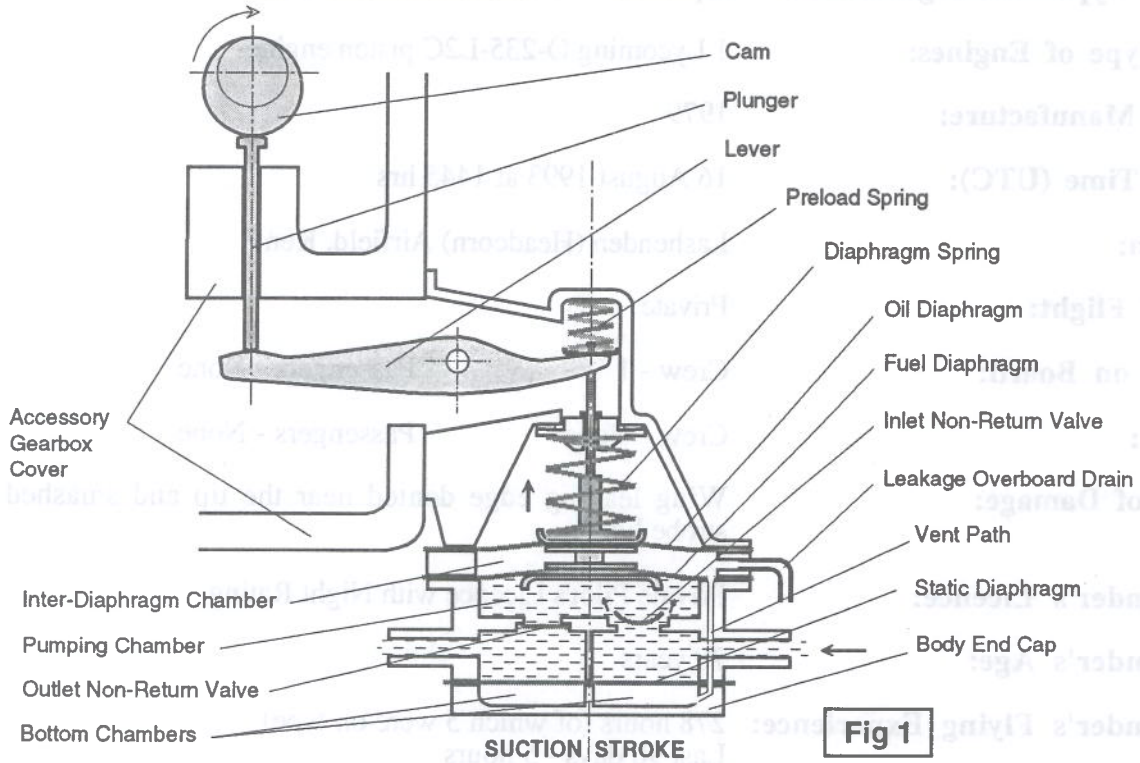
Fig 1

The EDFP supplies pressurised fuel to the injector unit by means of a flexible diaphragm assembly operated by an engine driven lever and springs. A circular eccentric cam in the engine accessory gearbox acts on the lever, via a plunger, to drive the diaphragm up and suck fuel into the pumping chamber via a non-return valve (Fig 1); further rotation of the cam allows the diaphragm to be driven downwards by helical compression springs and thus expel fuel from the chamber to the outlet chamber via a second non-return valve (Fig 2). A further helical compression spring acts on the diaphragm end of the lever to preload it downwards. The cam acts on the lever via a 3.59 inch long steel plunger located in a cylindrical bore in the accessory gearbox housing cover. The plunger is 0.31 inch in diameter with an integral 0.43 inch diameter domed head that is intended to bear on the cam. The face of the cam has a slight axial taper, believed to be intended to cause the plunger to rotate as it reciprocates in order to facilitate lubrication. The upper chamber of the pump is open to the gearbox interior and thus contains oil and oil mist; it is sealed by a second flexible diaphragm stacked above the fuel diaphragm. The inter-diaphragm chamber, which receives any oil or fuel leaking across the diaphragms, is drained overboard. The base of the fuel pumping chamber is formed by a static flexible diaphragm which is clamped between the pump body and an end cap that includes a central web, thus forming two chambers beneath the suction and pressure fuel chambers. The bottom chamber beneath the pressure fuel chamber is closed, but that beneath the suction side is vented to the inter-diaphragm chamber by small diameter drillings in the pump end cap and case.

ENGINE DRIVEN FUEL PUMP

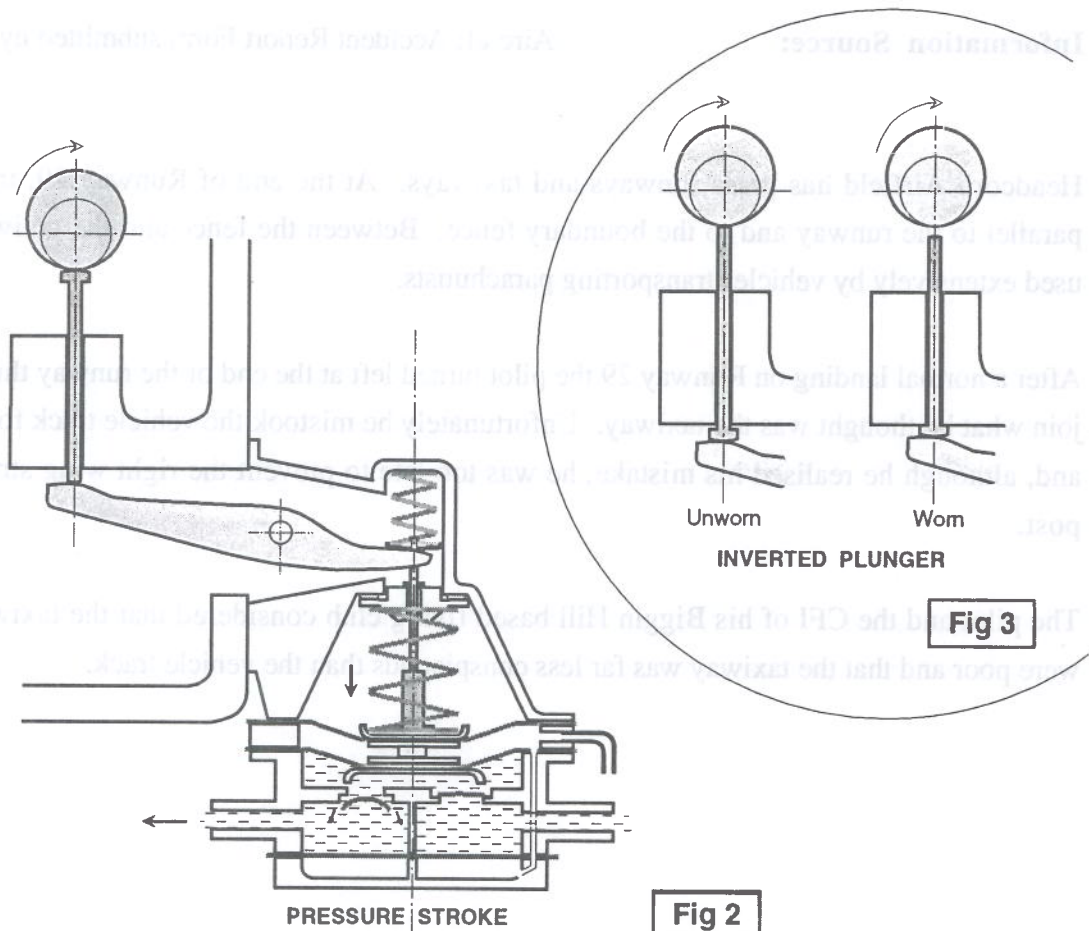
Fig 3

Removal of G-TOGA's engine accessory gearbox cover revealed signs of distress to the EDFP cam, with the surface in an area around the peak portion smeared from contact with the plunger, although measurement showed that the cam diameter had been reduced by only approximately 0.001 inch. However, the end of the plunger that had been in contact with the cam had worn away by almost 0.1 inch in comparison with a serviceable component. The evidence was consistent with the wear having occurred because of poor lubrication at the contact point, possibly due to lack of rotation of the inverted plunger. With a plunger of the correct length installed inverted the head remained clear of the end face of the plunger bore even when the plunger was at the upward limit of its travel, bearing on the base of the cam, and the travel of the pump lever was unaffected by the inversion. The total cam lift was measured as 0.425 inch, but the first 0.075 inch downward movement of the plunger as the cam was rotated from the base position was lost motion, taken up before the diaphragm assembly lifted from its seat and started the pumping stroke; the effective pumping stroke was thus 0.350 inch. With the shortened plunger found on G-TOGA installed inverted the head bottomed on the end face of the cover when the plunger was bearing within approximately $\pm 55^\circ$ of the base of the cam (Fig 3) and the pumping stroke was reduced to 0.250 inch.
