**AAIB Bulletin No: 6/94**

**Ref: EW/C94/2/4**

## **INCIDENT**

**Aircraft Type and Registration:** Boeing 737-236, G-BKYL  
**No & Type of Engines:** 2 Pratt & Whitney JT8D-15A turbofan engines  
**Year of Manufacture:** 1985  
**Date & Time (UTC):** 15 February 1994 at 1237 hrs  
**Location:** East Midlands Airport  
**Type of Flight:** Public Transport  
**Persons on Board:** Crew - 6 Passengers - 8  
**Injuries:** Crew - None Passengers - None  
**Nature of Damage:** None  
**Commander's Licence:** Airline Transport Pilot's Licence  
**Commander's Age:** 38 years  
**Commander's Flying Experience:** 8,500 hours (of which 1,600 were on type)  
Last 90 days - 95 hours  
Last 28 days - 34 hours  
Duty time - Started duty at 0625 hours  
**Information Source:** AAIB Field Investigation

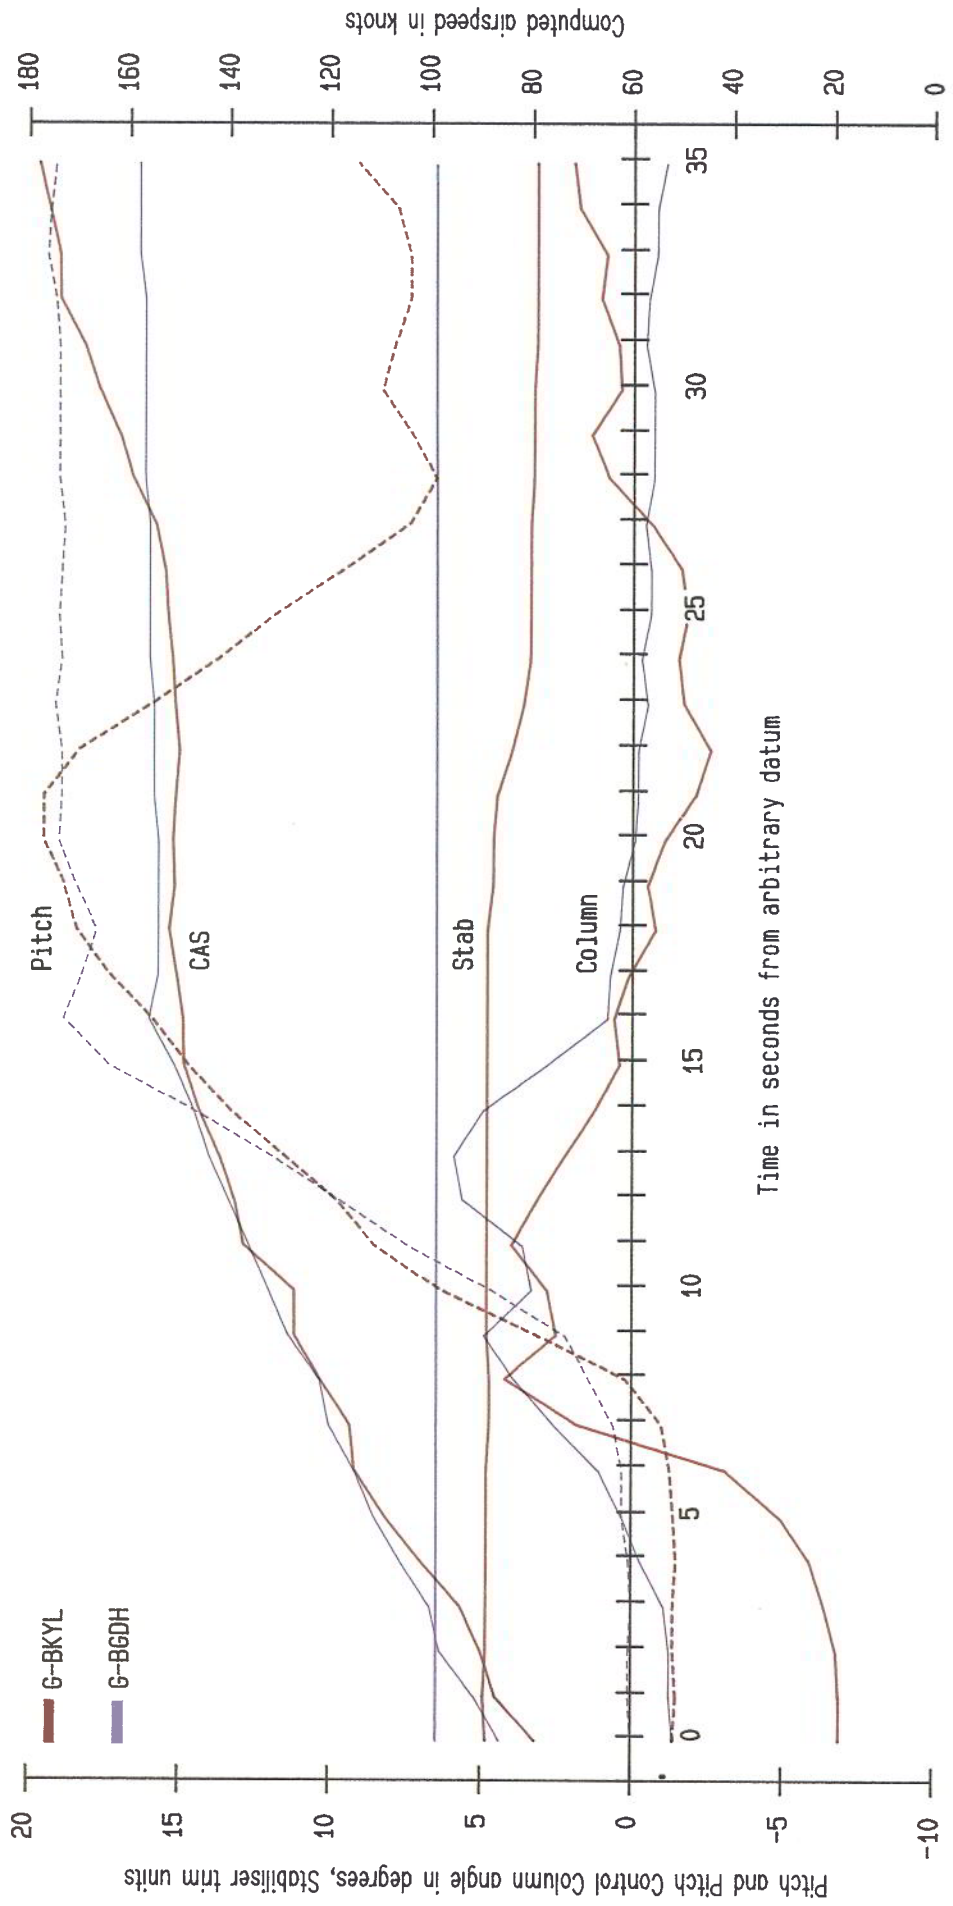
G-BKYL incident on 15 February 1994

The initiation of rotation of G-BKYL (YL) occurred at 5 seconds to 6 seconds between 110 and 115 kt computed airspeed (CAS). At 8 seconds the pitch control column angle reached a maximum value of 4.2° nose-up and the pitch rate was 3.2° per second. Over the period 11 seconds to 17 seconds the pitch rate was 1.7° per second whilst the control column angle reduced from 4° nose-up to 0°. Two seconds later the pitch was still increasing despite a control column angle of 1° nose-down and a nose-down trim increase from 4.8 units to 4.6 units. In comparison, 'DH', trimmed to 6.4 trim units throughout the period of the figure, held a constant pitch rate of 2.5° per second from 9 seconds to 15 seconds with a control column angle which reached a maximum of 5.9° nose-up at 13 seconds. No overall pitch change occurred from 16 seconds to 21 seconds a period when the control column was within 1° of neutral.

At 21 seconds 'YL's' pitch angle was 20° and beginning to decrease, following a reduction in stabiliser trim from 4.6 units to 3.3 units and a maximum pitch control column angle of 2.6° nose-down the pitch angle reduced to 7° at 28 seconds. Over the next 7 seconds a control column input averaging 1° and a pitch increase from 7° to 9° were recorded. One minute later with flaps retracted the stabiliser trim position was recorded as 4 units.
