AAIB Bulletin No: 5/93

Ref: EW/G93/01/07

Aircraft Type and Registration: BAe ATP, G-BMYK

Date & Time (UTC): 15 January 1993 at 0716 hrs

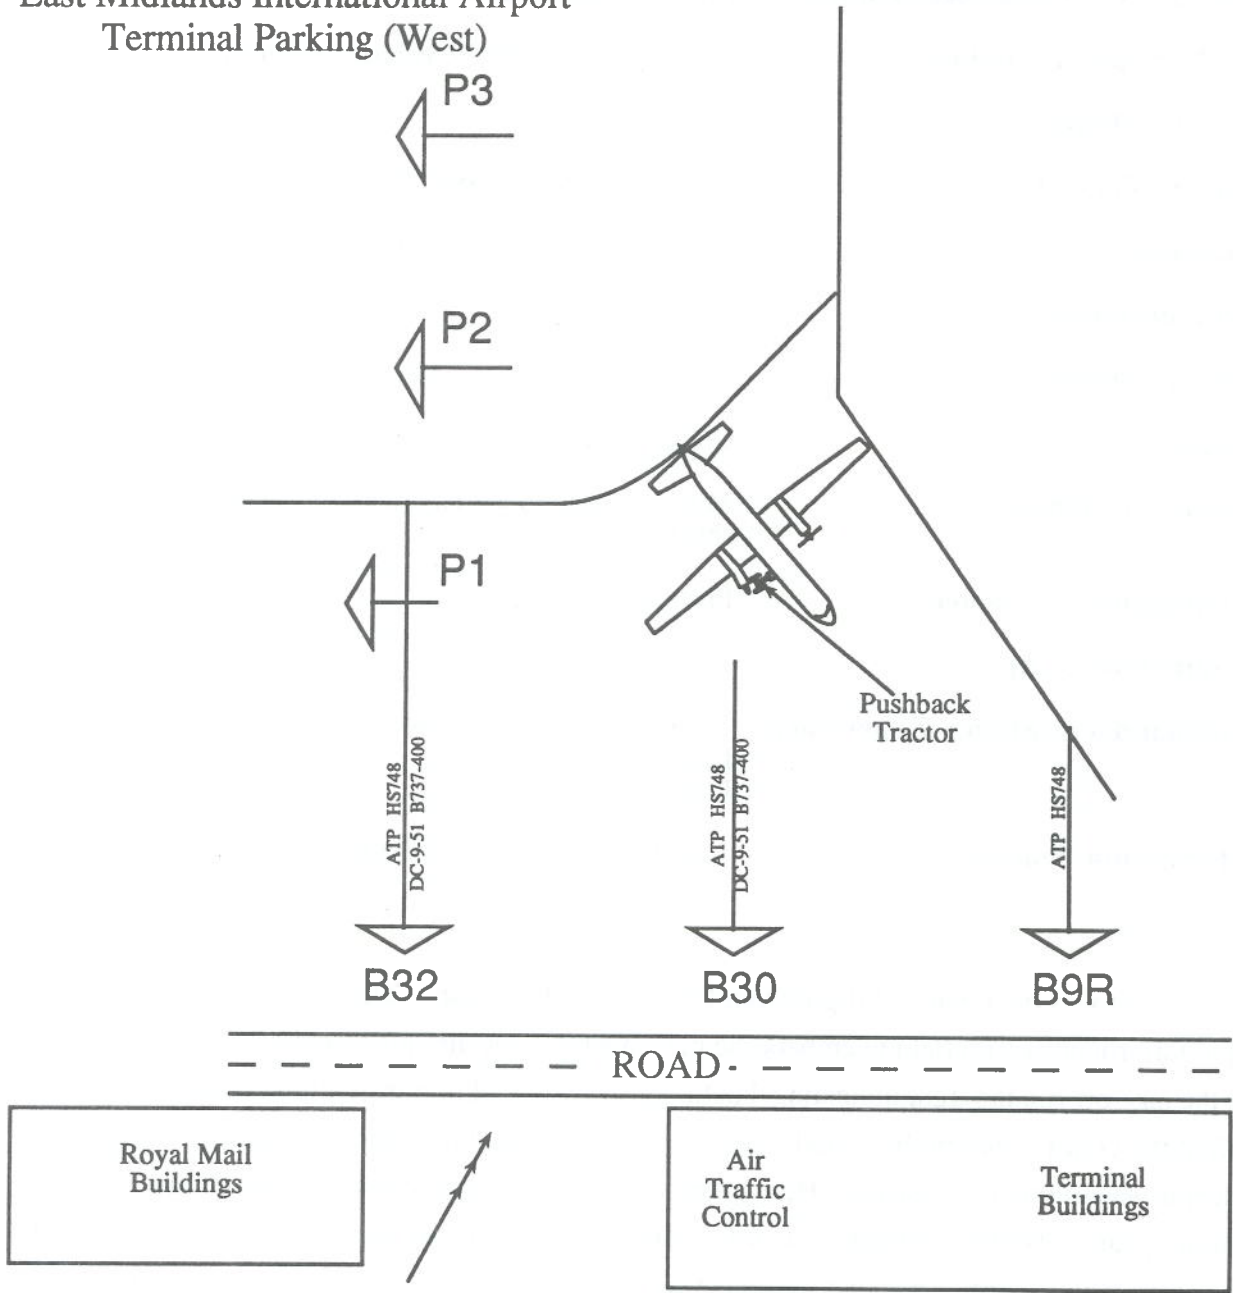
East Midlands International Airport
Terminal Parking (West)

Reported Surface Wind 200°/30-45 knots
