Aircraft Type and Registration: Cessna F177RG, G-BFIV

Date & Time (UTC): 22 August 1993 at 1659 hrs

Location: Wycombe Air Park, Buckinghamshire

Nature of Damage: Damage to lower cowling, exhaust stub, propeller and forward nose gear door

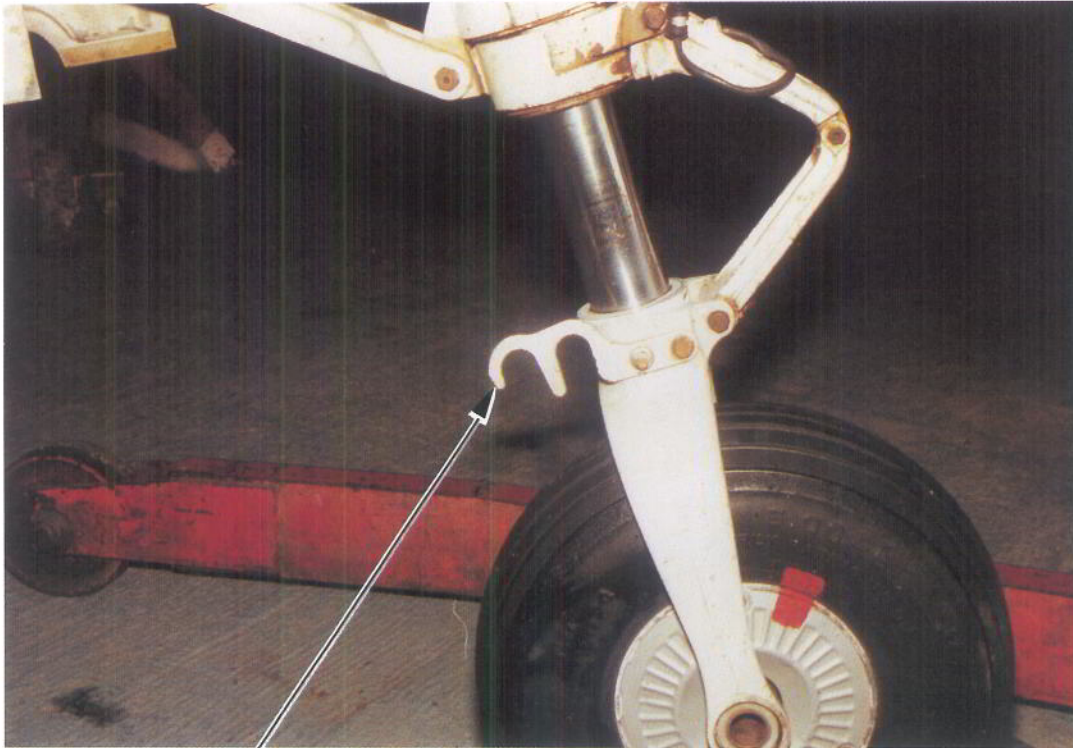
FIGURE 1. NOSEGEAR UPLOCK DETAILS OF G-BFIV

Engineering examination subsequently discovered that the nose gear had failed to extend because the uplock hook had caught round the head of the bolt that mounted the uplock roller, - see Figure 1. Further investigation revealed that the hook, which is aligned with the aircraft's longitudinal axis, had been distorted such that the tip of the hook was displaced 0.4 inches to the right. This meant that the hook had been engaging with the extreme right hand edge of the roller, adjacent to the bolt head, and marks on the right of the roller suggested that this state of affairs had existed for some time. It was not clear how the hook had become distorted, or why the hook had hung up on the bolt head on this particular occasion. It was observed however that the bellcrank which carries the roller, and which moves during the retraction/extension process, had some lateral free play of up to approximately 0.1 inches at the roller end. It was thus possible that the hook was likely to engage the bolt head only when the roller bellcrank was at one of its limits of free play.

The aircraft owner was unable to account for the hook distortion. It was of reasonably strong construction, being made from steel plate approximately 0.2 inches thick, and thus would require a substantial load to bend it. It exhibited no witness marks such as could have been made from a hard object. It was possible that it may have been kicked at some time, in an attempt to castor the nosewheel when the aircraft was being manoeuvred on the ground.

Rear of hook bent 0.4" towards camera

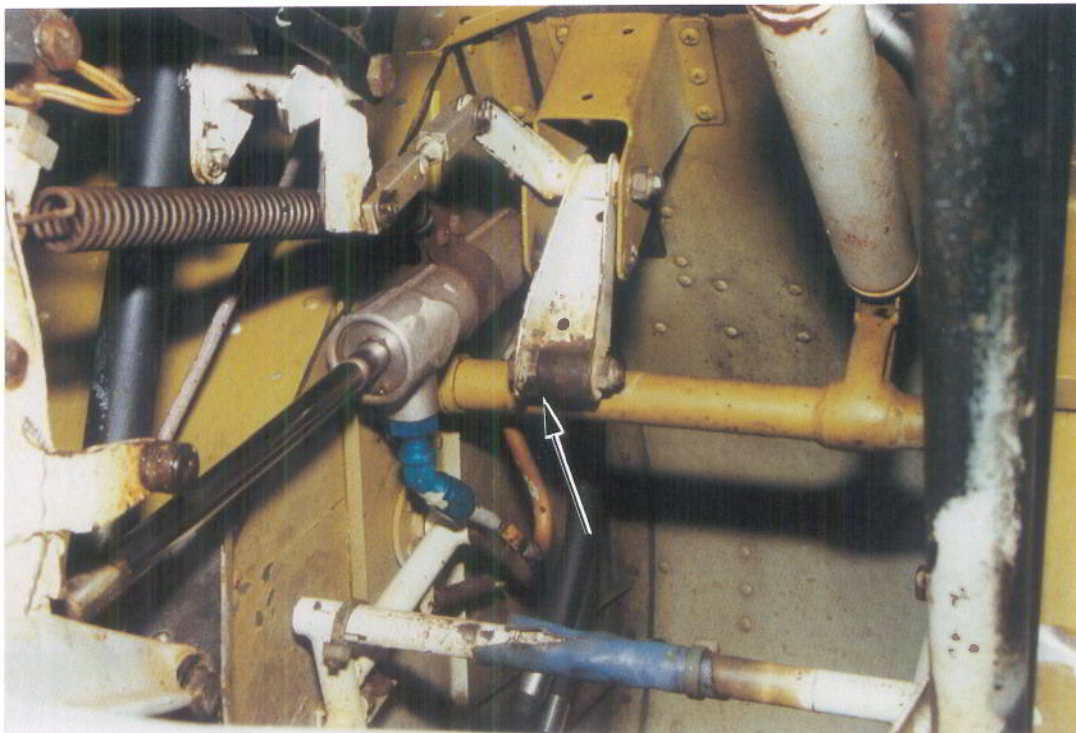
View of wheel well looking aft: hook had been engaging RHS of uplock roller (arrowed), adjacent to bolt head.
