ACCIDENT

Aircraft Type and Registration:	Airbus A340-642, G-VSHY	
No & Type of Engines:	4 Rolls-Royce Trent 556-61 turbofan engines	
Year of Manufacture:	2002	
Date & Time (UTC):	25 February 2006 at 1254 hrs	
Location:	Runway 09R, London Heathrow Airport	
Type of Flight:	Public Transport (Passenger)	
Persons on Board:	Crew - 18	Passengers - 268
Injuries:	Crew - None	Passengers - None
Nature of Damage:	Serious damage to two tyres and wheels; minor damage to flaps and right main landing gear	
Commander's Licence:	Airline Transport Pilot's Licence	
Commander's Age:	57 years	
Commander's Flying Experience:	10,000 hours (of which 7,000 were on type) Last 90 days - 240 hours Last 28 days - 80 hours	
Information Source:	AAIB Field Investigation

Synopsis

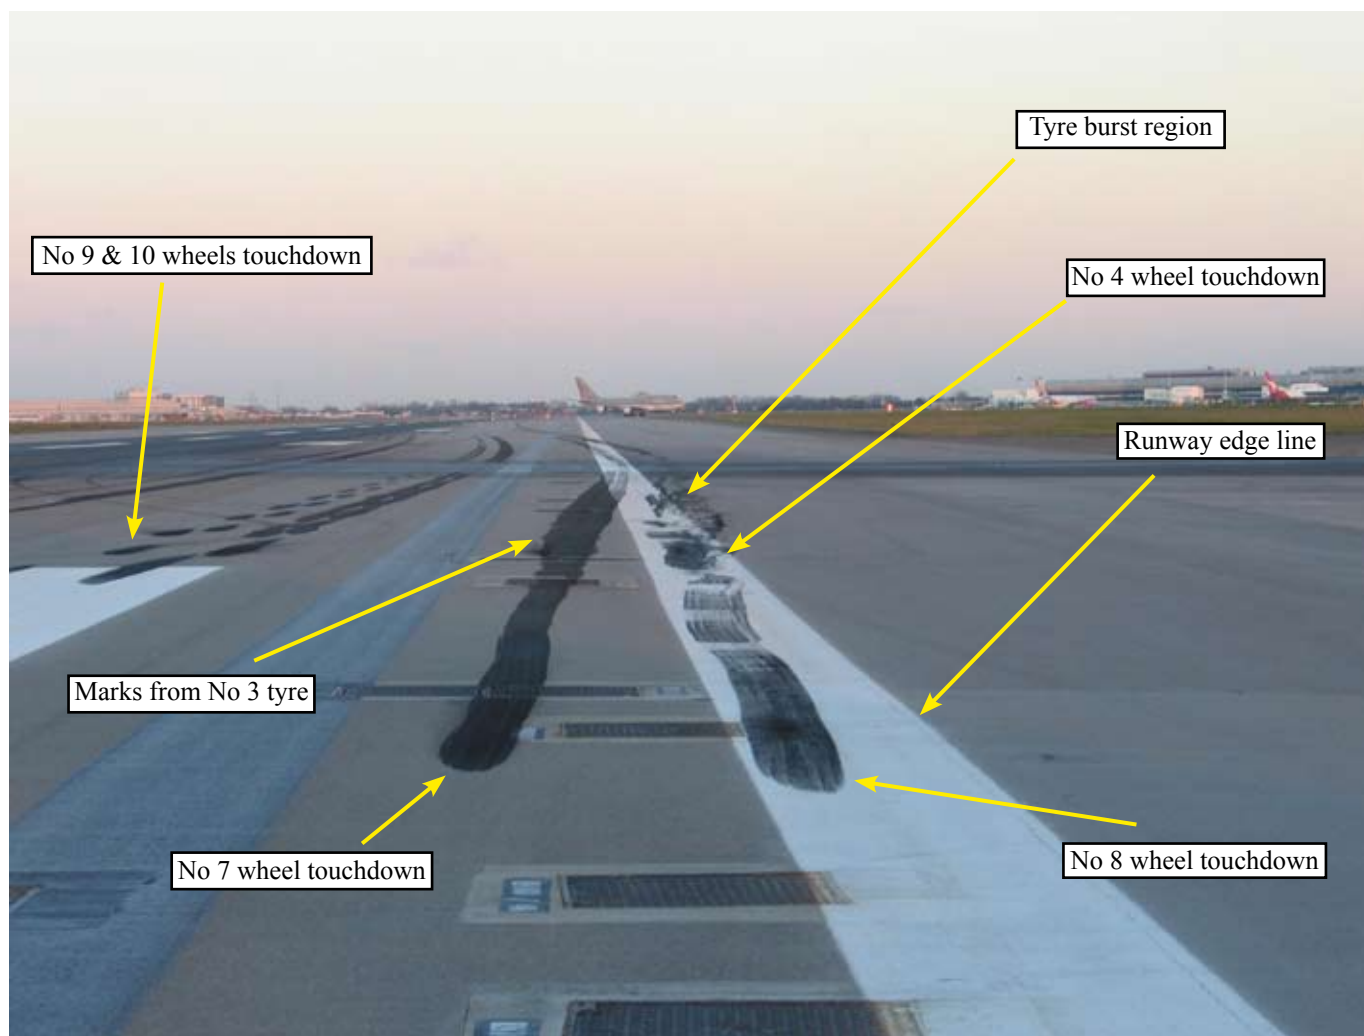
Figure 3

Clear tyre marks were made by all the main landing gear tyres on the runway during the landing, Figure 3. These indicated that the aircraft had touched down on a track of approximately 093°, adjacent to the aiming markers. Wheel No 7 and No 8 touched down first, followed approximately 10 m further on by wheel No 5 and No 6. Some 20 m after the initial touchdown point, wheel Nos 3, 4, 9 and 10 all made contact with the runway. Wheel No 4 and No 8 had touched down on the white line delineating the right edge of the runway. It was not possible to determine from the tyre marks where the nose wheels touched down. It was also apparent from the tyre marks that tyre Nos 4 and 8 had burst at about the same time that wheel Nos 3, 4, 9 and 10 made contact with the runway.

A gouge was present in the runway surface in the area where the two tyres had burst, most likely caused by the No 4 outer wheel rim contacting the ground. Whilst the fore and aft wheels on each bogey are in-line with the longitudinal axis of the aircraft, the marks on the runway made by the No 3 and 7 main gear tyres were consistent with the aircraft's heading being to the left of its track, ie, skidding to the right. Approximately 40 m after the start of the right main gear wheel tracks, wheel Nos 4 and 8 crossed over the runway right edge on to the hard shoulder for a short distance, after which the tyre tracks from all the main gear wheels indicated that the aircraft had tracked towards the runway centreline.

Marks made by the tyres from the right and centre main landing gear

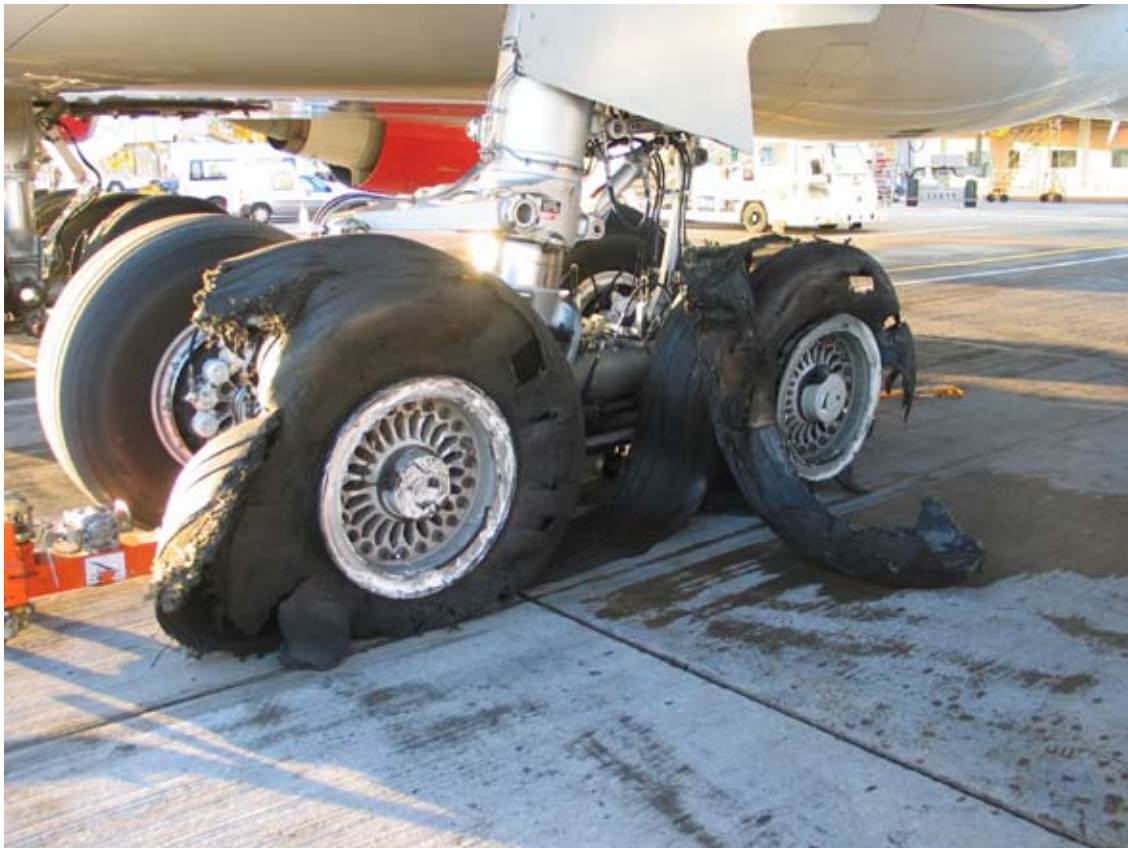
Figure 4

Tyres No 4 and 8 burst on landing, Figure 4. The resultant flaying rubber dislodged and broke a number of brackets on the bogey and caused several small dents on the inboard flap and flap track canoe fairing.

Damage had also occurred to the No 4 wheel, normal brake hydraulic line coupling (Part Number 201589204), sufficient to cause a slight seep of hydraulic fluid. Whilst wheel Nos 4 and 8 had remained intact, the outboard rim of the No 4 wheel had been ground flat over an arc of approximately 40° around its circumference.

Damage to the No 4 and No 8 tyres

The No 4 tyre was extensively damaged, with approximately 70% of the tyre detached from its two beads. Damage to the outboard sidewall indicated that the tyre had distorted sufficiently for the sidewall to rub along the runway, causing the plies to be ground away. This resulted in a hole in the sidewall and the sudden deflation of the tyre, which then appeared to have allowed the outboard rim of the wheel to make a brief contact with the ground. As the wheel continued to rotate, the rims cut through the tyre sidewalls, allowing most of the tyre to detach from its beads. The damage to the No 8 tyre was similar, with approximately 50% of the tyre detached from the beads. There was, however, only light scoring to the wheel flange, which probably occurred when the aircraft was taxiing off the runway.

Tyre Nos 4 and 8 both displayed evidence of overheating on their treads and sidewalls. The treads were also extensively scratched. However, given the distortion of the tyres following the loss of pressure, it was not possible to determine if this damage occurred before or after the tyres burst and such damage did not necessarily indicate the drift of the aircraft at touchdown. The manufacturer assessed that all the tyres were serviceable prior to the incident with no evidence that any had been incorrectly inflated.

The tyre marks on the runway were consistent with data on the Flight Data Recorder, in that when the aircraft touched down, it started to skid to the right. At this point, the load placed upon tyre Nos 4 and 8, generating the aircraft vertical and lateral accelerations, distorted both tyres sufficiently to allow their sidewalls to scrape along the runway. As they were worn through, both tyres would have suddenly deflated, allowing the wheel rims to cut through the sidewalls and largely separate the tyres from the beads. Flaying rubber then caused minor damage to components in the immediate area. As the aircraft decelerated, the amount of sideways

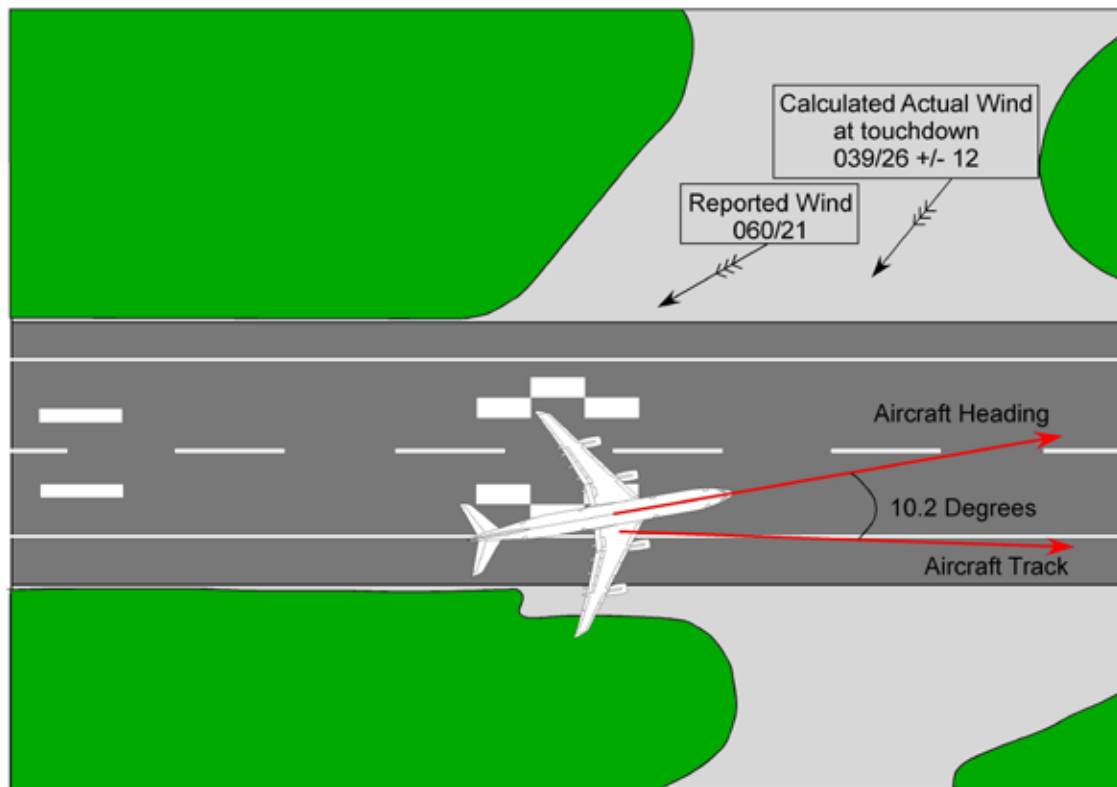
Figure 7

The aircraft landed at a speed of 156 kt, to the right of the centreline on a heading of 083°M and with a drift angle of 10.2°, Figure 7.

Roll attitude at touchdown was 3.5° right wing down. The right main landing gear contacted the ground first, followed almost immediately by the centre and left main landing gears. The aircraft's rate of descent at touchdown was calculated to have been approximately 500 ft/min; a normal acceleration of 1.75g and a lateral acceleration of -0.37g were recorded. Wheel speeds were recorded by the FDR and, with the exception of wheel Nos 4 and 8, all showed normal indications during and after spin-up. Speeds recorded from wheel No 4 remained at zero, whilst that from wheel No 8 peaked at only 38 kt.
