No: 2/91

Ref: EW/G90/11/05

**Aircraft Type and Registration:** Cessna 421C, G-BSSS

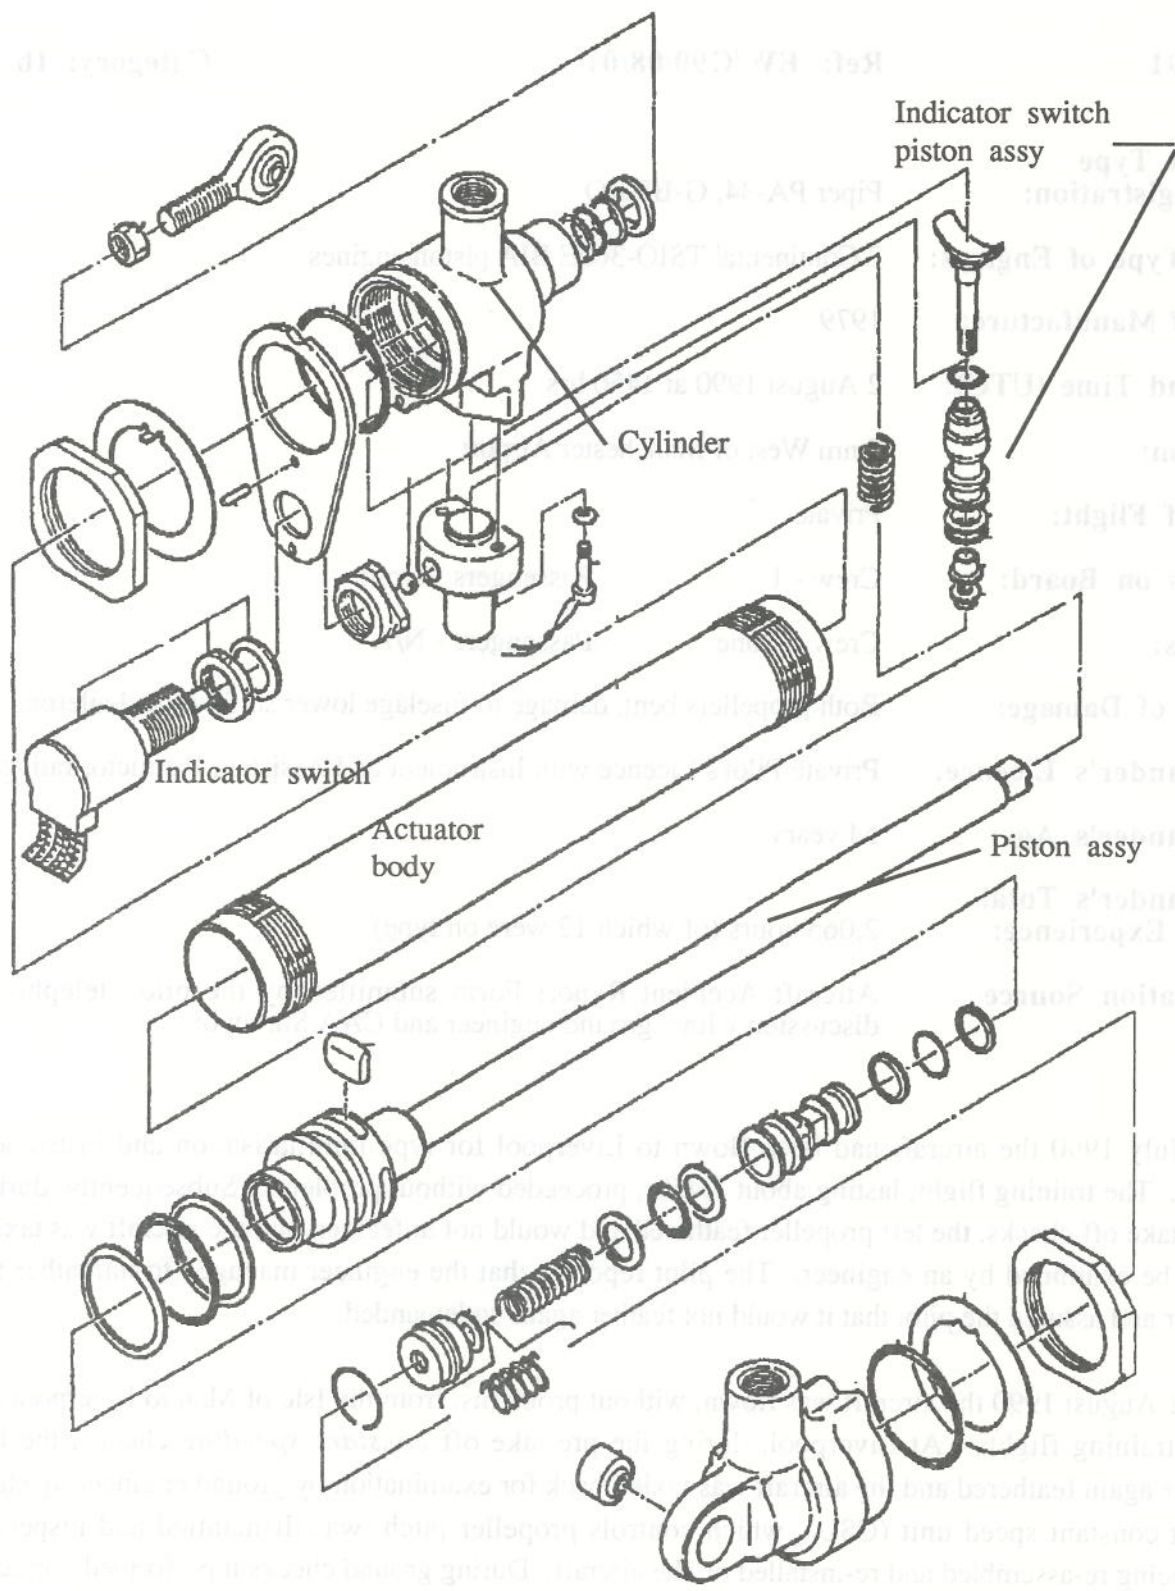
**CESSNA 421 NOSE ACTUATOR COMPONENTS**

When the nose leg actuator was removed from the aircraft and subjected to an examination at an engineering organisation, an electrical check confirmed that the integral switch remained in the "down and locked" position irrespective of whether the actuator was extended or retracted. Disassembly revealed that the piston that operated the switch had "stuck" in the extended position. Upon further investigation, it was found that corrosion was present within the cylinder that housed the switch

operating piston. The accompanying diagram shows the primary components of the actuator, including the switch.

In the Cessna 421 landing gear system, hydraulic power is cut off when all three downlock switches are made. In the case of G-BSSS, as soon as the main gear actuators had reached downlock and with the nose downlock switch stuck in the down position, hydraulic power would have been cut off, regardless of the position of the actuator.

The actuator has been the subject of a CAA Airworthiness Directive (No 002-02-90) which called for the sealing of points where moisture ingress may be expected. However it is considered that this may not have been effective if moisture was already present.

Following the accident, the operator has proposed an "in house" procedure to overhaul all Cessna 421 landing gear actuators (nose and main) immediately, followed by a strip examination after two years.
