**ACCIDENT**

<b>Aircraft Type and Registration:</b>	De Havilland DH53 Humming Bird, G-EBHX	
<b>No &amp; Type of Engines:</b>	1 ABC Scorpion II piston engine	
<b>Year of Manufacture:</b>	1923 (Serial no: 98)	
<b>Date &amp; Time (UTC):</b>	1 July 2012 at 0842 hrs	
<b>Location:</b>	Old Warden Aerodrome, Bedfordshire	
<b>Type of Flight:</b>	Private	
<b>Persons on Board:</b>	Crew - 1	Passengers - None
<b>Injuries:</b>	Crew - 1 (Fatal)	Passengers - N/A
<b>Nature of Damage:</b>	Substantial	
<b>Commander's Licence:</b>	Airline Transport Pilot's Licence	
<b>Commander's Age:</b>	52	
<b>Commander's Flying Experience:</b>	14,780 hours (of which 55 minutes were on type) Last 90 days - 151 hours Last 28 days - 56 hours	
<b>Information Source:</b>	AAIB Field Investigation

**Synopsis**

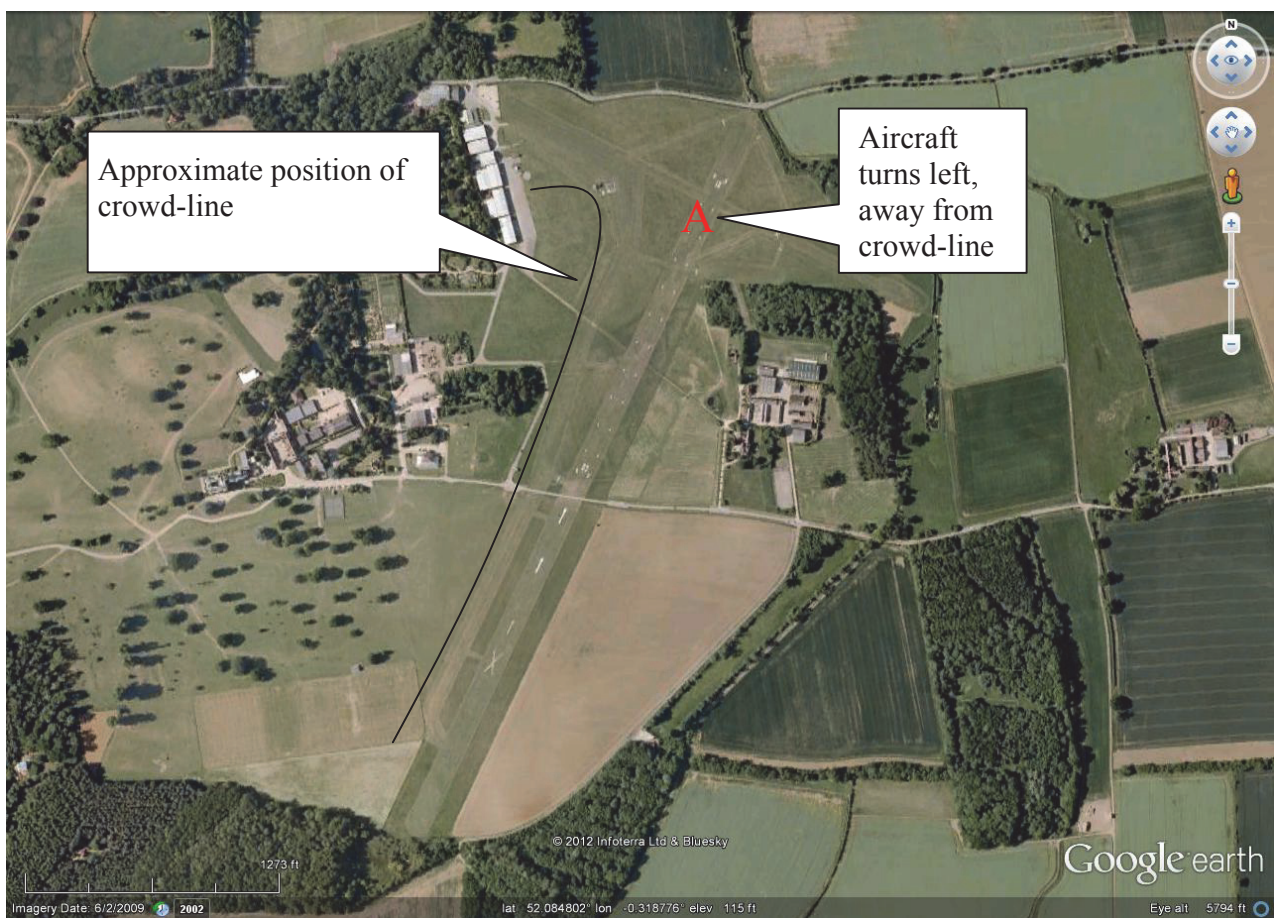
**Figure 1**

The aircraft's start, taxi and takeoff were without incident. The pilot flew to the southern end of the airfield where, at a height of between 600 ft and 800 ft, he performed a series of level turns. The Chief Pilot had watched the aircraft take off and conduct the initial turns; satisfied that all was well, he returned to his other duties. Another DH53-qualified pilot had also watched the takeoff and first minutes of the flight and, seeing nothing amiss, he too continued with other tasks. Several witnesses continued to watch the aircraft which, after a few minutes, flew downwind to the northern end of the airfield before descending to between 150 ft and 200 ft as it turned towards the airfield. The aircraft then established approximately along the Runway 21 centreline (Figure 1).

The aircraft continued to fly along the runway to position 'A' (Figure 1) before making a level turn to the left. This turn took the aircraft close to, and downwind of, a copse of tall trees. It is possible that the aircraft completed this turn before commencing a second turn; eyewitnesses were divided as to whether the aircraft had performed one or two turns away from the crowd-line prior to the accident. During the left turn preceding the accident, witnesses saw the left wing drop sharply; the aircraft then recovered to level flight after which the left

Approximate position of the turn away from the crowd-line

wing dropped again, with the aircraft rolling to a steep angle. The nose of the aircraft then dropped and the aircraft entered a very steeply descending left turn. It did not recover and struck the ground, near the intersection of Runway 25 and Runway 30, with a nose-down pitch attitude beyond the vertical. Witnesses estimated the total time from initial wing drop to the aircraft striking the ground as being two to three seconds.
