ACCIDENT

Aircraft Type and Registration:	Kolb Twinstar Mk3 (Modified), G-BTYA	
No & Type of Engines:	1 Rotax 582 piston engine	
Year of Manufacture:	2000	
Date & Time (UTC):	16 November 2007 at 1450 hrs	
Location:	Kilkeel, County Down, Northern Ireland	
Type of Flight:	Private	
Persons on Board:	Crew - 1	Passengers - 1
Injuries:	Crew - 1 (Minor)	Passengers - 1 (Minor)
Nature of Damage:	Aircraft damaged beyond economic repair	
Commander's Licence:	National Private Pilot's Licence	
Commander's Age:	53 years	
Commander's Flying Experience:	37 hours (all of which were on type) Last 90 days - 0 hours Last 28 days - 0 hours	
Information Source:	Aircraft Accident Report Form submitted by the pilot and meteorological aftercast provided by the Met Office

Synopsis

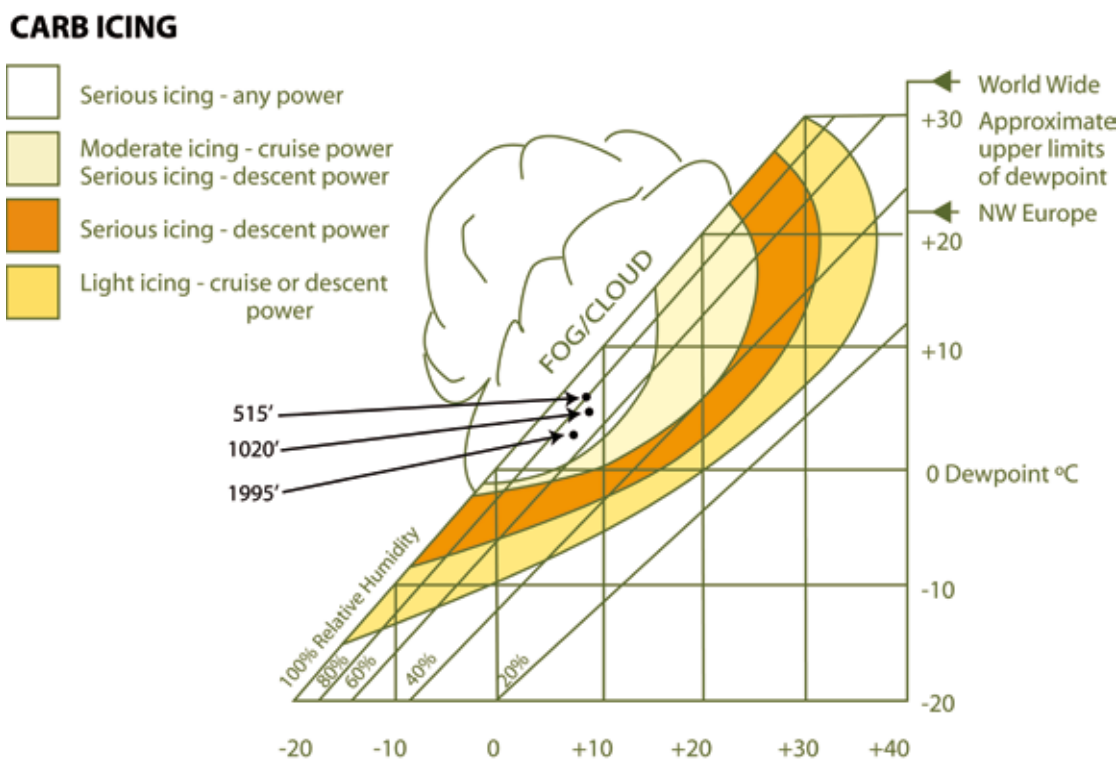
Figure 1
Carburettor Icing Probability Chart

A friend of the pilot removed the aircraft from the accident site. During this removal he noted that there was a reasonable quantity of fuel in the tank and that the engine was free to rotate. A few days after being released from hospital the pilot inspected the aircraft and, from external inspection, could find no reason why the engine had failed. He successfully started and ran the engine and no fault was found. In his opinion the engine failed due to the build-up of icing within the carburettor.

These temperature and humidity readings were plotted on a carburettor icing probability chart and the result, shown at Figure 1, indicates that there was a possibility of serious icing at any power.
