No: 2/91

Ref: EW/G90/09/04

Aircraft Type and Registration: Piper PA-28-161, G-BSFK

Nature of Damage: Damage to right main landing gear, right flap and leading edge of stabilator

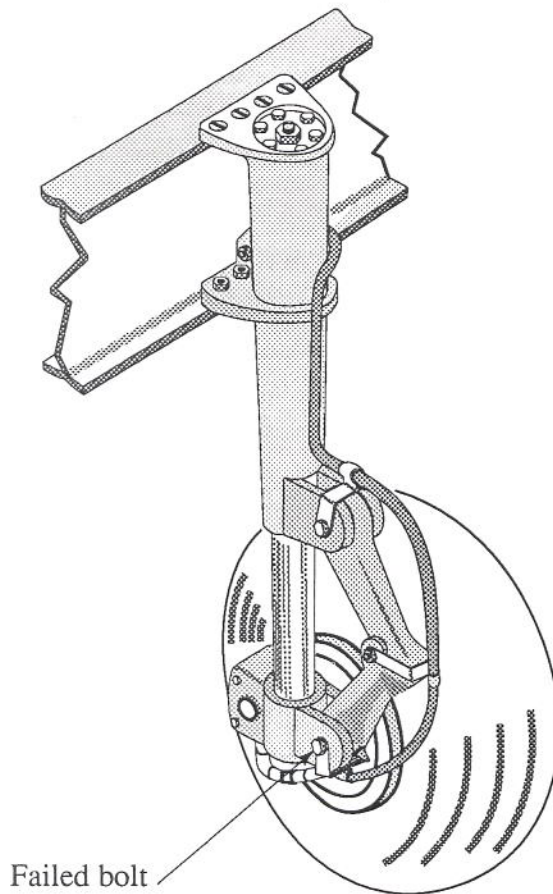
Figure 1
PA 28 Main Landing Gear Leg

Inspection revealed that the lower torque link retaining bolt on the right main landing gear (see fig.1) had come out of engagement, permitting the oleo piston to come out of the cylinder as the oleo extended after take-off. The bolt was recovered and a subsequent metallurgical examination revealed that it had suffered a double fatigue failure through the threaded portion of the bolt in the region of the base of the retaining nut. Both fatigue cracks had origins in the base of the thread form and had progressed about halfway across the section, the final part of the failure being overload (See fig.2).

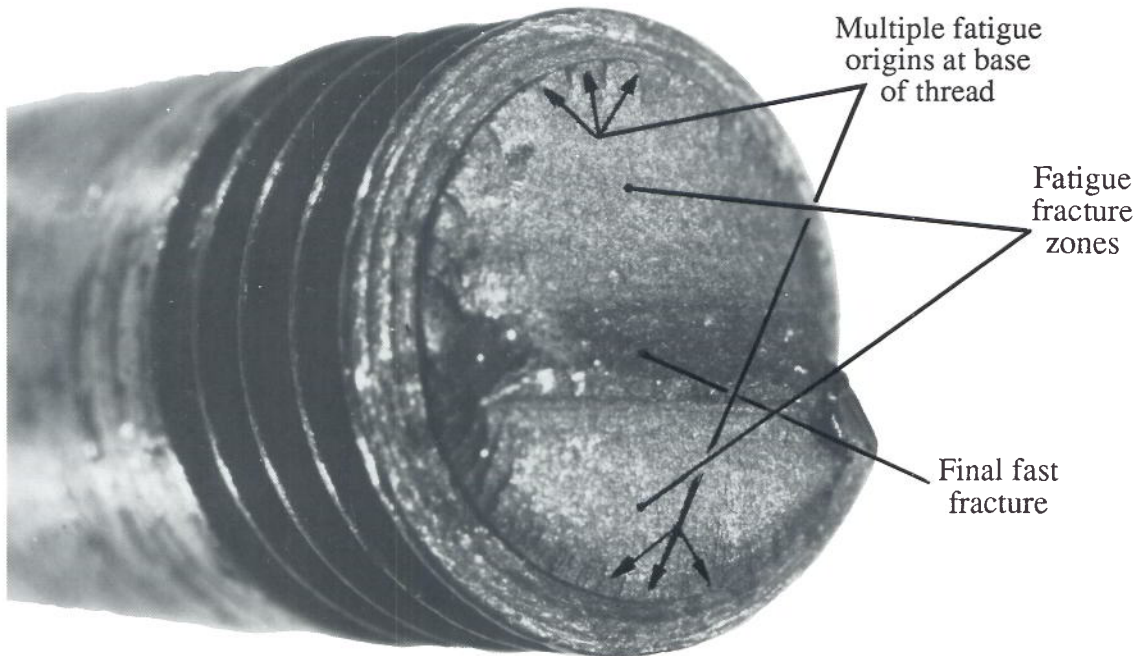
Figure 2 Fracture through threaded part of bolt.
