No: 3/89

Ref: EW/ C1093

Cessna 421C, G-FTAX

13 December 1988 at 0859 hrs.

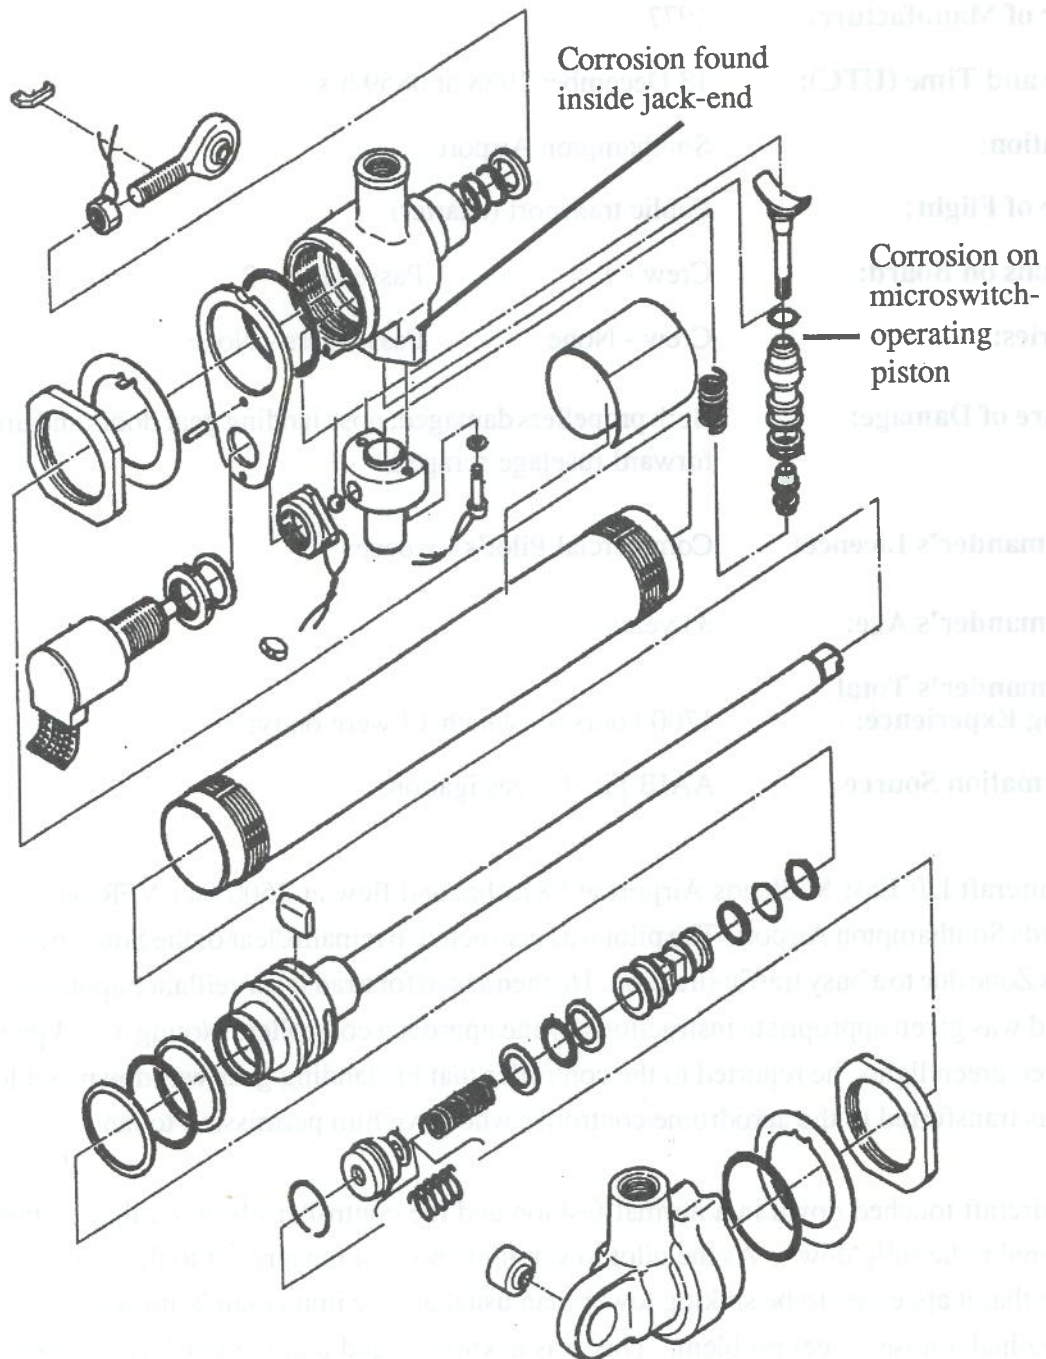
The nose gear was fitted with a Teijin Seiki jack assembly containing a downlock microswitch actuated by a mechanism driven by internal locking keys when the jack was fully extended. On retraction a spring was designed to move the mechanism away from the down position and allow the microswitch contacts to open.

Examination showed that the indicating mechanism remained in the 'down and locked' position irrespective of the position of the jack piston. Corrosion was found on both the jack cylinder-end containing the mechanism and on the corresponding end of the piston operating the microswitch. The return spring force was insufficient to overcome the friction between the two corroded parts, consequently the indicating mechanism remained in the down position.
