Beech Super King Air B200, G-BPPM

AAIB Bulletin No: 1/2002	Ref: EW/G2001/06/16	Category: 1.2
Aircraft Type and Registration:	Beech Super King Air B200, G-BPPM	
No & Type of Engines:	2 Pratt & Whitney Canada PT6A-42 turboprop engines	
Year of Manufacture:	1982	
Date & Time (UTC):	13 June 2001 at 0610 hrs	
Location:	Aberdeen Runway	
Type of Flight:	Public Transport (Passenger)	
Persons on Board:	Crew - 2	Passengers - 4
Injuries:	Crew - None	Passengers - None
Nature of Damage:	Damage to engine and propellers; minor airframe damage	
Commander's Licence:	Airline Transport Pilots Licence	
Commander's Age:	45 years	
Commander's Flying Experience:	6700 hours (of which 1000 were on type)	
	Last 90 days - 200 hours	
	Last 28 days - 35 hours	
Information Source:	Aircraft Accident Report Form submitted by the pilot and additional AAIB investigation

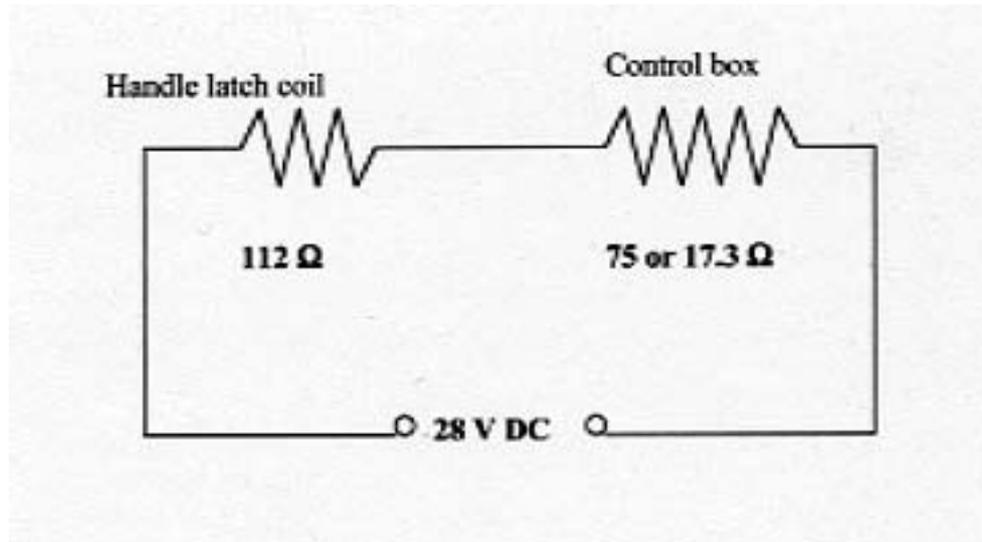
With the landing gear down-and-locked, and the gear selector handle in the DOWN position, the wires at 28 volts DC are indicated on the diagram at Figure 1. It can be seen that this includes the wire identified as G21A22, which leads to Pin 'H' on the plug upstream of the safety switch. In order for this voltage to find an earth via terminal 'F', there would have to be a short circuit onto wire G8A22 or G8B22. Such a condition could arise as a result of 'chafing', or perhaps an internal short circuit within the safety switch. The complete circuit could then be represented thus:

Depending on the position of the dynamic brake relay, the total resistance would be either 187 or 129.3 (assuming the short circuit condition contributed zero Ohms). From Ohm's Law, the current is V/R , ie approximately 0.15 or 0.22 amps. Again from Ohm's Law, the voltage drop across the handle latch coil is 16.8 or 24.6 volts, leaving either a 11.2 or 3.8 voltage drop across the control box. Both values are considerably less than the 20 volts required to operate the UP relay.
