**AAIB Bulletin No: 9/95**

**Ref: EW/C95/5/4**

## **INCIDENT**

**Aircraft Type and Registration:** Beech B95A Travelair, G-ATRC

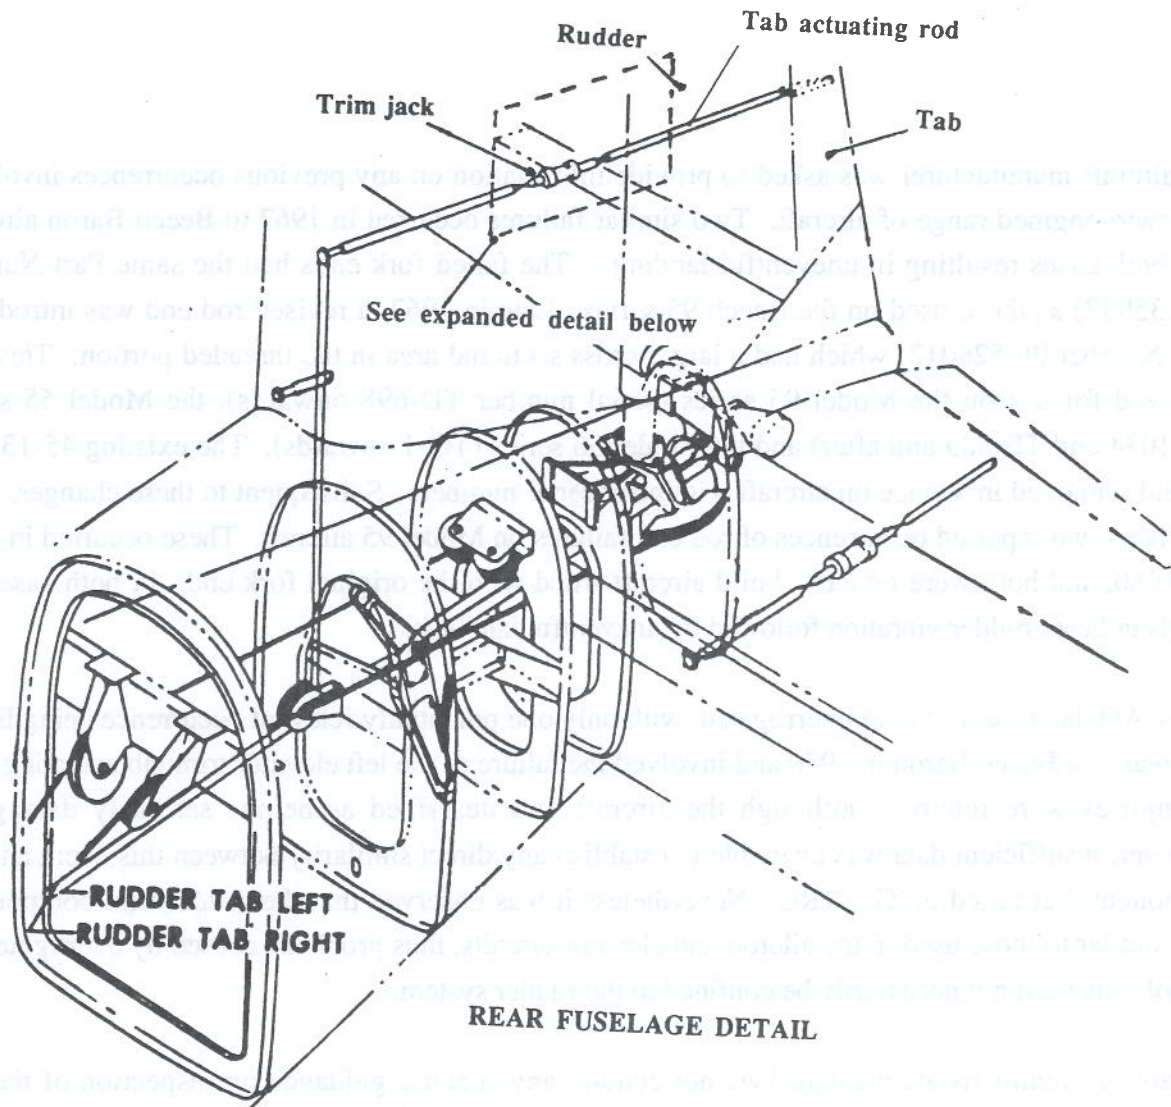
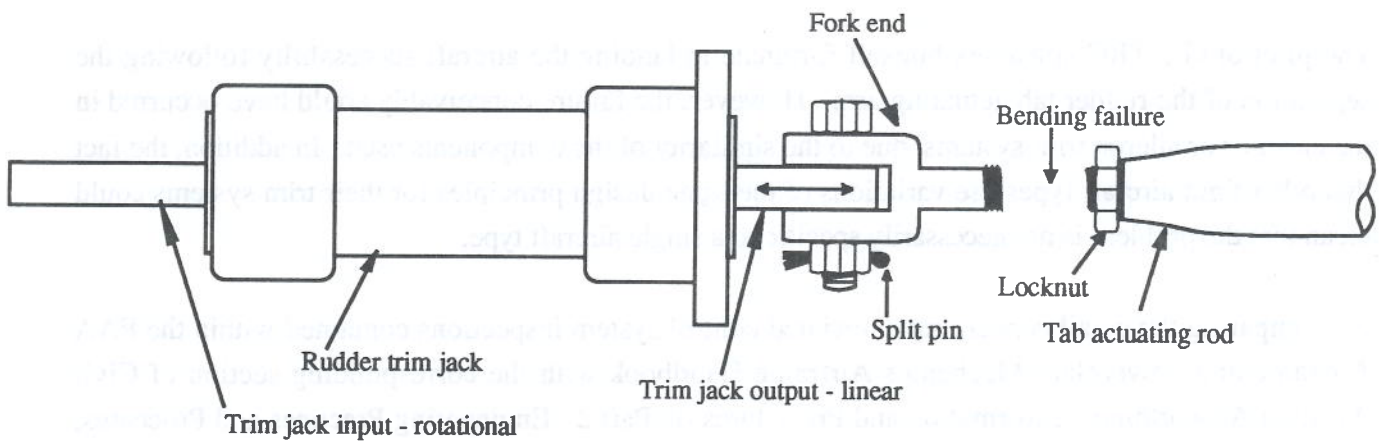
Subsequent examination of the aircraft revealed that the rudder tab actuating rod had failed at its attachment to the rudder trim jack, which is mounted in the rear of the fin. Once the failure had occurred, the tab would have been free to flutter, and to 'servo' the rudder giving rise to the violent pedal movement. A diagram of the relevant part of the rudder trim system is attached, together with a detail of the actual failure. The rudder trim system consists of pulleys and cables, with the input to the trim jack being via a rotating rod. The jack converts the rotational motion into a linear output, and the output rod is connected directly to the rudder tab. The fork end of the output rod had failed at its attachment to the jack. The problem appeared to be due to the bolt that attached the fork end to the jack fitting having been significantly overtightened. This prevented the joint from swivelling as the rudder moved left and right.

A metallurgical examination of the failed fork end did not reveal any evidence of pre-existing cracks, although the threads were somewhat rusty despite the assembly being liberally greased. The fracture surface was indicative of bending overload in one direction, although the expected failure mode would be one of reverse bending, low cycle fatigue.

The broken fork end that remained attached to the jack could not be rotated. Moreover it was noted that with a small amount of right trim applied (thereby extending the jack), the fork end could be made to foul on a flange within the rudder leading edge in such a way that the rudder was inhibited from returning to neutral from a large right deflection. This may have accounted for the rudder jam as reported by the pilot.

Removal of the fork end from the jack revealed no evidence of corrosion on the inner faces that might have contributed to an inability of the bolted joint to rotate. Furthermore, the split pin was still in position, thereby eliminating any possibility of the joint tightening in service. It was therefore concluded that the bolt was simply overtight, although this part of the flying controls had reportedly not been disconnected during the Annual Inspection.

**DETAIL OF RUDDER TRIM ACTUATING ARM FAILURE**
