AAIB Bulletin No: 9/93

Aircraft Type and Registration: Cessna 310Q G-BBHG

Location: Manston Airport, Kent

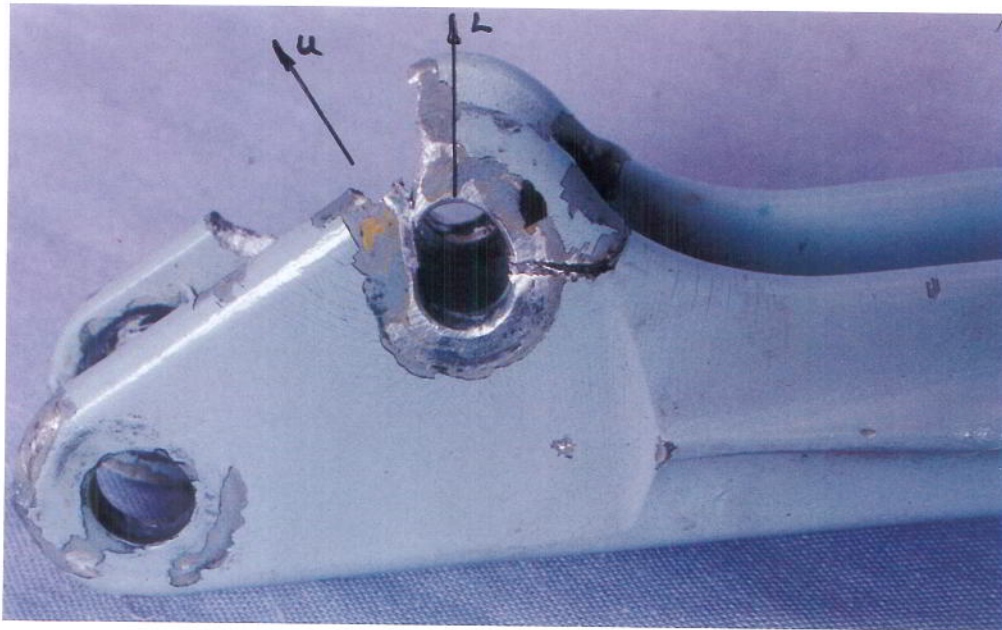
Figure 2

Examination of the aircraft quickly revealed that failures had occurred to the upper and lower lugs of an idler lever, Pt No 0842102-497, which supports the junction of the two push/pull rods which transmit the drive from the gearbox forward to the nose gear mechanism. This lever is located between the cabin floor and the fuselage skin and cannot be inspected without removing the front seats, trim and some floor panels. Specifically the lugs had failed through the attachment hole for the aftmost rod end bearing, Figure 2; the lugs associated with the other rod being intact.. Close examination of the failures revealed both to have been as a result of overload. However, deformation and the extent of wear and fretting patterns associated with the upper lug, rod end and particularly the attachment bolt suggested that the failure of the lower lug had occurred some time before the upper lug, probably during a previous flight. A wear /fretting step in the shank of the attachment bolt caused by the inner race being loaded asymmetrically during gear operation after the failure of the lower lug, Figure 3, is shown in Figure 4.

Arrows indicate directions of upper and lower lug failures

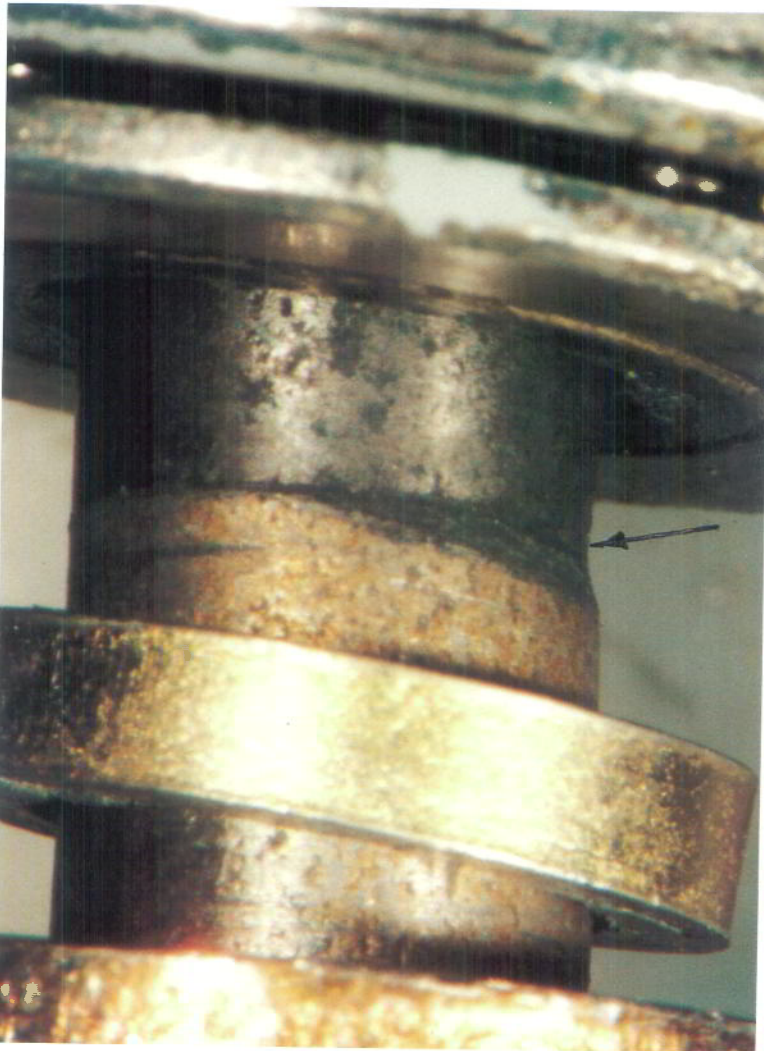
Figure 4

Region of heavy wear/fretting on bolt shank

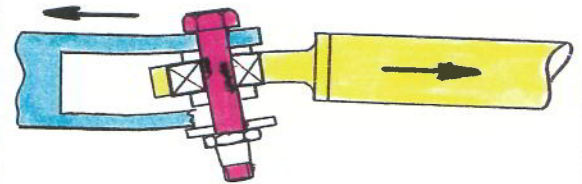
Figure 3

Working configuration of joint after failure of lower lug

Arrows indicate load transfer during gear retraction
