Ponsford Bensen B8MR (Modified), G-BIGU

AAIB Bulletin No: 9/2004	Ref: EW/C2003/06/05	Category: 2.3
Aircraft Type and Registration:	Ponsford Bensen B8MR (Modified), G-BIGU	
No & Type of Engines:	1 Rotax 532 piston engine	
Year of Manufacture:	2001	
Date & Time (UTC):	29 June 2003 at 1250 hrs	
Location:	Shipdham Airfield, near Dereham, Norfolk	
Type of Flight:	Private	
Persons on Board:	Crew - 1	Passengers - None
Injuries:	Crew - 1 (Fatal)	Passengers - N/A
Nature of Damage:	Aircraft destroyed	
Commander's Licence:	Private Pilot's Licence (Aeroplanes) and Private Pilot's Licence (Gyroplanes)	
Commander's Age:	44 years	
Commander's Flying Experience:	324 hours (of which 43 were on gyroplanes)	
	Last 90 days - 27 hours	
	Last 28 days - 5 hours	
Information Source:	AAIB Field Investigation

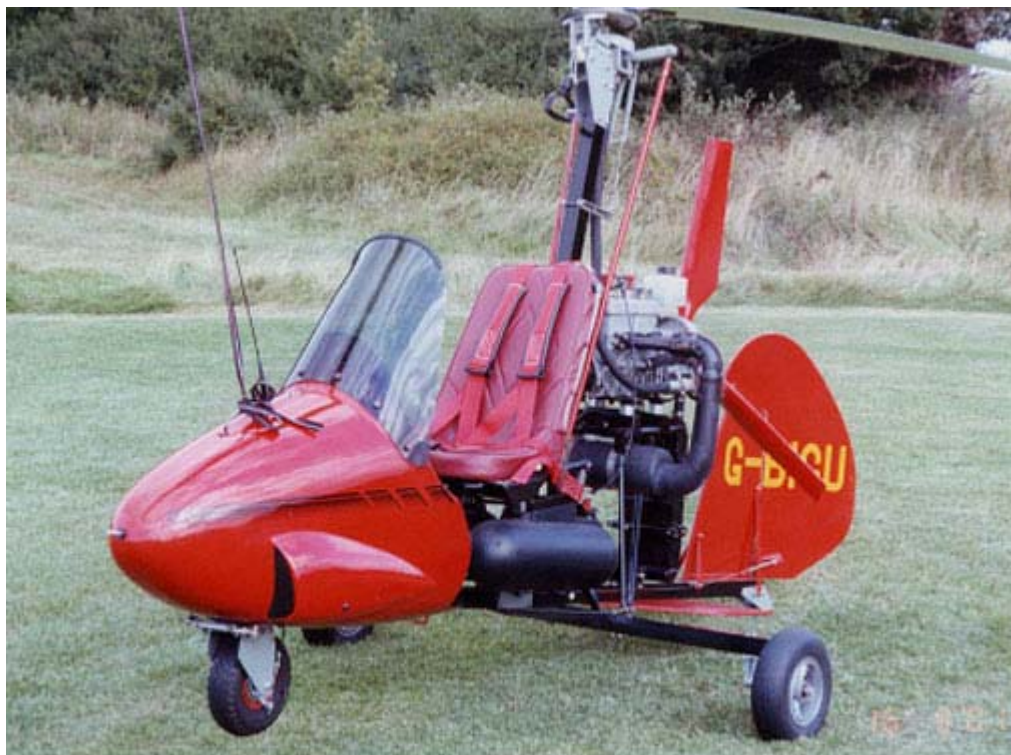
Figure 1 - Aircraft prior to the accident (G-BIGU)

The aircraft was a light single seat gyroplane with a pusher engine configuration and an open cockpit (see Figure 1). The aircraft was fitted with 22-foot diameter 'Dragon Wing' rotor blades and a Rotax 532 engine with a three-bladed composite propeller. The engine was not fitted with a carburettor heat system. In common with other Bensen type gyroplanes, the control stick was of the 'pump-action' (also known as 'Brock') type, which pivots at a point below the seat and moves vertically during forward and aft movements. This differs from a keel mounted stick that has no significant vertical movement during pitch control changes. The movement of a keel mounted stick would be similar to that encountered in conventional fixed wing aircraft.

The non-standard modifications included the addition of a modified nose cone fairing from the Air Command gyroplane design, the addition of side pod tanks and a seat incorporating a fuel tank, also from the Air Command design. The nose cone fairing and seat tank modifications had been approved by the PFA. The side pod tank modification had not yet been approved due to its potential adverse effect on vertical CG. However, a weight and balance study by the University of Glasgow had determined that the tanks had little effect on the vertical CG. From weight measurements the vertical position of the CG was calculated to be 4.8 ± 1.2 inches below the thrust line. The aircraft's mass with the accident pilot on board and with the seat tank half full was measured at 252 kg. The maximum total authorised weight of the aircraft was 280 kg.

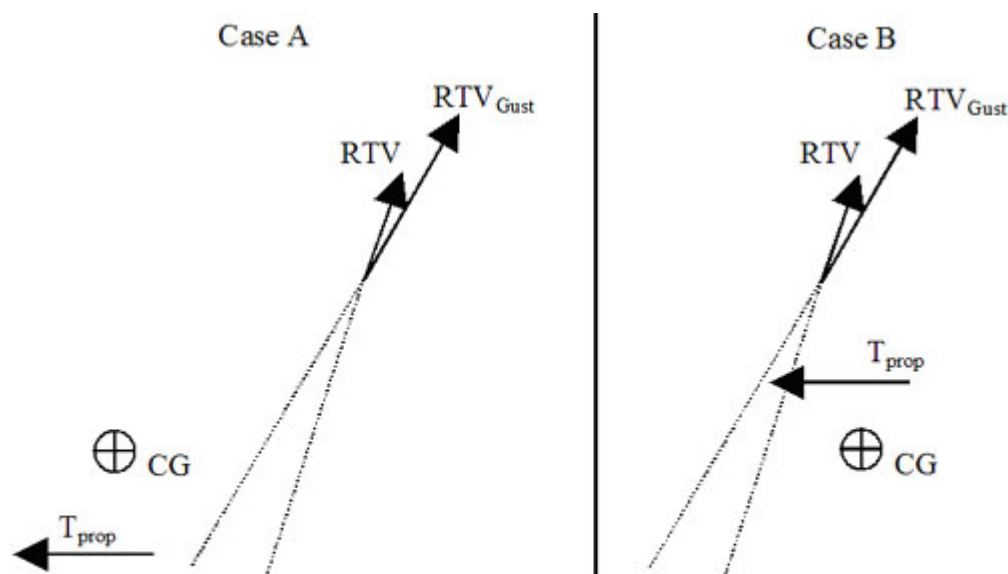
Figure 3 Diagram of Rotor Thrust Vector (RTV) change due to an upwards gust.
Case A: Propeller thrust line passes below CG. Case B: Propeller thrust line passes above CG.

In the same way that a fixed wing aircraft has longitudinal static stability when the CG is forward of the aircraft's lift vector, a gyroplane has longitudinal static stability when the CG is forward of the Rotor Thrust Vector (RTV). In this configuration when a gust causes the gyroplane to pitch up the rotor thrust will increase causing a restoring nose down pitching moment. A large factor in determining the balance of moments which affects the location of the RTV in steady flight is the vertical location of the propeller thrust line relative to the vertical CG. A simplified diagram showing the two dominant forces, propeller thrust (T_{prop}) and RTV, is shown in Figure 3 (the aerodynamic drag is assumed to be closely in line with the vertical CG). For case A, the thrust line is below the CG and therefore to establish equilibrium in flight the RTV lines up aft of the CG (to balance the nose up pitching moment of the thrust line). When a disturbance such as an upwards gust causes the aircraft to pitch up the RTV will increase and tilt aft (flap back), the net effect being to pitch the aircraft nose down - a restoring moment. For case B the thrust line is above the CG and therefore to establish equilibrium in flight the RTV lines up forward of the CG. When a disturbance causes the aircraft to pitch up the RTV will increase and tilt aft, the net effect being to pitch the aircraft nose up even further - an unstable configuration.

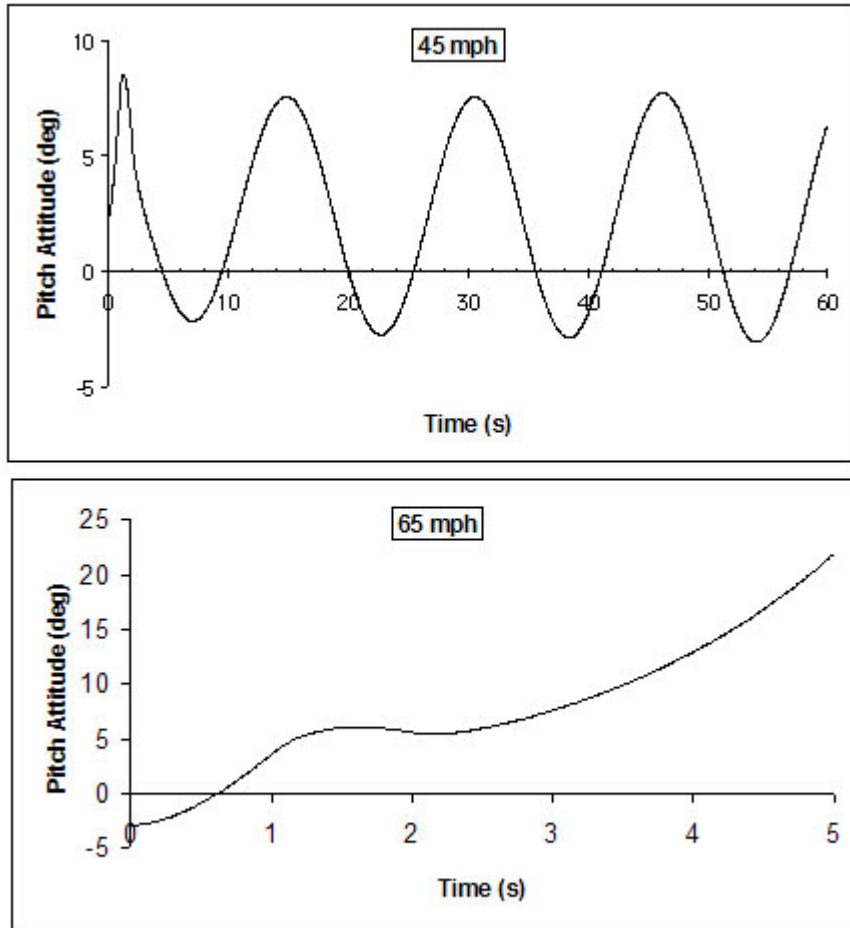
Figure 4 Modelled pitch response of accident at 45 mph and 65 mph following a fore and aft stick input

The University of Glasgow was asked to model the stability of G-BIGU using their RASCAL simulator that had been developed to model gyroplanes. The pod, tailplane and vertical tail aerodynamics were those estimated from a similar looking single-seat Air Command gyroplane. The mass properties, CG, thrust line and geometric data used were those specific to G-BIGU. The results showed that when the aircraft was excited by a fore and aft stick input, the response was a stable and lightly damped pitch oscillation (see Figure 4) at 45 mph. However, when the speed was increased to 65 mph the model predicted that G-BIGU would have an unstable rapidly divergent pitch response shown by the rapidly increasing pitch angle in Figure 4. The control stick was assumed to be held fixed following the initial input. Unfortunately, this simulator model for G-BIGU cannot be validated against the real aircraft and therefore these results must be treated with some caution. However, taken

together with the design characteristics of G-BIGU, the results indicate that the aircraft could have had an unstable mode in pitch and probably did not meet all the longitudinal stability criteria of BCAR Section T.

The reason for the discrepancy between the flight test assessment and the modelled results could be due to the test technique. The flight test studies conducted by the University of Glasgow with instrumented gyroplanes revealed that very experienced gyroplane pilots, who have not been trained as test pilots, have a subconscious tendency to correct for instabilities in the aircraft with small stick inputs. The true stability characteristics of an aircraft need to be assessed objectively both stick fixed and stick free.

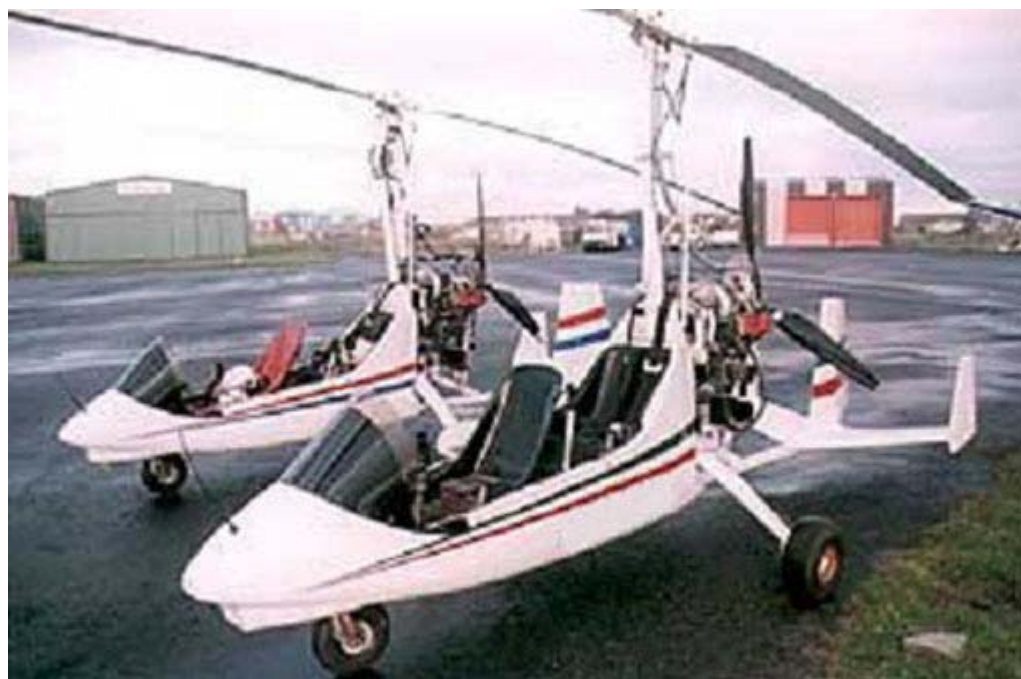
Figure 2 - In foreground, VPM M-16 used by accident pilot for majority of training

The accident pilot underwent the majority of his flight training on a VPM M-16. The VPM M-16 (shown in Figure 2) is a very different aircraft to G-BIGU. The VPM is a two seat aircraft and has a lower thrust-to-weight ratio than G-BIGU. Unlike G-BIGU the VPM has a stabilising horizontal tail, a keel mounted stick and its thrust line is closer to the vertical CG than on G-BIGU (between 2.4 and 3.4 inches above CG). The University of Glasgow carried out a flight test programme on an instrumented VPM M-16 with a former military test pilot. Various longitudinal stability tests were carried out including stick fixed pitch oscillations. The recorded flight test data was analysed and showed that the aircraft met the longitudinal dynamic stability criteria of Section T. Verbal accounts from those who have flown the VPM confirm that the aircraft is considerably more stable and easier to fly than most other gyroplanes.
