AAIB Bulletin No: 8/95 **Ref:** EW/C95/3/6 **Category:** 2.3

Aircraft Type and Registration: Schweizer 269C (300C) G-LSLH

Location: Oxford (Kidlington) Airport

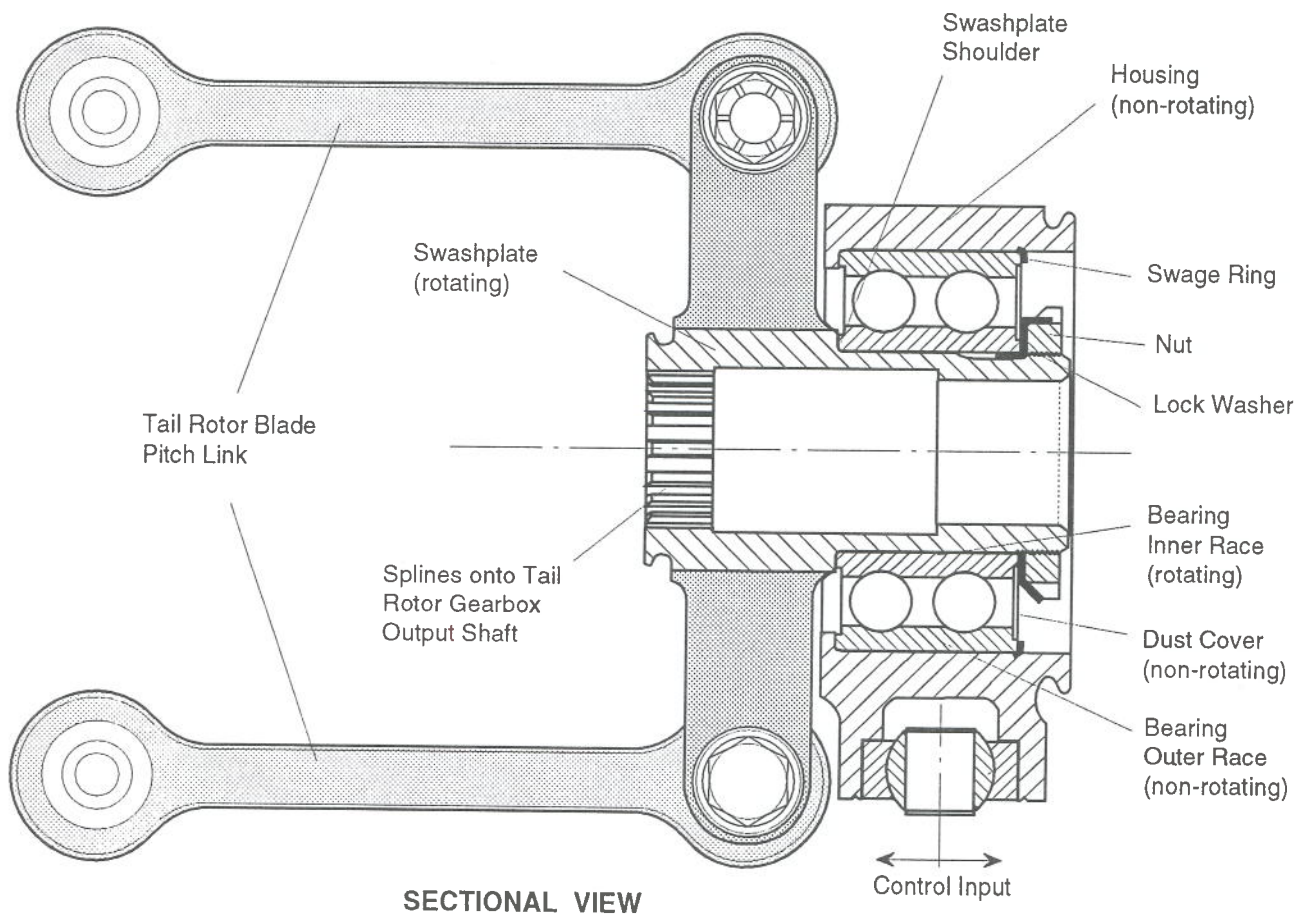
Fig 1

The pitch control assembly (PN 269A6050-5) comprised a non-rotating aluminium housing connected via a double row ball bearing to a rotating swashplate assembly splined to the gearbox output shaft (Fig 1). The outer race of the bearing was an interference fit in the housing and secured in it by a swage ring. The bearing inner race was an interference fit on a boss, or shaft, forming an integral part of the aluminium swashplate and was axially clamped against a shoulder formed at the outboard end of the boss by a nut screwed onto a thread formed on the inboard end of the boss. The nut was secured by a lock washer which was fitted between the nut and the inner race and prevented from rotating by a tang that protruded inside the internal diameter and located in a keyway in the boss; thirteen external tangs protruded from the outer diameter of the washer, one of which would be bent into one of eight slots formed in the nut. The inboard end of the pitch control assembly was covered by a non-rotating flexible boot wired to the housing and to the gearbox casing and the outboard end was covered by a rotating boot wired to the swashplate and to the fork assembly carrying the tail rotor blades.

AAIB examined the aircraft after partial disassembly of the tail rotor control system. This revealed that the nut in the pitch control assembly on the tail rotor gearbox output shaft had disengaged from the swashplate boss; the nut had not been damaged apart from signs of fretting wear on the face normally bearing against the lock washer, and the boss thread, while damaged, remained intact. The lock washer had been heavily rubbed and considerably distorted and had broken into two major portions with the internal and two external tangs fractured off, one of the latter showing signs of having been bent consistent with engagement with the nut. These components were recovered from within the stationary boot. The swashplate boss showed signs of major fretting and wear; the outer diameter was measured at 1.165-1.175 inches, 0.0166-0.0066 inch below the minimum requirement of 1.1816 inches. The bearing inner race bore was measured at approximately 1.180 inches. The swashplate thus exhibited considerable play within the bearing, both diametrically and in the angular rocking sense, together giving a relative motion of approximately 0.03-0.04 inch at the plane of the pitch link attachment bearings in the swashplate forks. The bearing remained secure within the housing and was apparently undamaged and rotated smoothly and without signs of play or binding. Markings on the component surfaces surrounding the normal position of the lock washer and nut suggested that parts of the lock washer had contacted the swage ring and the exposed bore of the housing inboard of the bearing after the washer had fractured. Other markings suggested washer rotational contact with the bearing inner race and dust cover (non-rotating) and showed that the washer's inner tang had been driven out of the swashplate keyway in a clockwise rotation direction, viewed from outboard. The tail rotor gearbox output shaft was undamaged apart from an area of rubbing adjacent to the gearbox casing, consistent with a period of running with the nut lying on the shaft in this region.

The evidence was consistent with wear of the swashplate boss having allowed the boss to spin within the bearing inner race and with friction loads between the inner race and/or the dust cover and the lock washer having applied a retardation torque to the washer. The boss had a normal right-hand thread and any retardation torque applied to the nut, either via the washer or by direct contact with a slower rotating inner race and/or non-rotating dust cover, would tend to unscrew the nut from the boss. No assessment of the operating timescale over which the major part of the wear had occurred was possible from the component damage.

The evidence was consistent with the effects of a loss of preload in the attachment of the swashplate to the tail rotor pitch change assembly bearing having allowed fretage wear to occur to the point where the swashplate became loose in the bearing, resulting in further wear. Subsequent relative rotation between the swashplate and the bearing inner race and dust cover caused the lock washer to disengage or fail and the nut to screw off the swashplate. The reason for a loss of preload could not be positively established but the assembly technique used by the maintainer, while in accordance with the HMI, did not include the procedure specified by Schweizer Notice N-163 published in 1979 for seating the swashplate in the bearing with a 2,000 lb press load that was likely to be much higher than that used if following the HMI procedure, together with an approximate doubling of the nut torque load. This procedure was not listed as applicable to G-LSLH's Serial No, as the change had been incorporated on the production line, and due to an oversight had not been incorporated in the HMI. The rate of progression of the failure could not be positively established but the previous occurrence to G-LSLH suggested that noticeable play in the assembly may be present for some period before disconnection occurs.

- 1 Liaise with the manufacturer to confirm the assembly procedure necessary to ensure a satisfactory installation of the tail rotor pitch change assembly.
- 2 Consider the implementation of a disassembly inspection of the tail rotor pitch change assembly for excessive wear and reassembly in accordance with the necessary procedure.
- 3 Consider the implementation of a suitable inspection of the tail rotor pitch change assembly for excessive play before each flight until the inspection and reassembly recommended in 2 has been carried out.
