AAIB Bulletin No: 8/95 **Ref:** EW/C95/3/6 **Category:** 2.3

Aircraft Type and Registration: Schweizer 269C (300C) G-LSLH

Location: Oxford (Kidlington) Airport

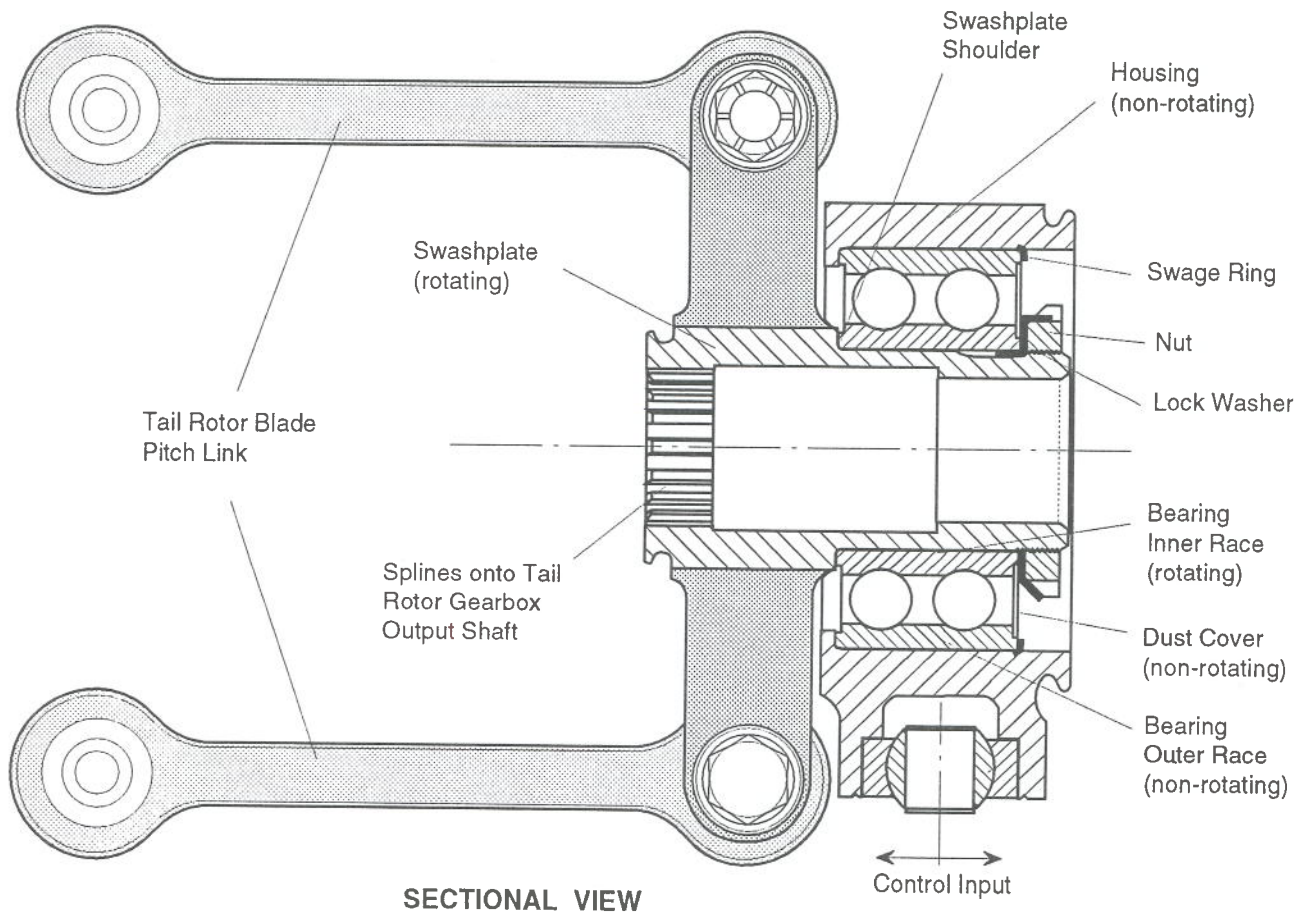
Fig 1

The pitch control assembly (PN 269A6050-5) comprised a non-rotating aluminium housing connected via a double row ball bearing to a rotating swashplate assembly splined to the gearbox output shaft (Fig 1). The outer race of the bearing was an interference fit in the housing and secured in it by a swage ring. The bearing inner race was an interference fit on a boss, or shaft, forming an integral part of the aluminium swashplate and was axially clamped against a shoulder formed at the outboard end of the boss by a nut screwed onto a thread formed on the inboard end of the boss. The nut was secured by a lock washer which was fitted between the nut and the inner race and prevented from rotating by a tang that protruded inside the internal diameter and located in a keyway in the boss; thirteen external tangs protruded from the outer diameter of the washer, one of which would be bent into one of eight slots formed in the nut. The inboard end of the pitch control assembly was covered by a non-rotating flexible boot wired to the housing and to the gearbox casing and the outboard end was covered by a rotating boot wired to the swashplate and to the fork assembly carrying the tail rotor blades.

AAIB examined the aircraft after partial disassembly of the tail rotor control system. This revealed that the nut in the pitch control assembly on the tail rotor gearbox output shaft had disengaged from the swashplate boss; the nut had not been damaged apart from signs of fretting wear on the face normally bearing against the lock washer, and the boss thread, while damaged, remained intact. The lock washer had been heavily rubbed and considerably distorted and had broken into two major portions with the internal and two external tangs fractured off, one of the latter showing signs of having been bent consistent with engagement with the nut. These components were recovered from within the stationary boot. The swashplate boss showed signs of major fretting and wear; the outer diameter was measured at 1.165-1.175 inches, 0.0166-0.0066 inch below the minimum requirement of 1.1816 inches. The bearing inner race bore was measured at approximately 1.180 inches. The swashplate thus exhibited considerable play within the bearing, both diametrically and in the angular rocking sense, together giving a relative motion of approximately 0.03-0.04 inch at the plane of the pitch link attachment bearings in the swashplate forks. The bearing remained secure within the housing and was apparently undamaged and rotated smoothly and without signs of play or binding. Markings on the component surfaces surrounding the normal position of the lock washer and nut suggested that parts of the lock washer had contacted the swage ring and the exposed bore of the housing inboard of the bearing after the washer had fractured. Other markings suggested washer rotational contact with the bearing inner race and dust cover (non-rotating) and showed that the washer's inner tang had been driven out of the swashplate keyway in a clockwise rotation direction, viewed from outboard. The tail rotor gearbox output shaft was undamaged apart from an area of rubbing adjacent to the gearbox casing, consistent with a period of running with the nut lying on the shaft in this region.

The evidence was consistent with wear of the swashplate boss having allowed the boss to spin within the bearing inner race and with friction loads between the inner race and/or the dust cover and the lock washer having applied a retardation torque to the washer. The boss had a normal right-hand thread and any retardation torque applied to the nut, either via the washer or by direct contact with a slower rotating inner race and/or non-rotating dust cover, would tend to unscrew the nut from the boss. No assessment of the operating timescale over which the major part of the wear had occurred was possible from the component damage.

The evidence was consistent with the effects of a loss of preload in the attachment of the swashplate to the tail rotor pitch change assembly bearing having allowed fretting wear to occur to the point where the swashplate became loose in the bearing, resulting in further wear. Subsequent relative rotation between the swashplate and the bearing inner race and dust cover caused the lock washer to disengage or fail and the nut to screw off the swashplate. The reason for a loss of preload could not be positively established but the assembly technique used by the maintainer, while in accordance with the HMI, did not include the procedure specified by Schweizer Notice N-163 published in 1979 for seating the swashplate in the bearing with a 2,000 lb press load that was likely to be much higher than that used if following the HMI procedure, together with an approximate doubling of the nut torque load. This procedure was not listed as applicable to G-LSLH's Serial No, as the change had been incorporated on the production line, and due to an oversight had not been incorporated in the HMI. The rate of progression of the failure could not be positively established but the previous occurrence to G-LSLH suggested that noticeable play in the assembly may be present for some period before disconnection occurs.

- 1 Liaise with the manufacturer to confirm the assembly procedure necessary to ensure a satisfactory installation of the tail rotor pitch change assembly.
- 2 Consider the implementation of a disassembly inspection of the tail rotor pitch change assembly for excessive wear and reassembly in accordance with the necessary procedure.
- 3 Consider the implementation of a suitable inspection of the tail rotor pitch change assembly for excessive play before each flight until the inspection and reassembly recommended in 2 has been carried out.
