**ACCIDENT**

<b>Aircraft Type and Registration:</b>	Avid Speedwing Mk4, G-BUFV	
<b>No &amp; Type of Engines:</b>	1 BMW R100 piston engine	
<b>Category:</b>	1.3	
<b>Year of Manufacture:</b>	1992	
<b>Date &amp; Time (UTC):</b>	10 June 2005 at 2000 hrs	
<b>Location:</b>	Lough Neagh, Northern Ireland	
<b>Type of Flight:</b>	Private	
<b>Persons on Board:</b>	Crew - 1	Passengers - 1
<b>Injuries:</b>	Crew - None	Passengers - None
<b>Nature of Damage:</b>	Ditched	
<b>Commander's Licence:</b>	FAA Private Pilot's Licence	
<b>Commander's Age:</b>	38 years	
<b>Commander's Flying Experience:</b>	135 hours (all on type) Last 90 days - 21 hours Last 28 days - 8 hours	
<b>Information Source:</b>	Aircraft Accident Report Form submitted by the pilot and engine examination by AAIB

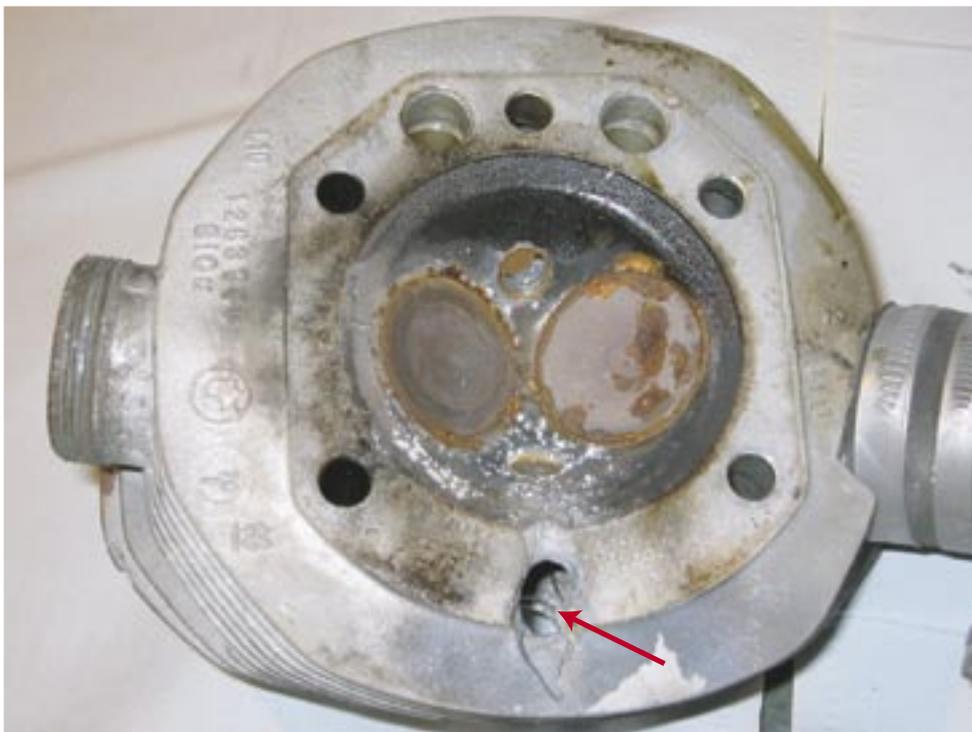
**Figure 1**

The engine was stripped in the presence of the PFA and representatives from a maintenance organisation specialising in the conversion of BMW motorcycle engines for aircraft installation. The left cylinder rocker cover was removed and the cylinder head nuts that tighten onto the cylinder through studs were removed. The torque values on the cylinder head nuts were noted to be less than that required in the manual (26-29 lbf ft). The cylinder head was then removed and a hole observed around one of the two cylinder head studs where hot gasses had burned through the head gasket and the outer cylinder casing (see figure 1 and 2). The right cylinder head nuts were also found to be tightened to less than the correct torque setting. The engine was otherwise mechanically sound and free to rotate.

Left cylinder head showing burn through of the casing around one cylinder head stud

The engine would have been re-built when it was converted to the aircraft installation by a previous owner. Although there is no specific advice in the overhaul manual, it is normal good engineering practice to check

the torque tightening of cylinder head nuts after an initial run-in period of 5-10 hours, as loosening of the nuts can occur during operation.

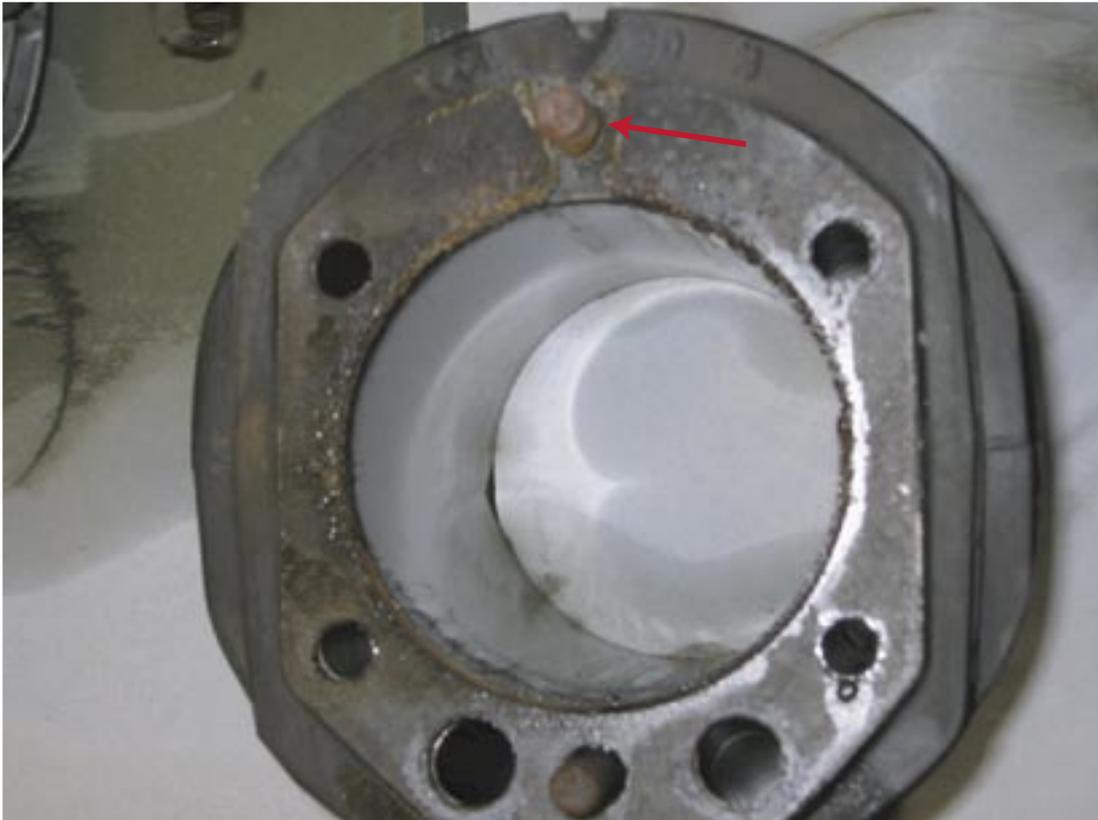
**Figure 2**

Left cylinder head gasket
