Beech 200 King Air, VP-BBK

AAIB Bulletin No: 7/2003	Ref: EW/C2000/12/7	Category: 1.2
Aircraft Type and Registration:	Beech 200 King Air, VP-BBK	
No & Type of Engines:	2 Pratt & Whitney PT6A-42 turboprop engines	
Year of Manufacture:	1995	
Date & Time (UTC):	23 December 2000 at 1351hrs	
Location:	1 nm north-east of Blackbushe Airport, Surrey	
Type of Flight:	Private	
Persons on Board:	Crew - 1	Passengers - 4
Injuries:	Crew - 1 (Fatal)	Passengers - 4 (Fatal)
Nature of Damage:	Aircraft destroyed	
Commander's Licence:	FAA Airline Transport Pilot's Licence	
Commander's Age:	53	
Commander's Flying Experience:	2,664 hours (of which 1,243 were on type)	
	Last 90 days - 108 hrs	
	Last 28 days - 24 hrs	
Information Source:	AAIB Field Investigation

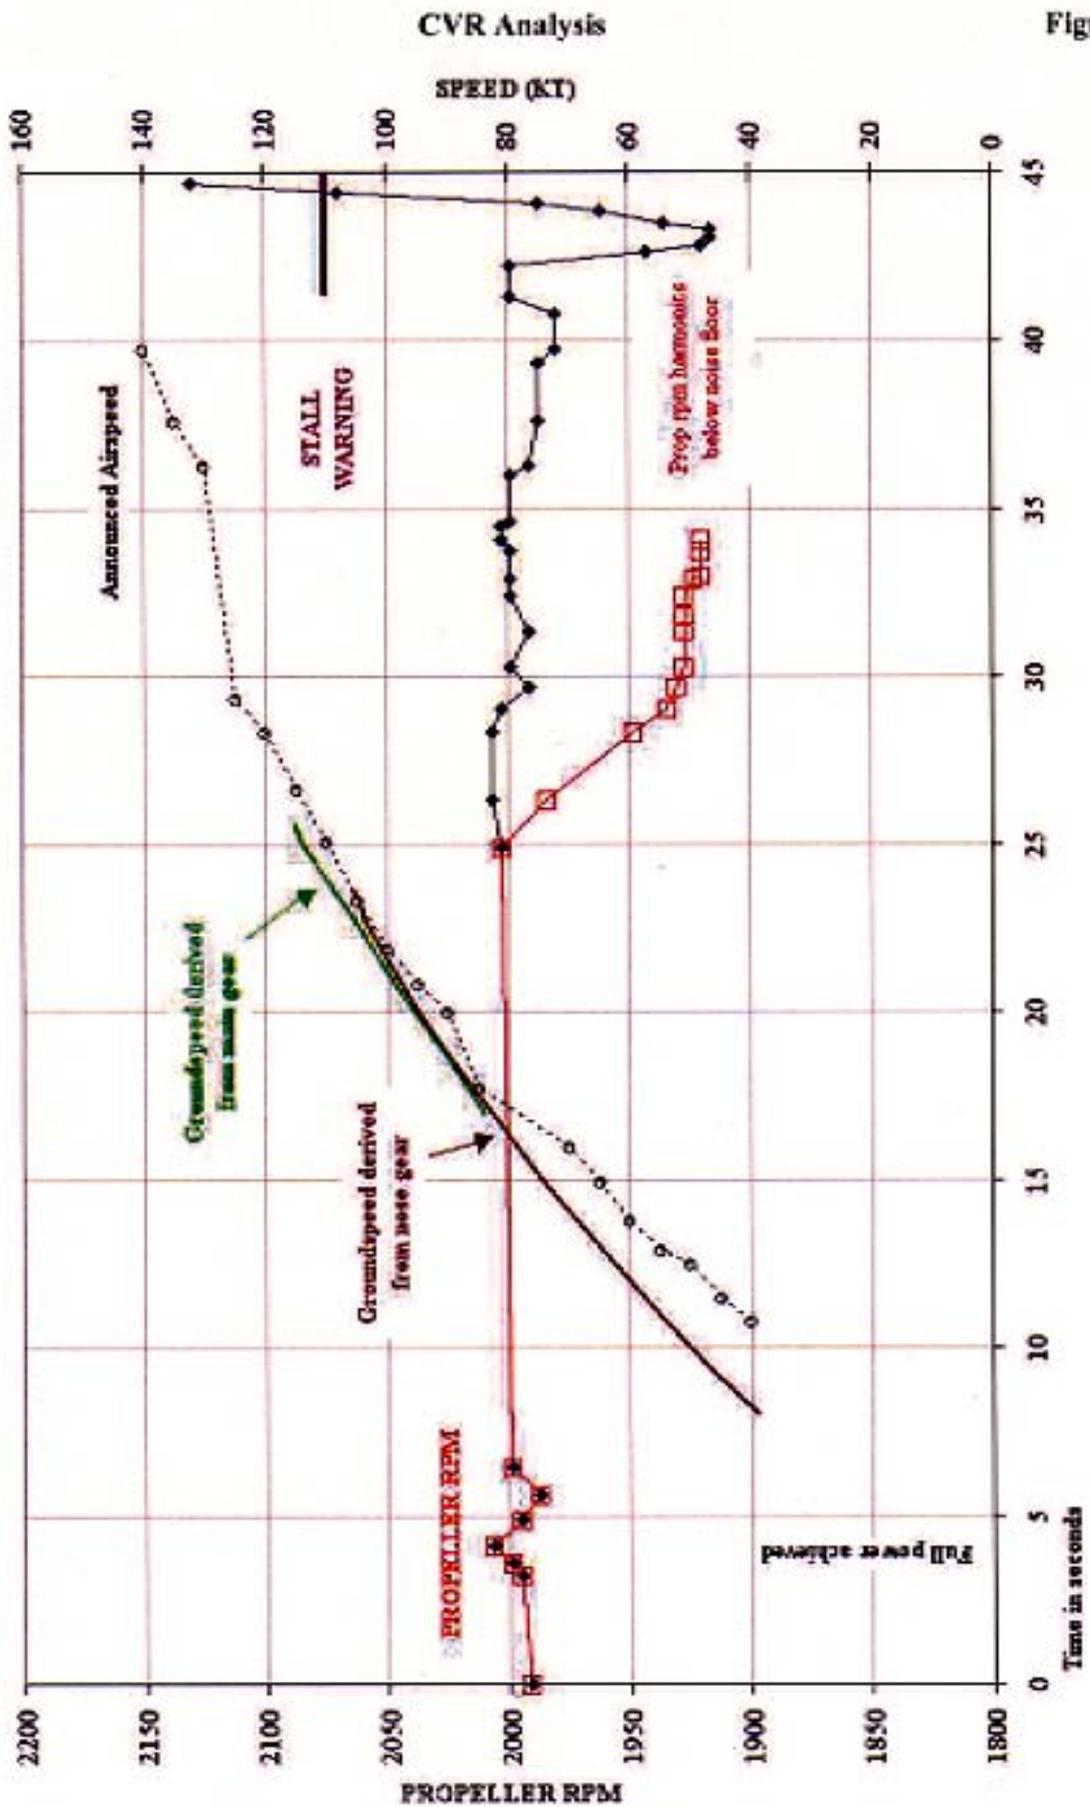
The spectral analysis showed that the propeller rotational speeds were symmetrical at 2,000 rpm during the take-off roll. However, where the nature of the sound changed, it was observed that one of the propellers started to reduce in speed; decaying to approximately 1,925 rpm over a period of five seconds before stabilising at that value. The frequencies associated with this lower speed propeller were discernible for the next five seconds before reducing in amplitude (but remaining constant in frequency) until they could not be distinguished from background noise. This reduction in amplitude may be attributable to a reduction in the air mass flow rate through the propeller disc.

During the period of decaying speed of one propeller, the frequencies associated with the other propeller indicated a slight rise in rotational speed to 2,007 rpm for four seconds, before reducing to marginally below 2,000 rpm and then stabilising back at the take-off speed.

During the last 10 seconds of flight, frequencies associated with the lower speed propeller could not be observed and so it was not possible to determine rotational speed. The frequencies from the other propeller could be distinguished and a speed derived. From the plot of parameters calculated using spectral analysis, shown in Figure 1, it can be seen that the speed of this propeller reduced towards 1,900 rpm at a point 2.5 seconds before impact and then increased rapidly. The final, derived value of rotational speed was in excess of 2,125 rpm and occurred at impact.

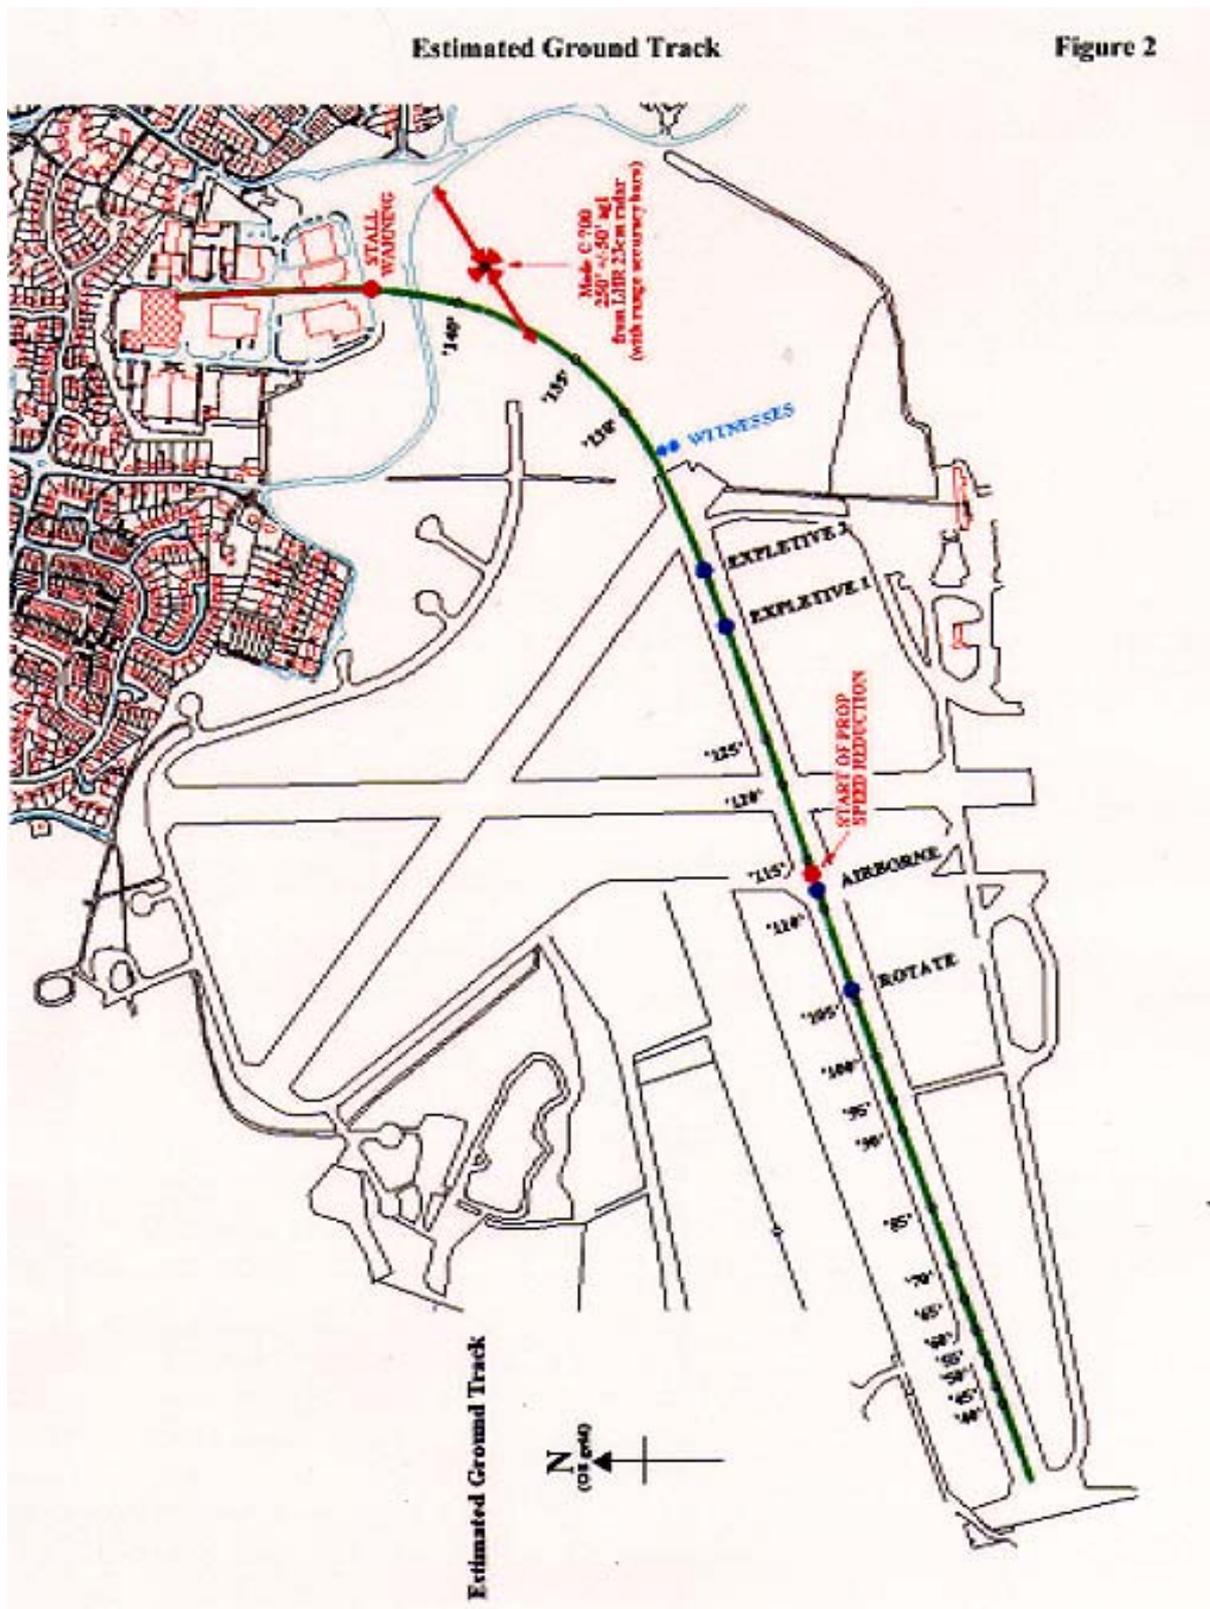
From information recorded on the CVR, one 'Mode C' radar return recorded from the Heathrow 23 cm radar, witness evidence, and flight trials using an Islander aircraft, the track of the aircraft over the ground was derived. This, overlaid with the aircraft's airspeed, is shown in Figure 2.
