## ACCIDENT

<b>Aircraft Type and Registration:</b>	Piper PA-28-140 Cherokee, G-BBBK	
<b>No &amp; Type of Engines:</b>	1 Lycoming O-320-E3D piston engine	
<b>Year of Manufacture:</b>	1967	
<b>Date &amp; Time (UTC):</b>	3 February 2007 at 1713 hrs	
<b>Location:</b>	In the sea close to Blackpool Beach, Lancashire	
<b>Type of Flight:</b>	Private	
<b>Persons on Board:</b>	Crew - 1	Passengers - 1
<b>Injuries:</b>	Crew - 1 (Fatal)	Passengers - 1 (Fatal)
<b>Nature of Damage:</b>	Aircraft destroyed	
<b>Commander's Licence:</b>	Private Pilot's Licence	
<b>Commander's Age:</b>	26 years	
<b>Commander's Flying Experience:</b>	110 hours (of which 105 were on type) Last 90 days - 4 hours (flown on the day of the accident) Last 28 days - 4 hours (flown on the day of the accident)	
<b>Information Source:</b>	AAIB Field Investigation

## Synopsis

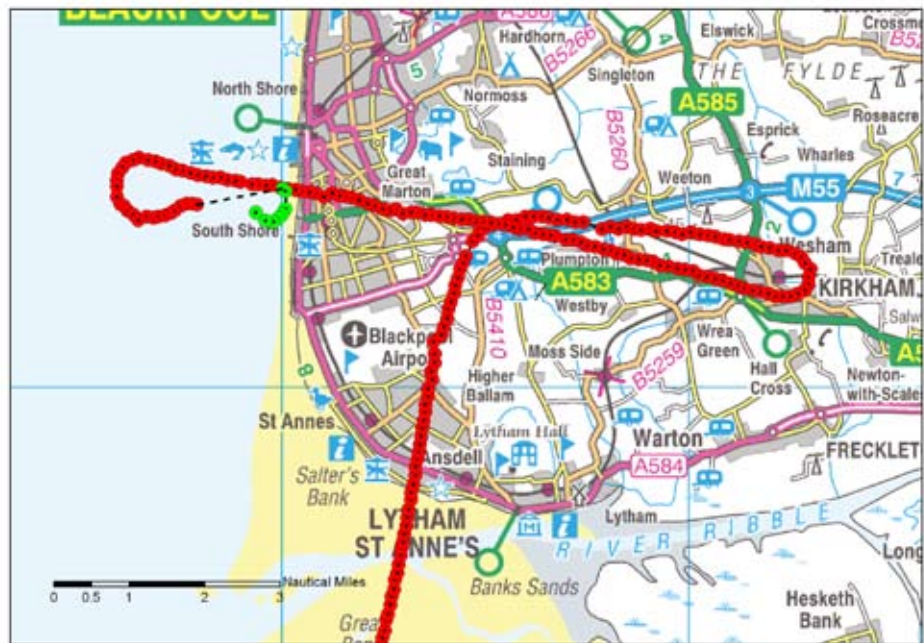
Recorded data from St Annes radar, identified as belonging to the accident aircraft, started at 1638 hrs with the aircraft near Mold, North Wales, when it was tracking to the North. Figure 2 shows this track just as G-BBBK approached Blackpool, and ends when radar contact was finally lost at 1713:18 hrs. Radar contact, however, was briefly lost at 1711:01 hrs (the end of the red track) in Figures 2 and 3, before being re-established 1 minute 39 seconds later (the start of the green track) for a further 38 seconds.

**Figure 2**  
Radar track of G-BBBK positioning to land at Blackpool Airport
