# Piper PA-28R-200-2 Cherokee Arrow II, G-BKCB

| <b>AAIB Bulletin No: 11/2003</b> | <b>Ref: EW/C2000/12/2</b> | <b>Category: 1.3</b> |
| <b>Aircraft Type and Registration:</b> | Piper PA-28R-200-2 Cherokee Arrow II, G-BKCB | |
| <b>Location:</b> | Warren Farm, Lambourne, Berkshire | |

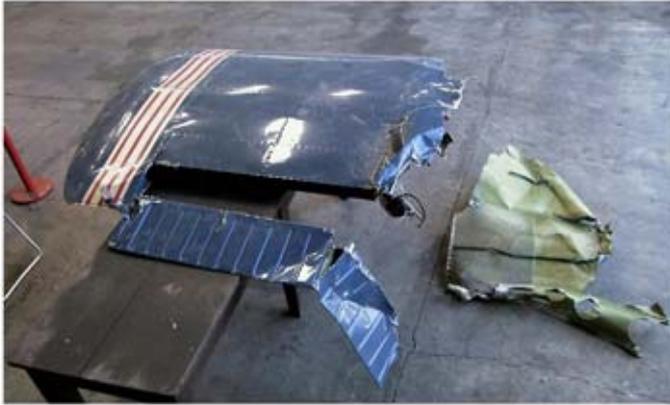
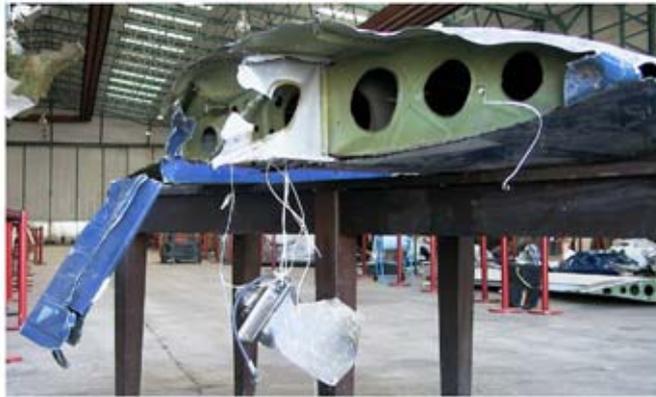
**Figure 2**

The wing failure had occurred between the two hinges of the left aileron, Figure 2, such that its separation led to the release of the aileron.

Details of separated left outer wing structure

Examination of the separated left outer wing section confirmed that the failure had occurred very close to the wing splice, i.e., where the extruded aluminium alloy section inboard spar is riveted to the pressed sheet aluminium alloy outer spar. The plot of the wreckage distribution indicated that the first event of the structural failure was the separation of the outermost section of the left wing. This was apparently followed by loss of a section of wing skin inboard of the initial failure, extending from the upper to the lower flange of the wing spar around the leading edge. The fin mounted rotating beacon and the rudder mass-balance weight were recovered from an area remote from other wreckage. It was calculated that the separation of these items had occurred whilst the aircraft was travelling at approximately 90° to the aircraft's initial flight path, and at an altitude not greatly below 4,200 feet. Witness marks indicated that this had occurred as a result of being struck by the section of the failed wing skin.

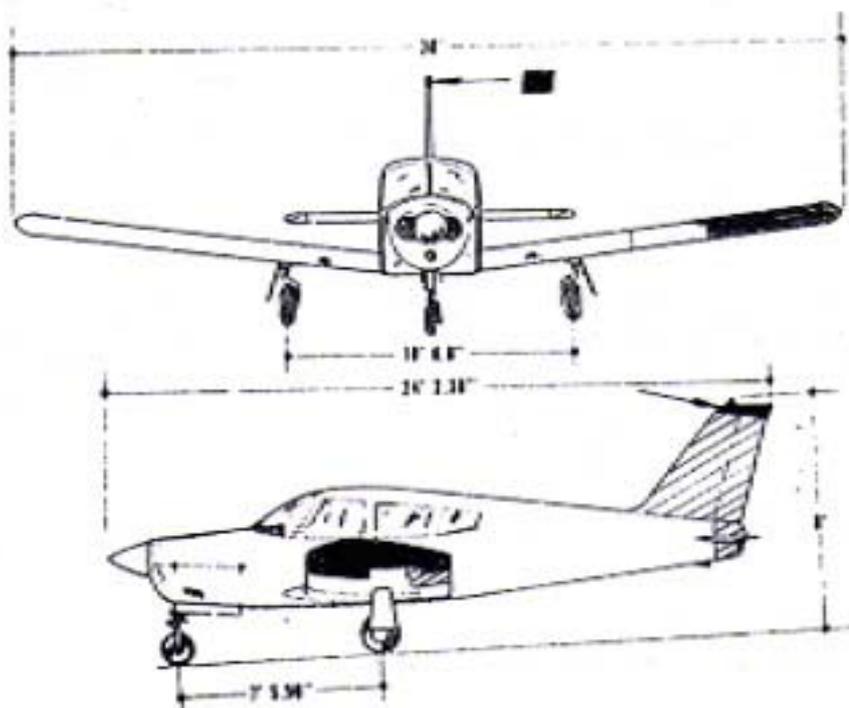
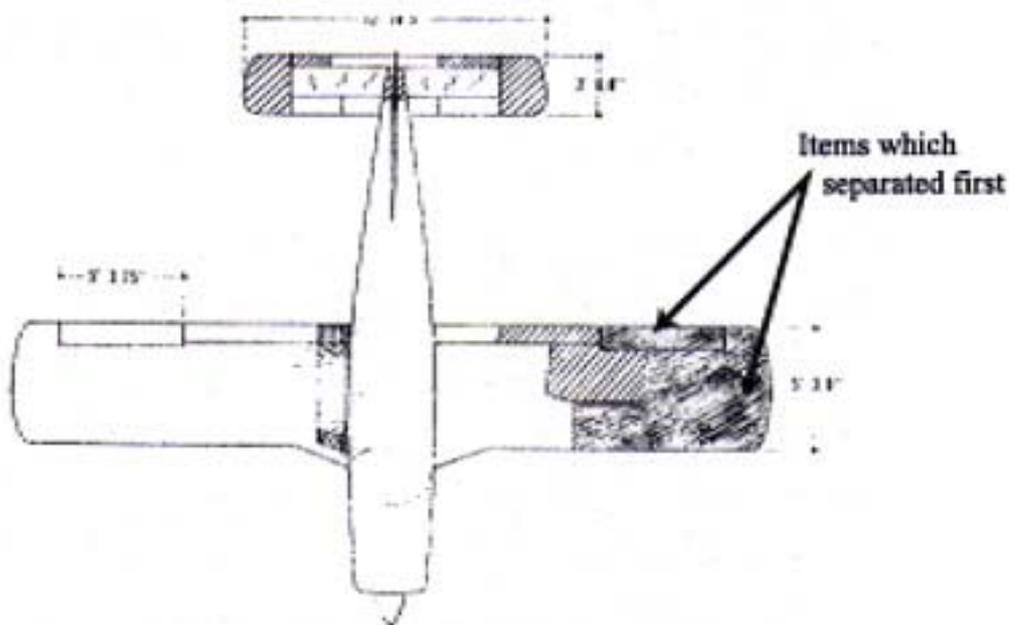
#### **Figure 3**

The wreckage of G-BKCB was recovered to the AAIB for detailed examination. This revealed that all items which had separated in flight, Figure 3, with the exception of the left outer wing, the adjacent wing skin panel, the port aileron, the beacon and the rudder mass-balance, did so in a manner consistent with excessive speed reached once the aircraft was descending out of control, following the wing failure.

Diagram illustrating sections of structure which separated first, and subsequently, in-flight

The separation of the outer wing appeared to have been the result of excessive load applied in a downward direction. Interpretation of the radar data indicated that this had occurred within five seconds of the aircraft being in approximately straight and level flight. Despite the considerable effort devoted to detailed examination of the wreckage, in particular the airframe and flying controls, no technical failure was found in the wreckage which could have accounted for overload of the wing in such an unusual manner. Also, no evidence was found in the failed area of the wing of corrosion, fatigue cracking, repairs, material defects, or any other feature, which could have degraded the strength of the structure.

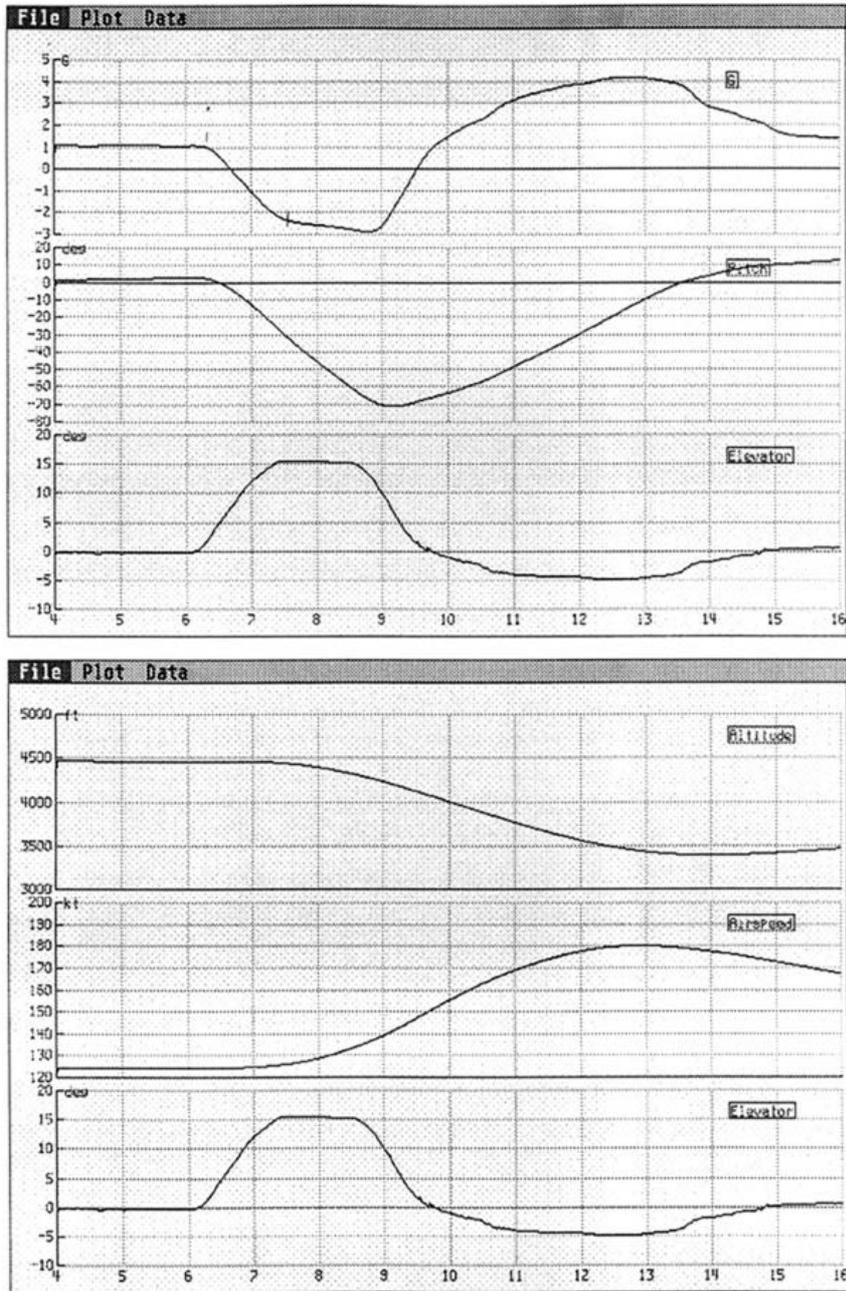
### **Figure 4**

It was noted that a large, progressively applied, sustained input produced higher loadings than did a more rapidly applied, less sustained control deflection. In most cases, maximum negative g loading occurred before significant loss of altitude or gain of airspeed took place. One deflection/time history, Figure 4, produced a maximum normal acceleration of approximately -2.7g; this exceeded the design strength specified in the airworthiness code applying to the aircraft category. This time history was chosen and used to generate loadings which were applied to the FE model of the failing wing bay structure. It was noted that little change in EAS or altitude occurred before peak load was reached.

Calculated aircraft response - 15° stabilator angle for 3 seconds

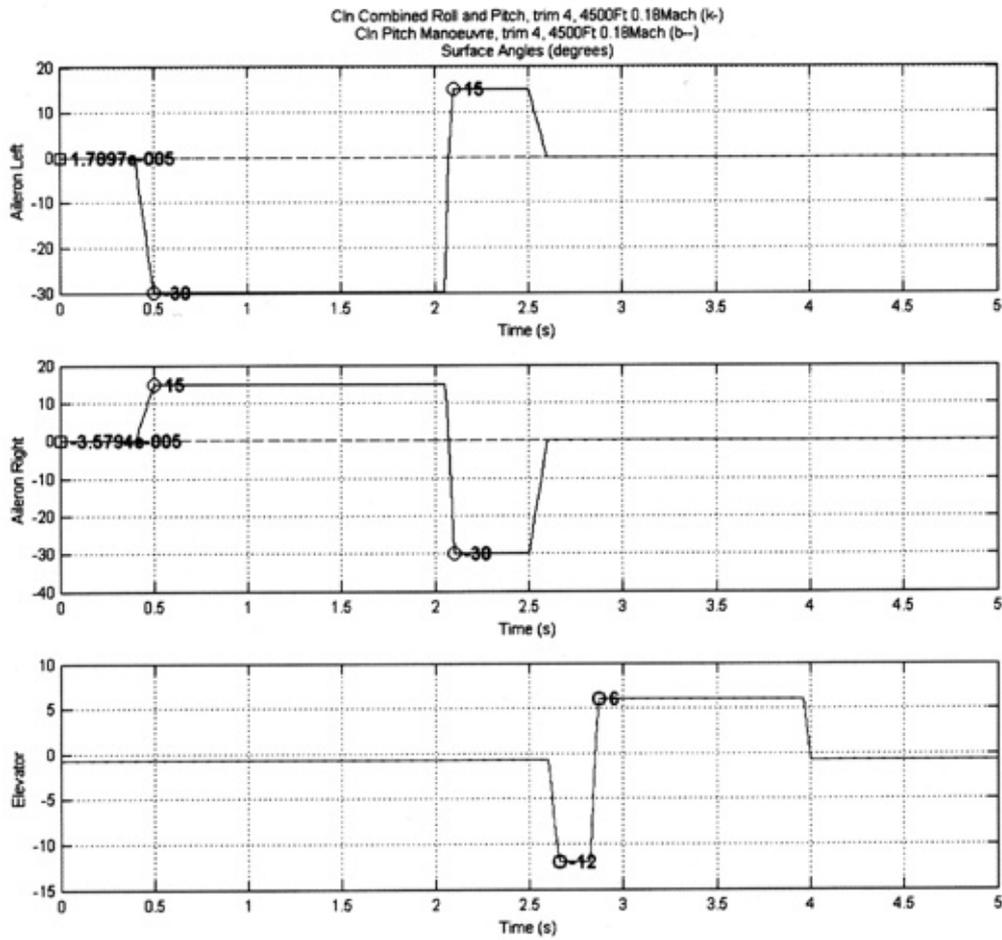
**Figure 6**

During this analysis, some errors were noted in some assumptions used to generate the high forces in both the manoeuvre sequences, ie, those producing high loads in both the upward and downward directions. With some corrections and refinements in the computer model, however, it proved possible to demonstrate that with certain initial trimmed conditions, very high loads in a downward bending direction could be developed using the sequence of control inputs shown in Figure 6.

Control input sequence which resulted in very high wing loads in a downwards direction

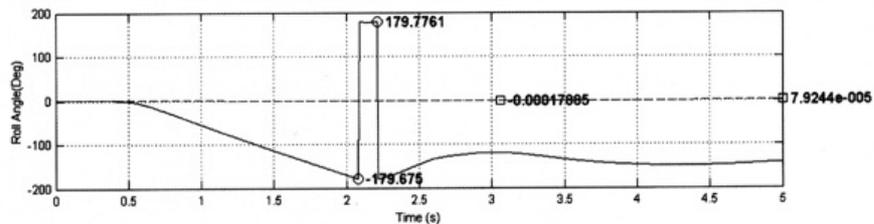
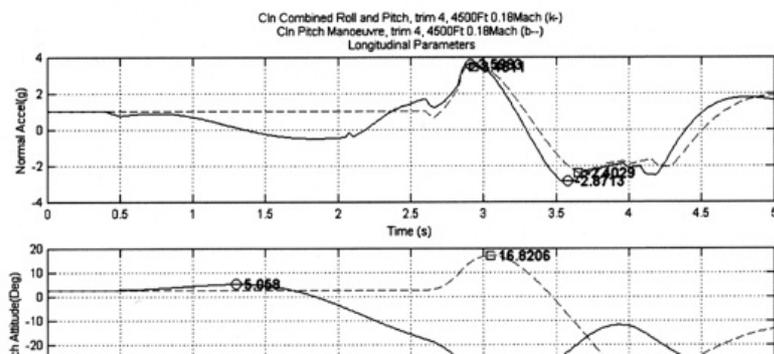
Figure 7

These involved use of full available control deflection in both pitch and roll, and the resulting aircraft manoeuvres are illustrated in Figure 7.

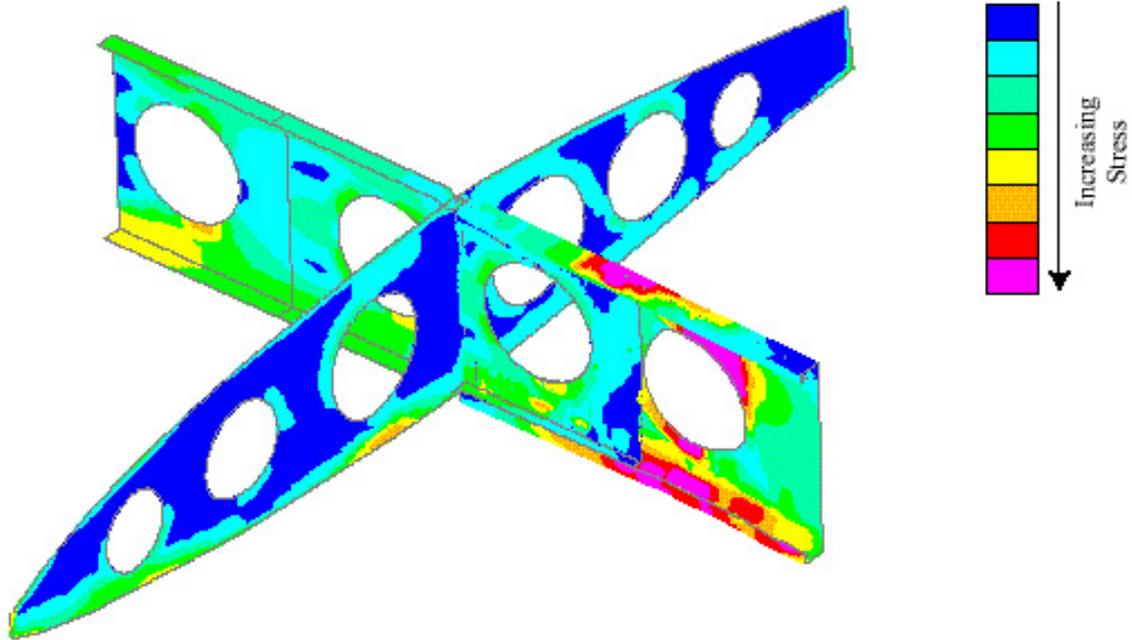
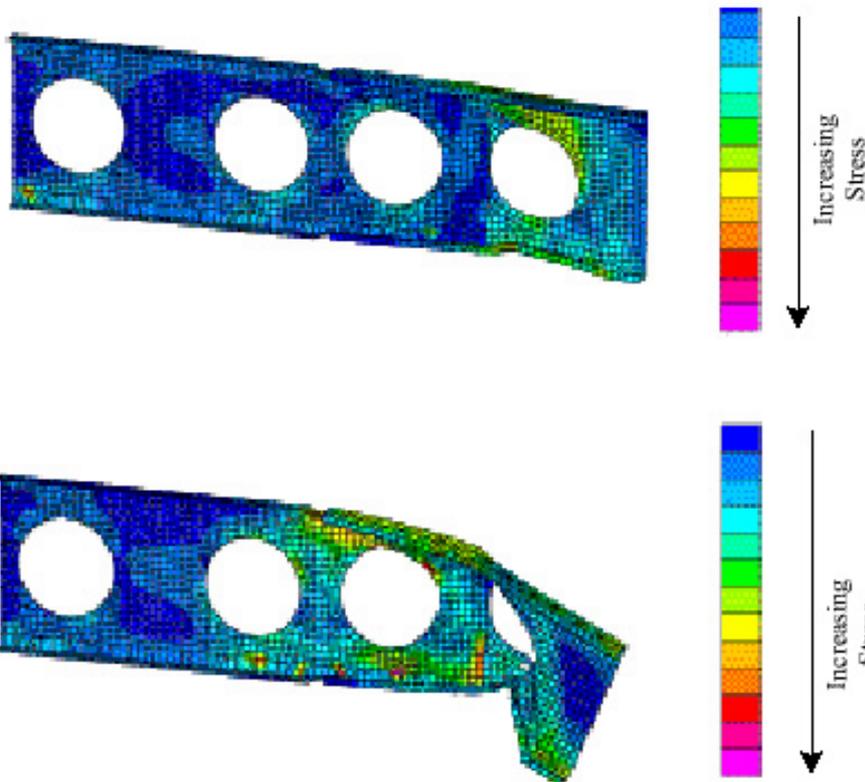
**Figure 9b**

Progressive buckling of spar

It is likely that a number of slightly different combinations of pitch and roll control inputs, having similar total duration but slightly differing spacings, could be developed, resulting in stresses being generated at the failure plane having comparable magnitude to those realised in the above case. It was noted that the shear force and bending moment figures, presented for the trimmed flight condition at which failure load was approached, were computed specifically for the span-wise station at which wing separation occurred. Re-examination of both the failed structure and the FE results show that initial failure began very close to the end of the extruded inner spar, rather than at the more outboard point of final separation. Shear force and bending moment curves against time were presented for the manoeuvre at a range of span-wise stations. Interpolation showed that the bending moment at the initial failure station was approximately 30% greater than at the point of final separation.

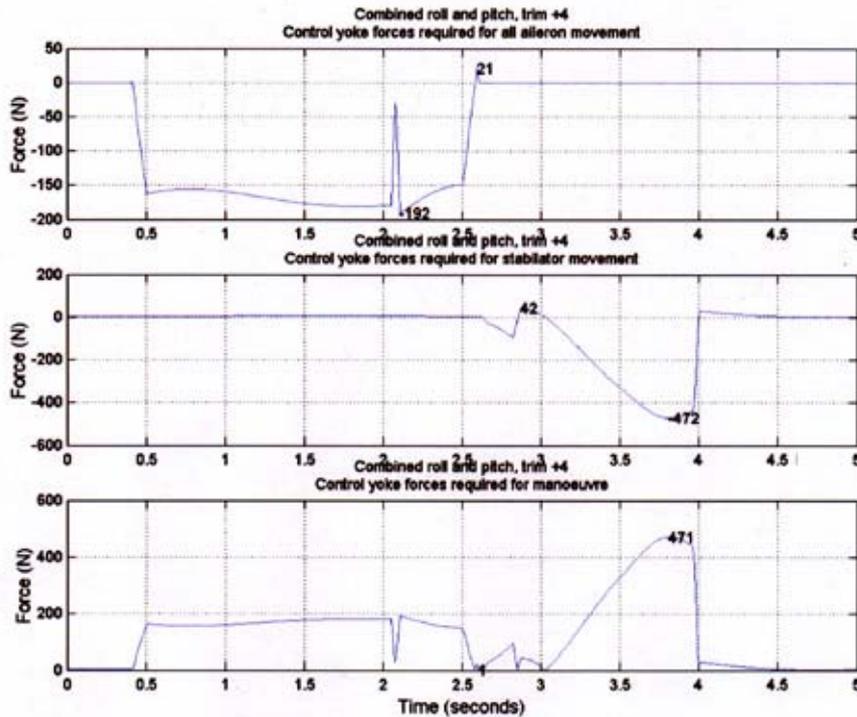
Figure 10

The control yoke pitch and roll force/time histories required to achieve the surface deflections assumed in the analysis are shown in Figure 10. These were calculated from the hinge moments produced as part of the NASTRAN/PATRAN analysis and the geometry of the control system, calculated by measurement of control surface angles and corresponding control yoke travel on an example of the aircraft type. They did not take account of frictional losses in the control system.

Control forces predicted to achieve wing failure
