AAIB Bulletin No: 3/93

Ref: EW/G92/12/02

Aircraft Type and Registration: Champion 7GCBC Citabria, G-BDBH
No & Type of Engines: 1 Lycoming O-320-A2D piston engine
Year of Manufacture: 1975
Date & Time (UTC): 6 December 1992 at 1100 hrs
Location: Popham Airfield, Hampshire
Type of Flight: Private
Persons on Board: Crew - 1 Passengers - 1
Injuries: Crew - None Passengers - None
Nature of Damage: Left main landing gear leg failed, distortion of fuselage frame, left wing damaged and engine shock loaded
Commander's Licence: Private Pilot's Licence with Night rating
Commander's Age: 33 years
Commander's Flying Experience: 638 hours (of which 176 were on type)
Last 90 days - 66 hours
Last 28 days - 19 hours
Information Source: Aircraft Accident Report Form submitted by the pilot and metallurgical examination of landing gear leg

G-BDBH Left Mainleg Failure

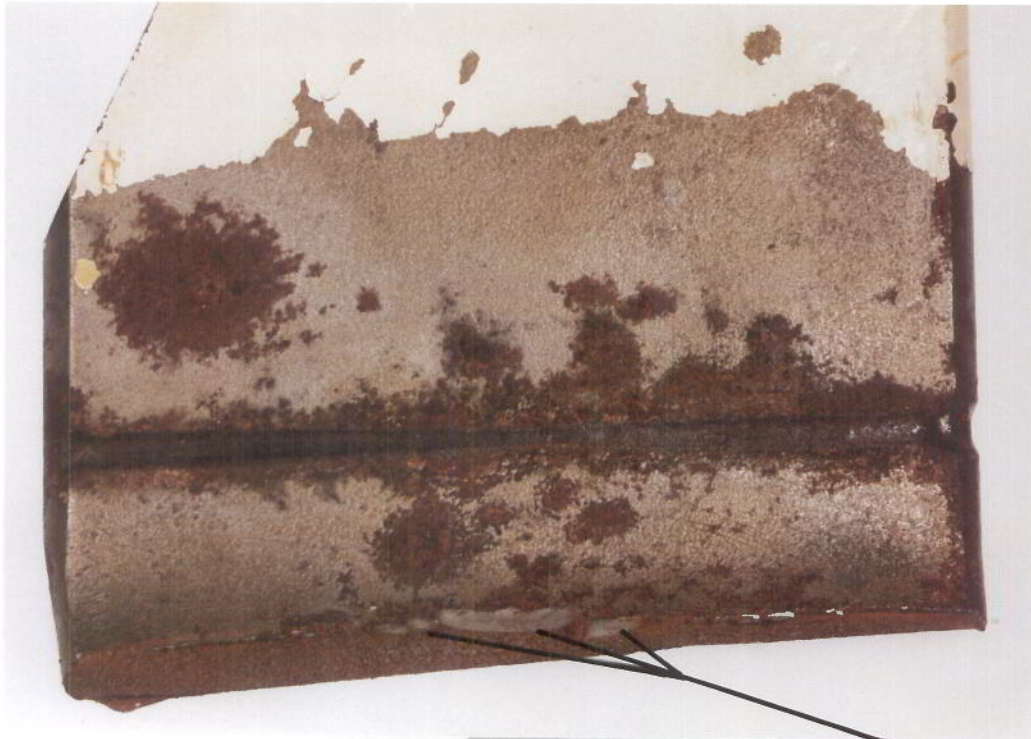
The mainlegs are a simple steel spring type. Each leg is a separate unit, its tapered inboard end forms a horizontal tongue which fits into a slot in the fuselage steel tube frame, where it is clamped, and a bolt secures the inboard end of the tongue within the fuselage. The left mainleg had broken at its upper bend just outboard of its location in the fuselage. The fracture showed areas of fatigue initiating from corrosion on the inside surface of the bend (see photographs). The surface had been painted but paint had been re-applied over cracked paint and corrosion. When the paint was removed more fatigue cracks were found in the corroded areas under the paint. The right leg was in a similar condition as regards paint condition and corrosion but no fatigue cracks were identified. The aircraft had accumulated 2,880 operating hours and, given that it had been used almost exclusively as a glider tug, this probably represented about 18,000 landings. However, the fatigue damaging portion of those landings was probably much smaller given that corrosion had to develop first to provide the initiation.

Upper leg
with paint
removed

Fatigue
