**No: 11/88**

**Ref: EW/C1061**

**Aircraft Type and Registration:** Boeing 747-136, G-AWNA

**Nature of Damage:** Portion of No. 11 Krueger (leading edge) flap detached and further damage to flap and to leading edge of wing

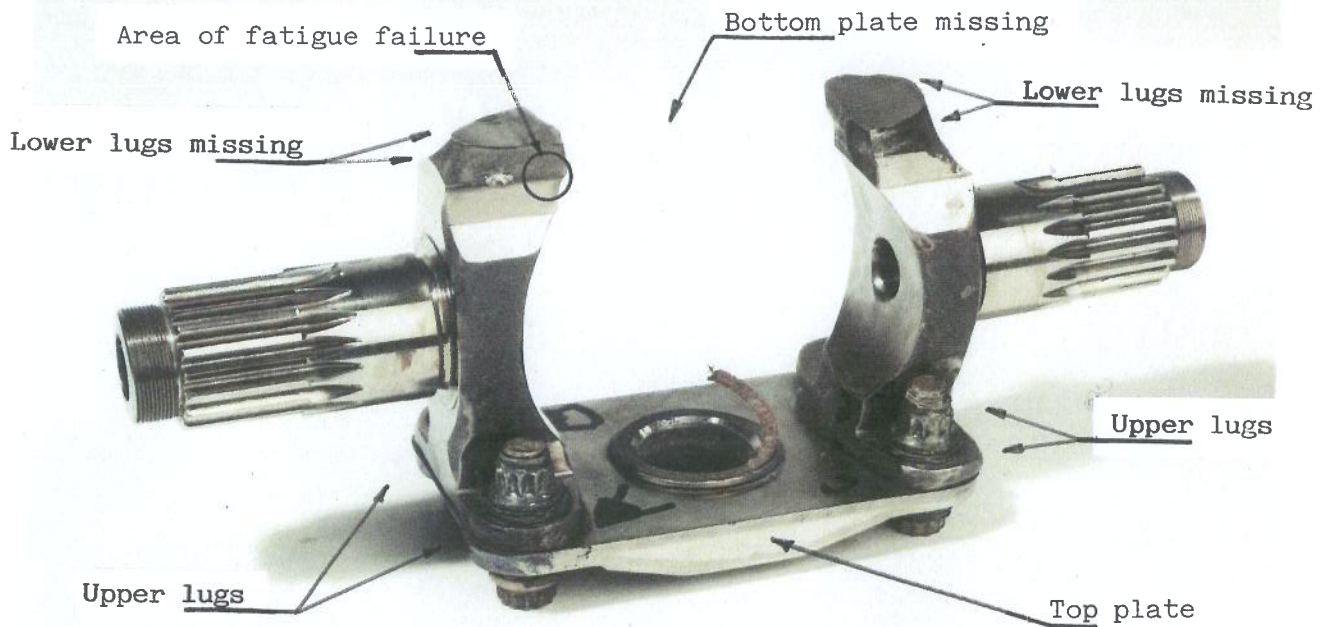
Gimbal fitting (G-AWNA)  
- Figure 1

Examination of the aircraft showed that the gimbal fitting (figures 1 and 2) attached to the No.11 Krueger flap assembly had failed. The gimbal fitting consists of two splined gimbal end fittings (both present in figures) and top and bottom plates (only top plate present in figures 1 and 2): the bottom plate was missing and it was not found on any of the subsequent runway and taxiway sweeps. The mechanism which extends each Krueger flap. With the bottom plate missing, the ballscrew nut was

As shown in figures 1 and 2, the failure had occurred around the radii of the lower lugs on the two gimbal end fittings and, additionally, there was one bolt missing (figure 2) between one of the end fittings and the top plate. The failure to find the missing bottom plate indicates that it had become detached prior to the accident flight, probably during flap extension on the previous sector.

Detailed metallurgical examination of the fracture surfaces was performed at the Royal Aerospace Establishment and revealed a small area of fatigue, shown in figure 1. Fatigue fracture in this Titanium material is characterized by an extremely small critical crack length. Although, in this particular instance, it is not apparent whether the fatigue failure or bolt failure occurred first, the manufacturer has attributed past failures of these fittings to looseness or fracture of the attachment bolts. Boeing Service Bulletin (SB) 747-27-2148, first issued in 1976, specified an increase of the torque on the 8 attachment bolts in each gimbal fitting and G-AWNA was modified in accordance with this SB.

The gimbal fitting was subsequently returned to the aircraft manufacturer in the USA. There it was confirmed that the fitting material was of the specified Titanium alloy and that the failure sequence was probably initiated by loosening or breakage of one or more of the bolts. On disassembly, all 3 of the remaining bolts were found to be correctly torqued; they were, however, also found to be extensively pitted and one bolt had a 0.016 inch crack emanating from a corrosion pit.

A Special Check of the gimbal fittings throughout the operator's fleet, performed after this accident, revealed that a number of bolts were at reduced torque and that some bolts were missing. The appropriate Service Bulletin (SB 747-27-2148) only calls for a one-time check, with no repetition; the operator, who maintains all the 747-100 series aircraft on the UK register, has, however, instituted the following:-

- (1) replacement of all H11 gimbal attachment bolts with Inconel versions,
- (2) changing of all gimbal assemblies which the Special Check identified as having operated with attachment bolt torque of less than 95 inch-lbs, and
- (3) amendment of the maintenance schedule to include a torque check at Inter check frequency.
