**INCIDENT**

<b>Aircraft Type and Registration:</b>	Boeing 737-33V, G-EZYN	
<b>No &amp; Type of Engines:</b>	2 CFM56-3C1 turbofan engines	
<b>Year of Manufacture:</b>	1999	
<b>Date &amp; Time (UTC):</b>	22 March 2005 at 1050 hrs	
<b>Location:</b>	Near Lyons, France	
<b>Type of Flight:</b>	Public Transport (Passenger)	
<b>Persons on Board:</b>	Crew - 5	Passengers - 110
<b>Injuries:</b>	Crew - None	Passengers - None
<b>Nature of Damage:</b>	None	
<b>Commander's Licence:</b>	Airline Transport Pilot's Licence	
<b>Commander's Age:</b>	46 years	
<b>Commander's Flying Experience:</b>	5,555 hours (of which 5,355 were on type) Last 90 days - 211 hours Last 28 days - 88 hours	
<b>Information Source:</b>	AAIB Field Investigation

**Synopsis**

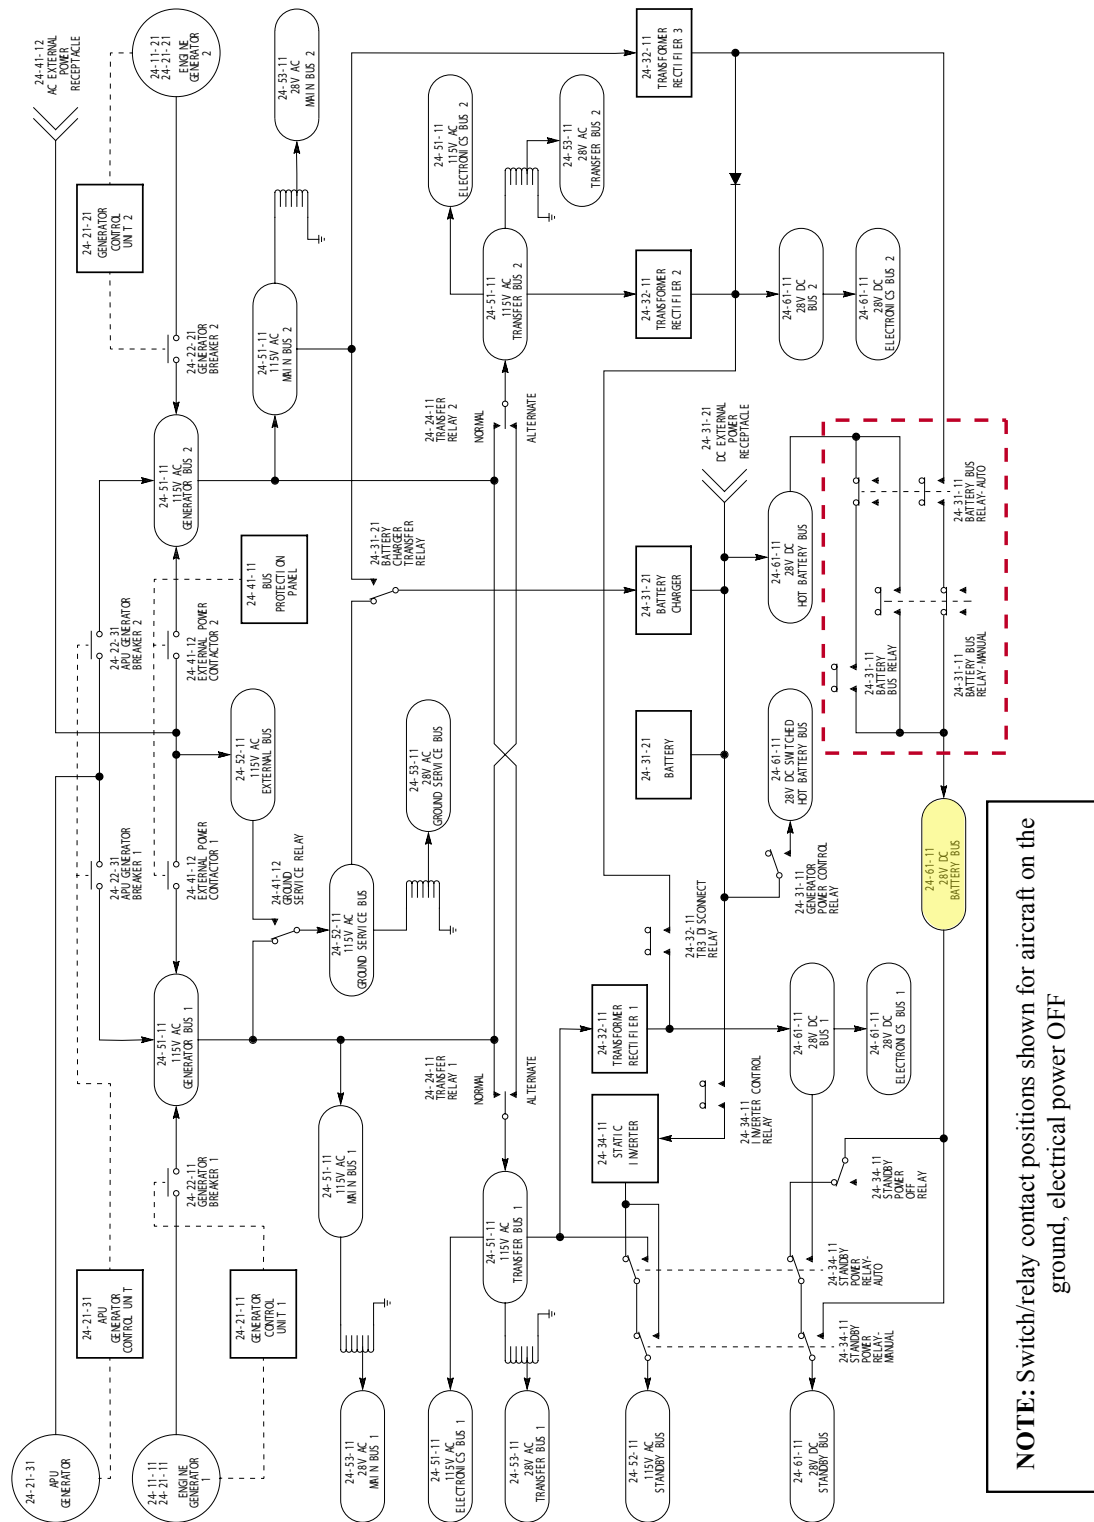
**Figure 1**  
Boeing 737-300/400/500 Electrical Schematic  
Page 24-00-01, Boeing Systems Schematic Manual

A schematic diagram of the aircraft electrical system is shown at Figure 1, where the battery relays are in the area enclosed by the dashed line. Additional detail of

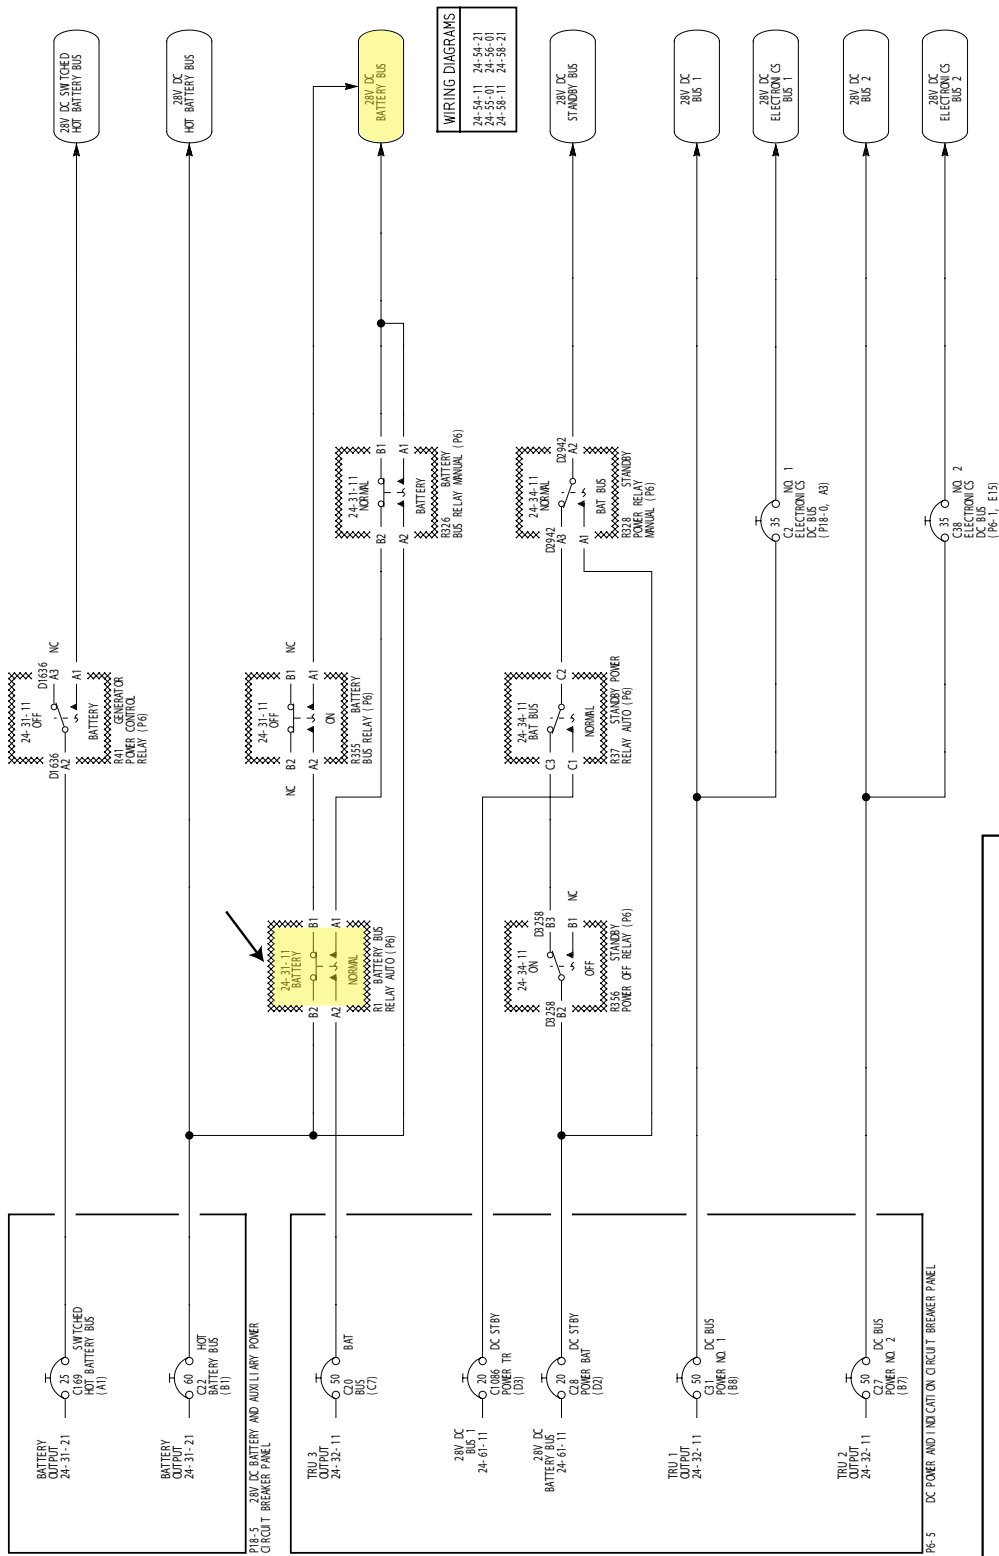
**Figure 2**

the 28 volt DC system is shown at Figure 2, where it can be seen that the Battery Bus is supplied from the Transformer-Rectifier Unit (TRU) No 3. In the event of a main AC failure, the DC and AC elements of the Standby power system are supplied by the Battery Bus and static inverter respectively.

In this incident, the battery and its charging system, remained unaffected and power to the Battery Bus could have been restored by moving the Standby Power switch on the overhead panel from the 'AUTO' to the 'BAT' position.
