## ACCIDENT

<b>Aircraft Type and Registration:</b>	Rans S6-ES Coyote II, G-BYMV	
<b>No &amp; Type of Engines:</b>	1 Rotax 582-48 piston engine	
<b>Year of Manufacture:</b>	2000 (Serial no: PFA 204-13444)	
<b>Date &amp; Time (UTC):</b>	14 July 2013 at 1744 hrs	
<b>Location:</b>	Near Stoke Golding Airfield, Leicestershire	
<b>Type of Flight:</b>	Private	
<b>Persons on Board:</b>	Crew - 1	Passengers - 1
<b>Injuries:</b>	Crew - 1 (Fatal)	Passengers - 1 (Fatal)
<b>Nature of Damage:</b>	Aircraft destroyed	
<b>Commander's Licence:</b>	National Private Pilot's Licence	
<b>Commander's Age:</b>	76 years	
<b>Commander's Flying Experience:</b>	365 hours (of which 305 were on type) Last 90 days - 7 hours Last 28 days - 4 hours	
<b>Information Source:</b>	AAIB Field Investigation

## Synopsis

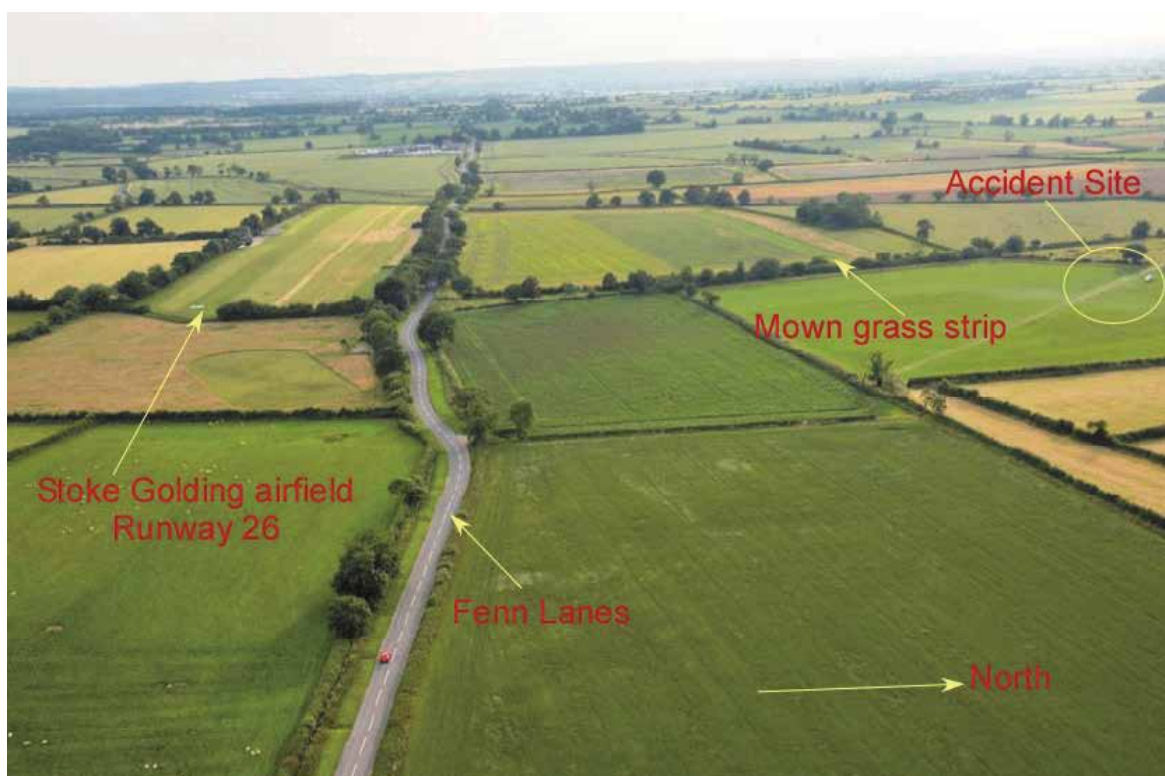
**Figure 1**  
Stoke Golding Airfield and surrounding area

Figure 1 shows Stoke Golding Airfield, Fenn Lanes, and the fields to the north. The grass Runway 08/26 at Stoke Golding is approximately 500 m in length and about 21 m wide. It also shows an area of mown grass in a field about 270 m to the north of the airfield.

The mown strip was approximately 260 m in length and 18 m wide, aligned on a westerly direction of approximately 240° and bordered by an area of crop and long grass.

pilot possibly mistook the distinctive mown grass strip in the field north of Fenn Lanes and flew his approach towards it. Factors influencing this may have been his eyesight, and, once on final approach, the setting sun and any glare it caused on the windscreen. It is also possible that some other unidentified factor that degraded his performance accounted not only for this but also the unusual terminology in his final radio transmission.

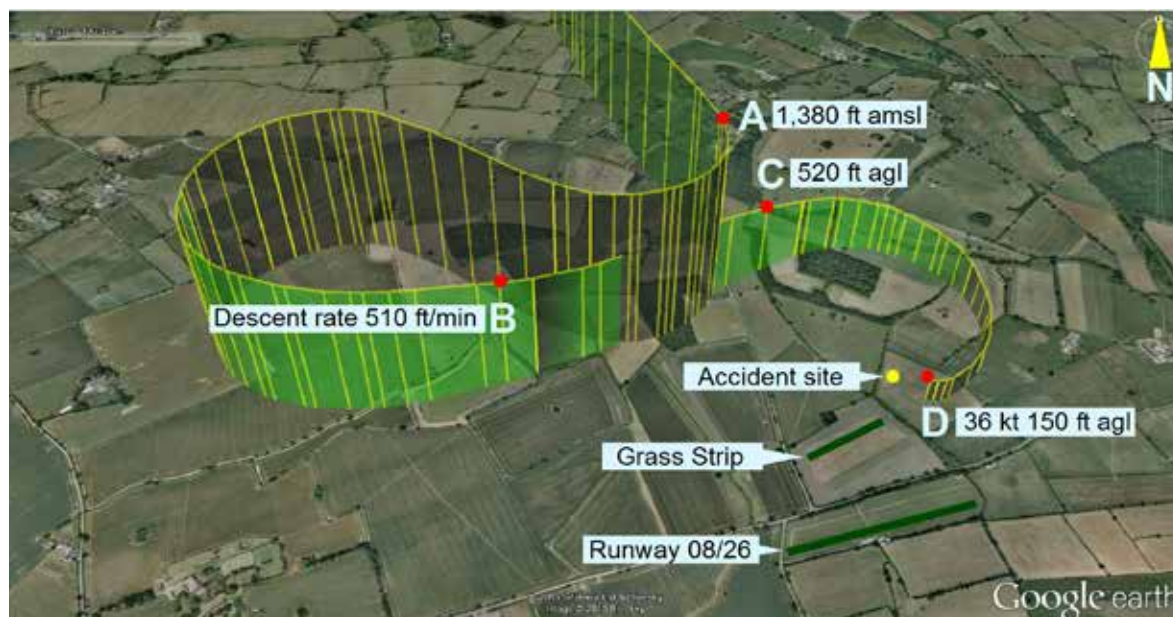
**Figure 2**

Approximately 0.7 nm to the north-west of Stoke Golding Airfield, and at an altitude of approximately 1,380 ft, the aircraft made a right turn (Point A). As the turn continued, the aircraft climbed to its maximum altitude of approximately 1,400 ft, before starting a gradual descent. Having positioned 0.9 nm from the airfield, the aircraft made a left turn as though positioning onto a downwind track for Runway 26 and the descent rate was stabilised at about 510 ft/min (Point B). However, instead of remaining parallel to the runway, the aircraft maintained a near parallel track relative to a strip of mown grass (Figure 1).

GPS track of approach to Stoke Golding Airfield<sup>2</sup>

When the aircraft was almost abeam the threshold of Runway 26 (which coincided with the easterly boundary of the adjacent mown strip), it started a gradual 180° right turn from an altitude of approximately 800 ft (520 ft agl) (Point C). The aircraft's groundspeed was then about 51 kt. The turn rate remained constant at about 4.5° per second and the descent rate remained at about 510 ft/min. However, rather than positioning onto the final approach for Runway 26, the aircraft turned onto an inbound track consistent with lining up to land on the mown grass strip in the field north of the road. The final seconds of the data indicate that when the aircraft was about 150 m from the field boundary and at a height of about 170 ft agl, the aircraft turned to the right (Point D). At the final data point, recorded approximately 110 m to the south-east of the wreckage position, the groundspeed was about 36 kt, and the aircraft was at a height of about 150 ft agl.

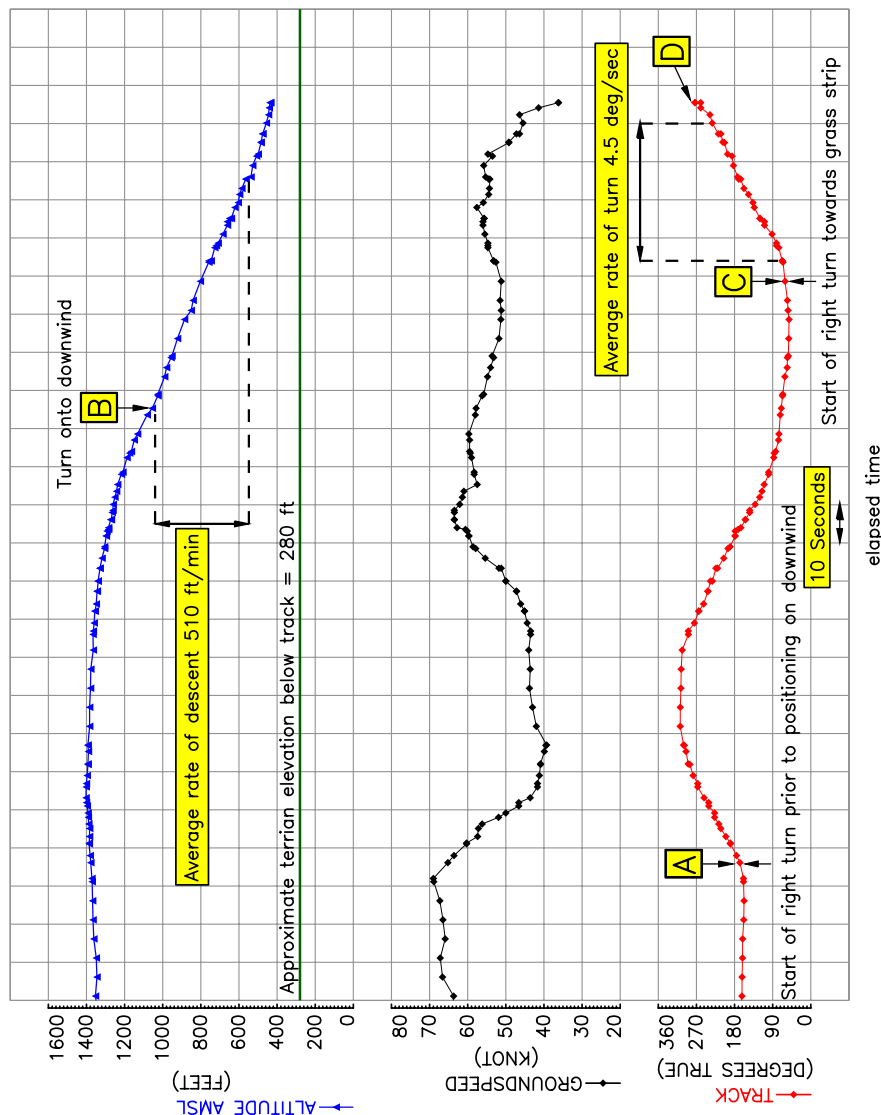
**Figure 3**

No further data points were recorded. Possible explanations for this were considered. The nominal logging rate of each data point is once every 5 seconds, although some points were recorded more frequently, resulting in the average logging rate of 2.5 seconds. It is possible that the next data point was to be logged 5 seconds later, and the aircraft struck the ground prior to this. Further possibilities are that the device buffered the data for several seconds prior to writing to memory, or satellite signals to the GPS device were lost, perhaps with the aircraft in an attitude that resulted in the signal becoming obscured.

Time history plot of approach
