No: 2/90

Ref: EW/G89/11/02

**Aircraft Type
and Registration:**

Piper PA-28-180, G-BHFL

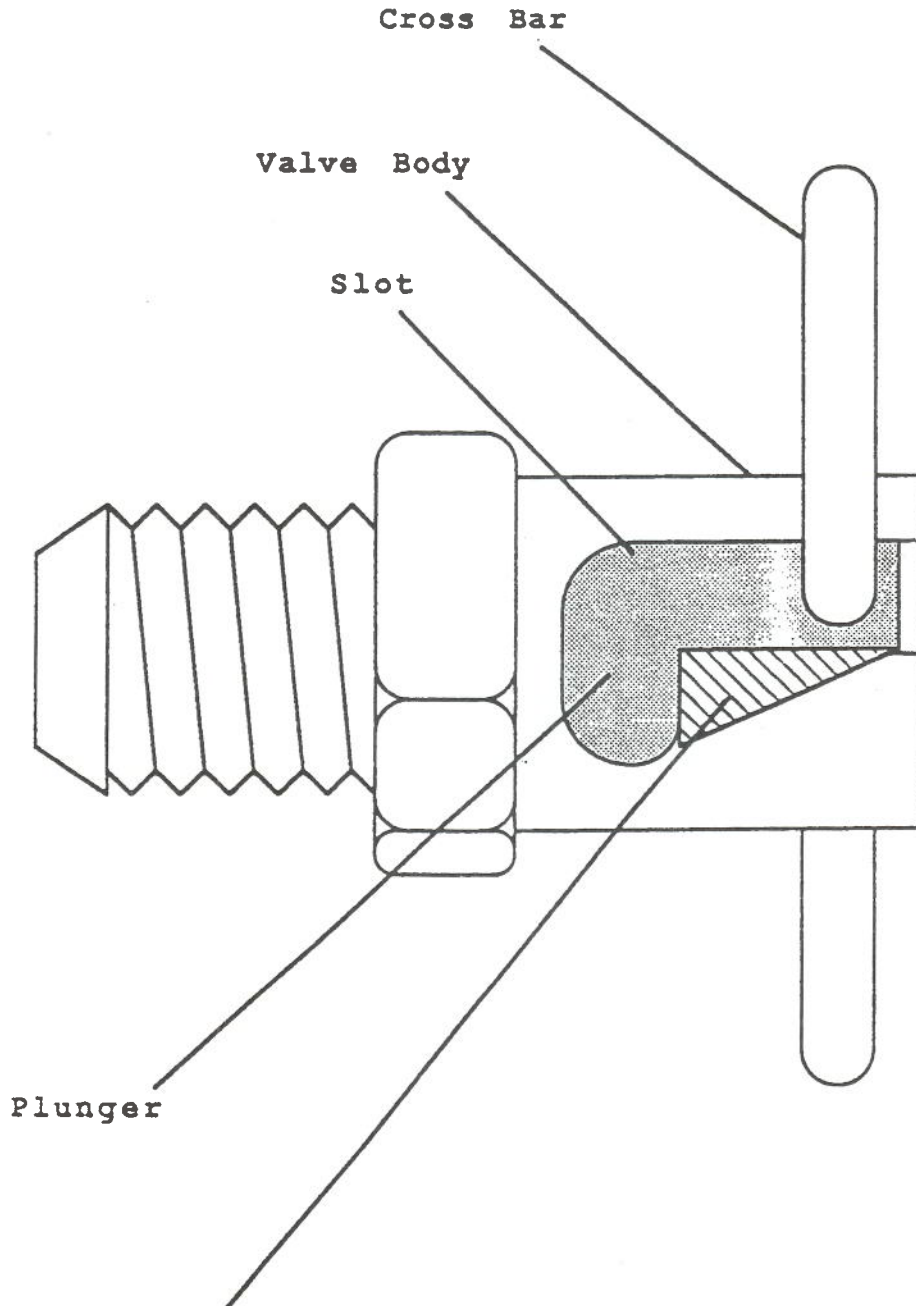
FIG 1

SCHEMATIC OF CURTISS DRAIN VALVE

Shaded area of slot for filing off in accordance with CSE Service Bulletin 6/75 (schematic only)
