AAIB Bulletin No: 5/94

Aircraft Type and Registration: Luton LA4A Minor, G-ASXJ

Date & Time (UTC): 28 February 1994 at 1740 hrs

Location: Stapleford Tawney Airfield, Essex

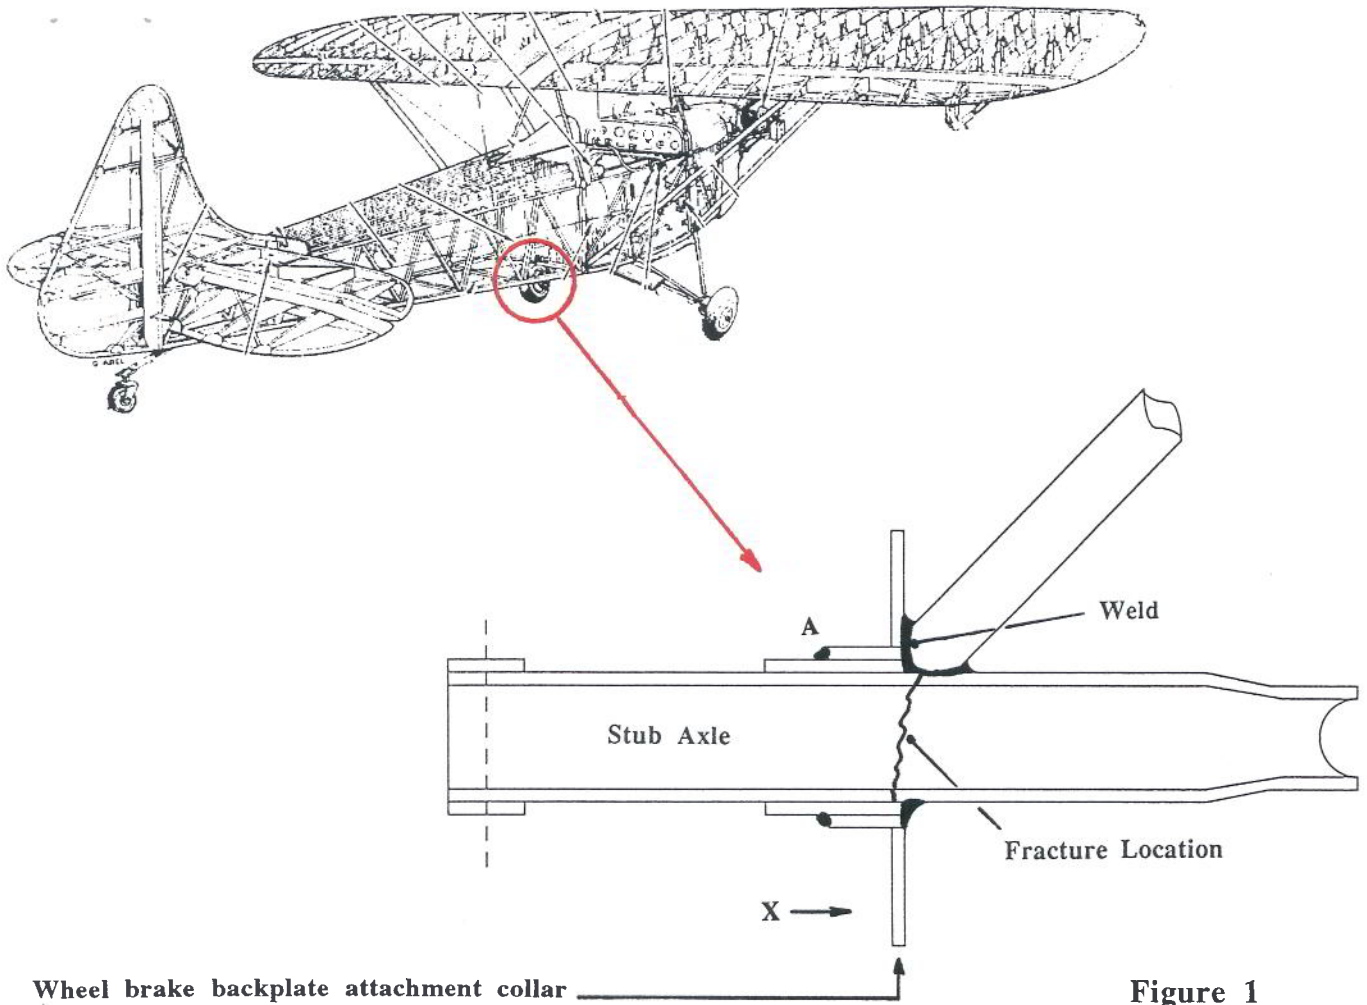
Figure 1

A diagram of this area and photographs of the failure are shown in Figures 1 to 4. As may be seen, the axle is a cantilevered tube with its outboard end open to the environment. The failed axle was subjected to a detailed metallurgical examination, the findings of which included the following:-

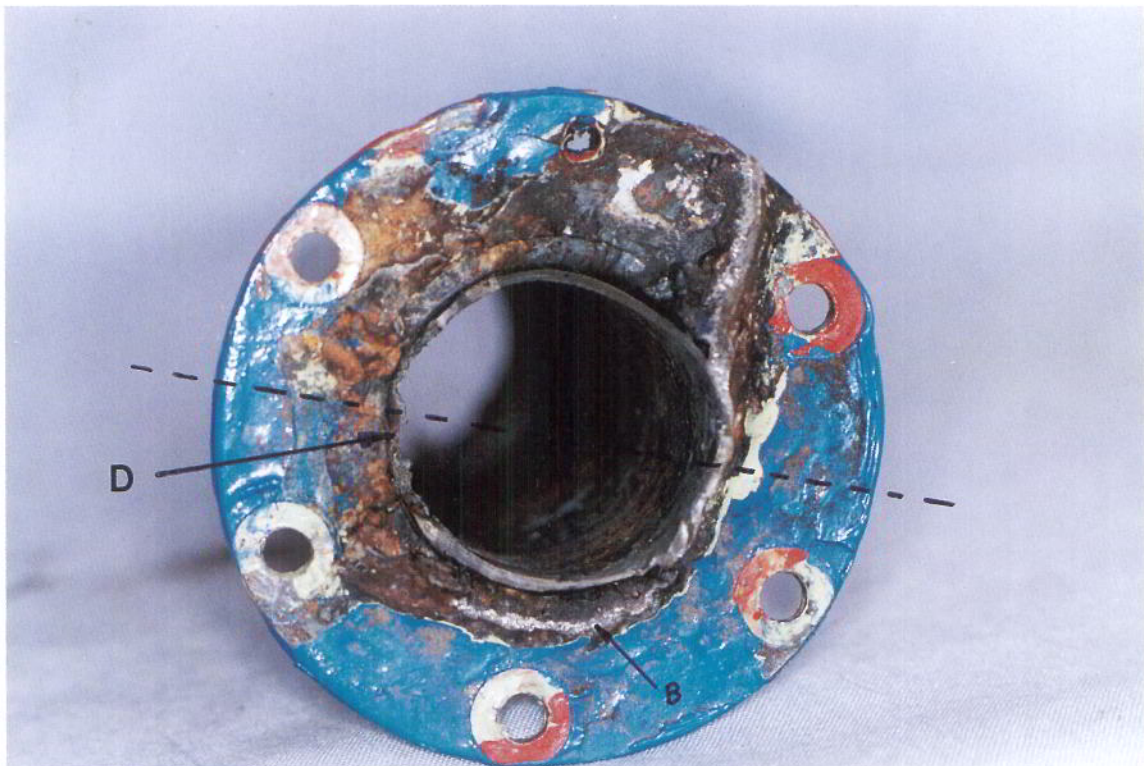
Figure 2

- a) The stub axle assembly had fractured across the diameter of the axle tube just inboard of the inner face of the brake drum attachment plate.
- b) The fusion length of the weld on the backing plate and axle tube was almost non-existent and limited to the silver coloured band arrowed 'B' in Figures 2 and 3.

Region where weld detachment on backplate was negligible
 Leg length fusion limited to 'B' - silver coloured band

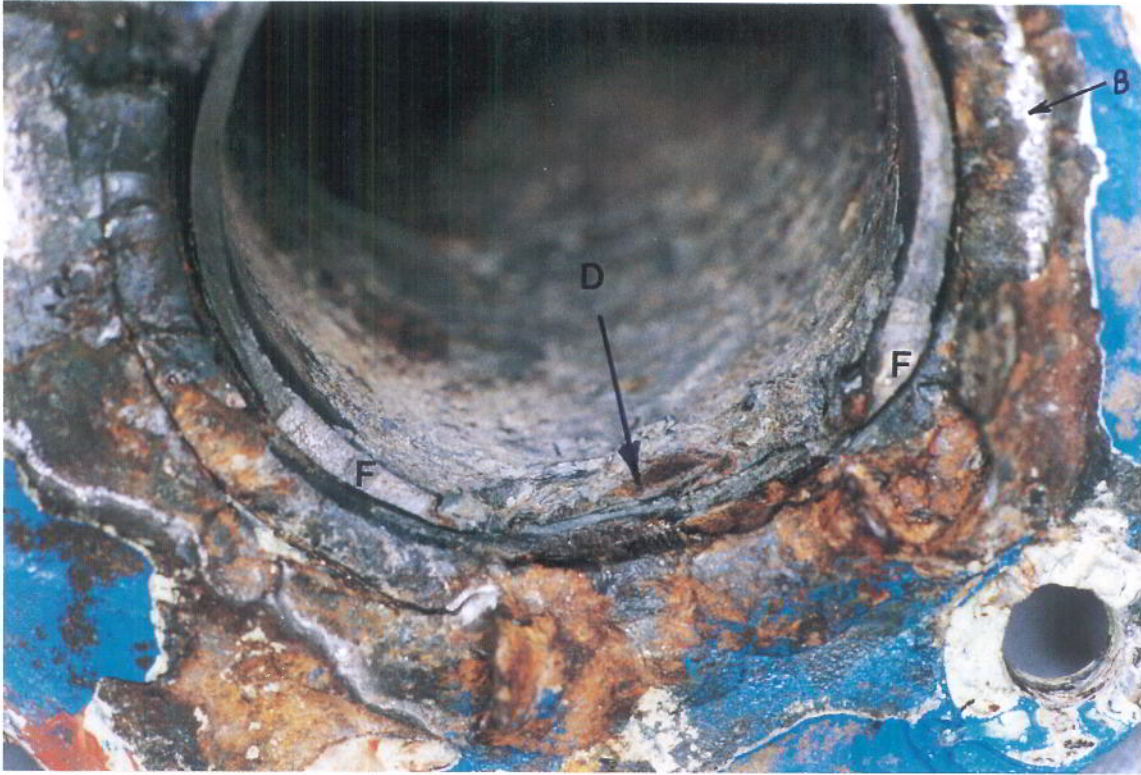
Figure 3

- c) Part of a hole was present in the axle tube, which had been painted internally, and is as arrowed 'D' in Figure 3. This hole had broken into the plane of fracture. The nature of this hole indicated that it could have occurred as a result of a weld 'melt-through', possibly due to the use of excessive electric current in a shielded arc welding process.
- d) There were two small regions, at positions 'F' in Figure 3, where fracture progression could have progressed from a very low cycle, high stress, tension fatigue mechanism.
- e) Hardness test results obtained on the component parts of the subject axle assembly indicated that the sleeves had not been manufactured from material to BS T45 (minimum spec. strength requirement of 45 ton/sq. inch) as required by the drawing, but from a material with a minimum strength of approximately 28 ton/sq.inch.

View on X on inboard face of backplate showing failure

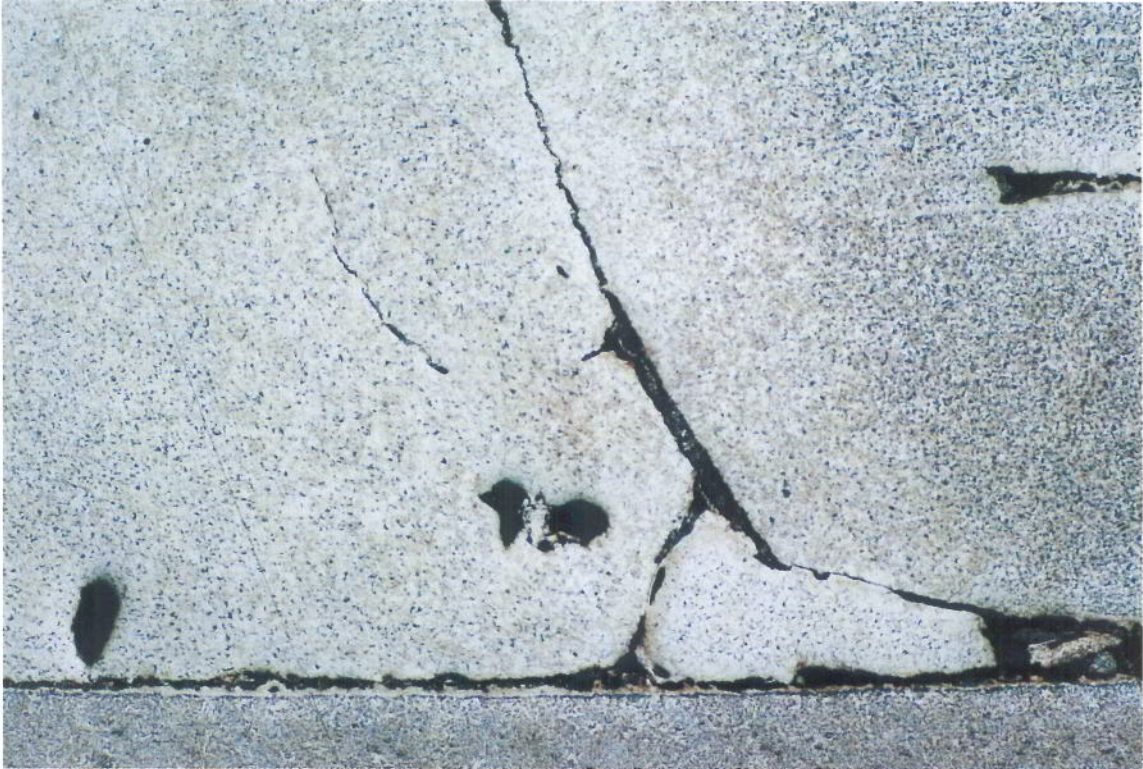
Figure 4

Region where melt-through occurred - 'D'
Fatigue areas - 'F'

Oxide film in weld root
