**AAIB Bulletin No: 6/98**

**Ref: EW/C97/10/6**

**Aircraft Type and Registration:** Pierre Robin HR200/120B, G-BWPG

**Location:** In the Cromarty Firth off Nigg Yard, Scotland

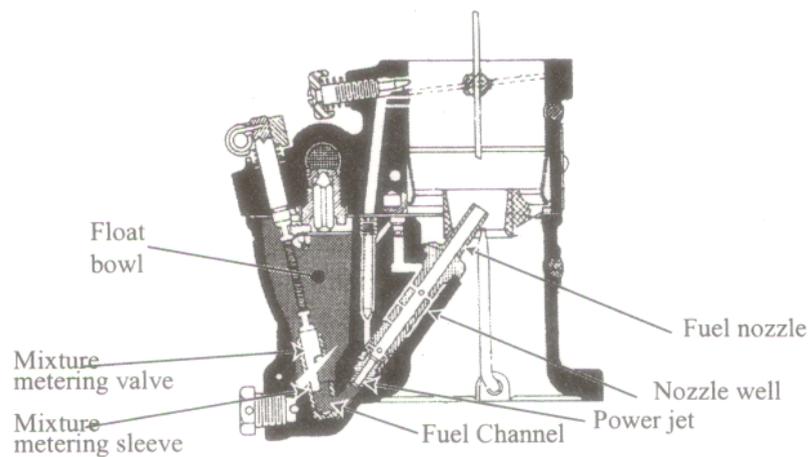
Figure 3 Section through carburettor

The carburettor was removed from the engine for more detailed examination. It was observed to be undamaged although there was some salt encrustation in the venturi and around the main jet nozzle. The carburettor upper housing was removed and the float bowl found to be filled with water and salt sediment. The float valve was checked and found to flow freely. The content of the float bowl was poured into a container and appeared to be clear of particles other than salt crystals. The fuel nozzle was removed and its bore and the power jet were observed to be clear of obstructions. The fuel channel between the mixture metering valve and the power jet was then flushed by pouring clean fuel into the mixture metering sleeve and into the power jet nozzle well (see Figure 3). A sizeable particle was seen in the carburettor fuel bowl sump after this process. This particle was taken and measured using a travelling microscope which showed that it was of irregular shape, large enough not to pass through the power jet and able to partially occlude it.

When viewed under the microscope, the particle appeared to be an insect and it was subsequently identified as the thorax of a type of fly found in Northern Europe and North America. An assessment indicated that the opportunities for such a foreign object to enter the carburettor appeared to be limited to those times when the carburettor float bowl had been opened, via the fuel inlet and float valve whilst the finger filter was removed, or via the float bowl breather bores whilst the carburettor was immersed in water after the ditching. It was further observed that the path to the fuel channel, via the mixture metering valve, was difficult under all circumstances for such an object.

The reported characteristics of the power reduction experienced were consistent with a sudden partial blockage of the carburettor power jet. If the blockage had affected the fuel inlet to the carburettor, and thereby reduced the fuel level in the float bowl, it is considered unlikely that pumping the throttle could have consistently sustained about 1500 RPM over the protracted period reported.

Although the foreign object found appeared to have suitable characteristics to cause a blockage of the main jet, the likelihood that it was responsible for the loss of power must be considered inconclusive by virtue of its deterioration during fuel immersion test.
