**AAIB Bulletin No:** 12/95      **Ref:** EW/G95/09/10      **Category:** 1.3

**Aircraft Type and Registration:** Piper PA-28R-200 Cherokee Arrow II, G-BMJG

**Date & Time (UTC):** 9 September 1995 at 1615 hrs

**Location:** Elstree Aerodrome, Hertfordshire

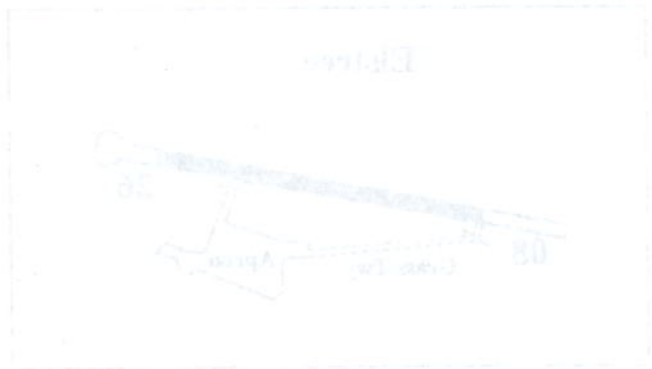
As the pilot of 'JG made his approach, there was a Piper Navajo on the dumbbell extension of Runway 26 waiting to depart with its engines running. The pilot of 'JG decided to land over the top of the Navajo which, by its orientation within the dumbbell, was obviously not about to takeoff. On short finals he lowered full flap and cut the power. Unfortunately he misjudged his aircraft's glide characteristics in the 15 kt headwind and he landed short of the threshold. His aircraft passed over the top of the Navajo's left propeller which cut the underside of the rear of 'JG's fuselage. The hard landing on the upslope before the displaced threshold damaged the PA-28's landing gear and engine mounting assembly. The Navajo suffered only abrasion damage to its left propeller.

The diagram illustrates the damage to the underside of the rear fuselage. The aircraft was flying over the top of the Piper Navajo's left propeller, which cut through the fuselage. The diagram shows the rear fuselage, the engine mounting, and the landing gear. The damage is indicated by a shaded area on the underside of the rear fuselage.
