ACCIDENT

Aircraft Type and Registration:	Turbolet Let L 410 UVP-E, OK-RDA	
No & Type of Engines:	2 Walter 601-E turboprop engines	
Year of Manufacture:	1986	
Date & Time (UTC):	28 April 2008 at 1003 hrs	
Location:	En route from Belfast City to Ronaldsway, Isle of Man	
Type of Flight:	Commercial Air Transport (Passenger)	
Persons on Board:	Crew - 2	Passengers - 16
Injuries:	Crew - None	Passengers - None
Nature of Damage:	Damage to right nose baggage door	
Commander's Licence:	Airline Transport Pilot's Licence	
Commander's Age:	44 years	
Commander's Flying Experience:	7,452 hours (of which 4,440 were on type) Last 90 days - 130 hours Last 28 days - 53 hours	
Information Source:	Aircraft Accident Report Form submitted by the pilot

Synopsis

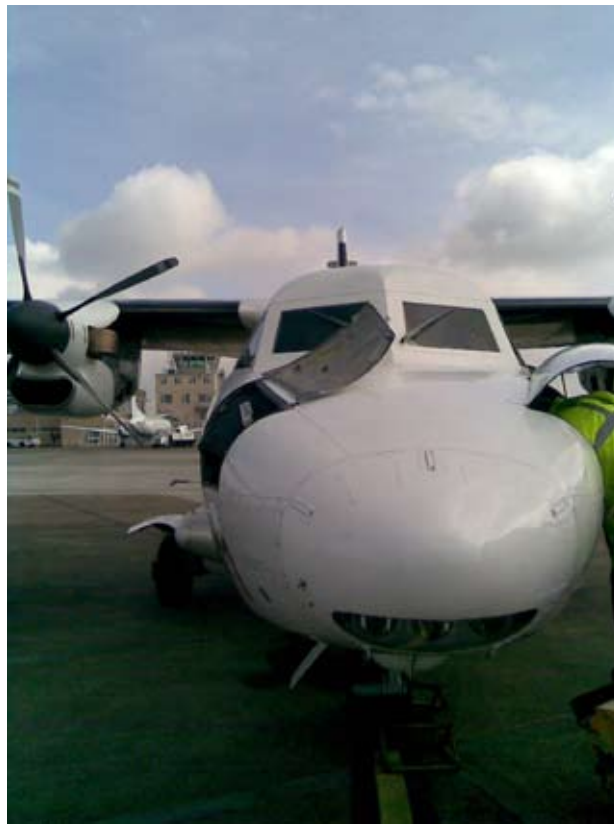
The airport Duty Manager at Ronaldsway was notified at 0950 hrs that the aircraft was landing with an open baggage door. From his position in the control tower, he could see that the door was open and a holdall was hanging out of the aircraft. One piece of baggage was subsequently found to be missing, which the commander believed might have been mislaid by the ground handling agency at Belfast City Airport. Figure 1 shows the position of the right nose baggage door after arrival at Ronaldsway.

Nose baggage door after arrival at Ronaldsway

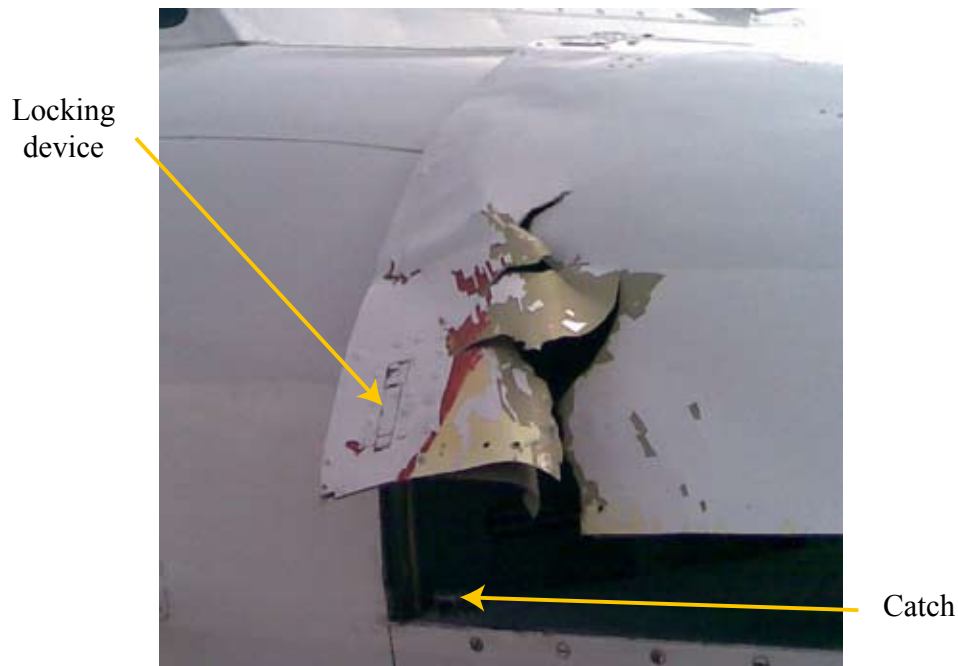
Figure 2
Door locking mechanism

The operator's maintenance engineer inspected the baggage door and reported that there were no defects with either the door or its locking device that would have prevented the door from locking. From photographs taken by the Airport Manager at Ronaldsway, it can be seen that whilst the locking device appeared to be locked from the outside, the hook on the mechanism had not engaged with the catch (Figure 2).

did not open during the outbound journey suggests that it was probably opened at Belfast City Airport. Whilst the door locking mechanism appeared from the outside to have been locked, it is apparent, from the lack of damage, that the hook did not engage in the catch when

the locking mechanism was closed. A modification is available to fit a physical indicator to the front door locking mechanism, but the modification had not been incorporated on this aircraft.
