No: 1/88

Aircraft type and registration: Beech Aircraft Corporation B 200 Super King Air G-MDJI

Date and time (UTC): 19 October 1987 at 0616 hrs

Location: Chevin ridge, Otley, South Yorkshire

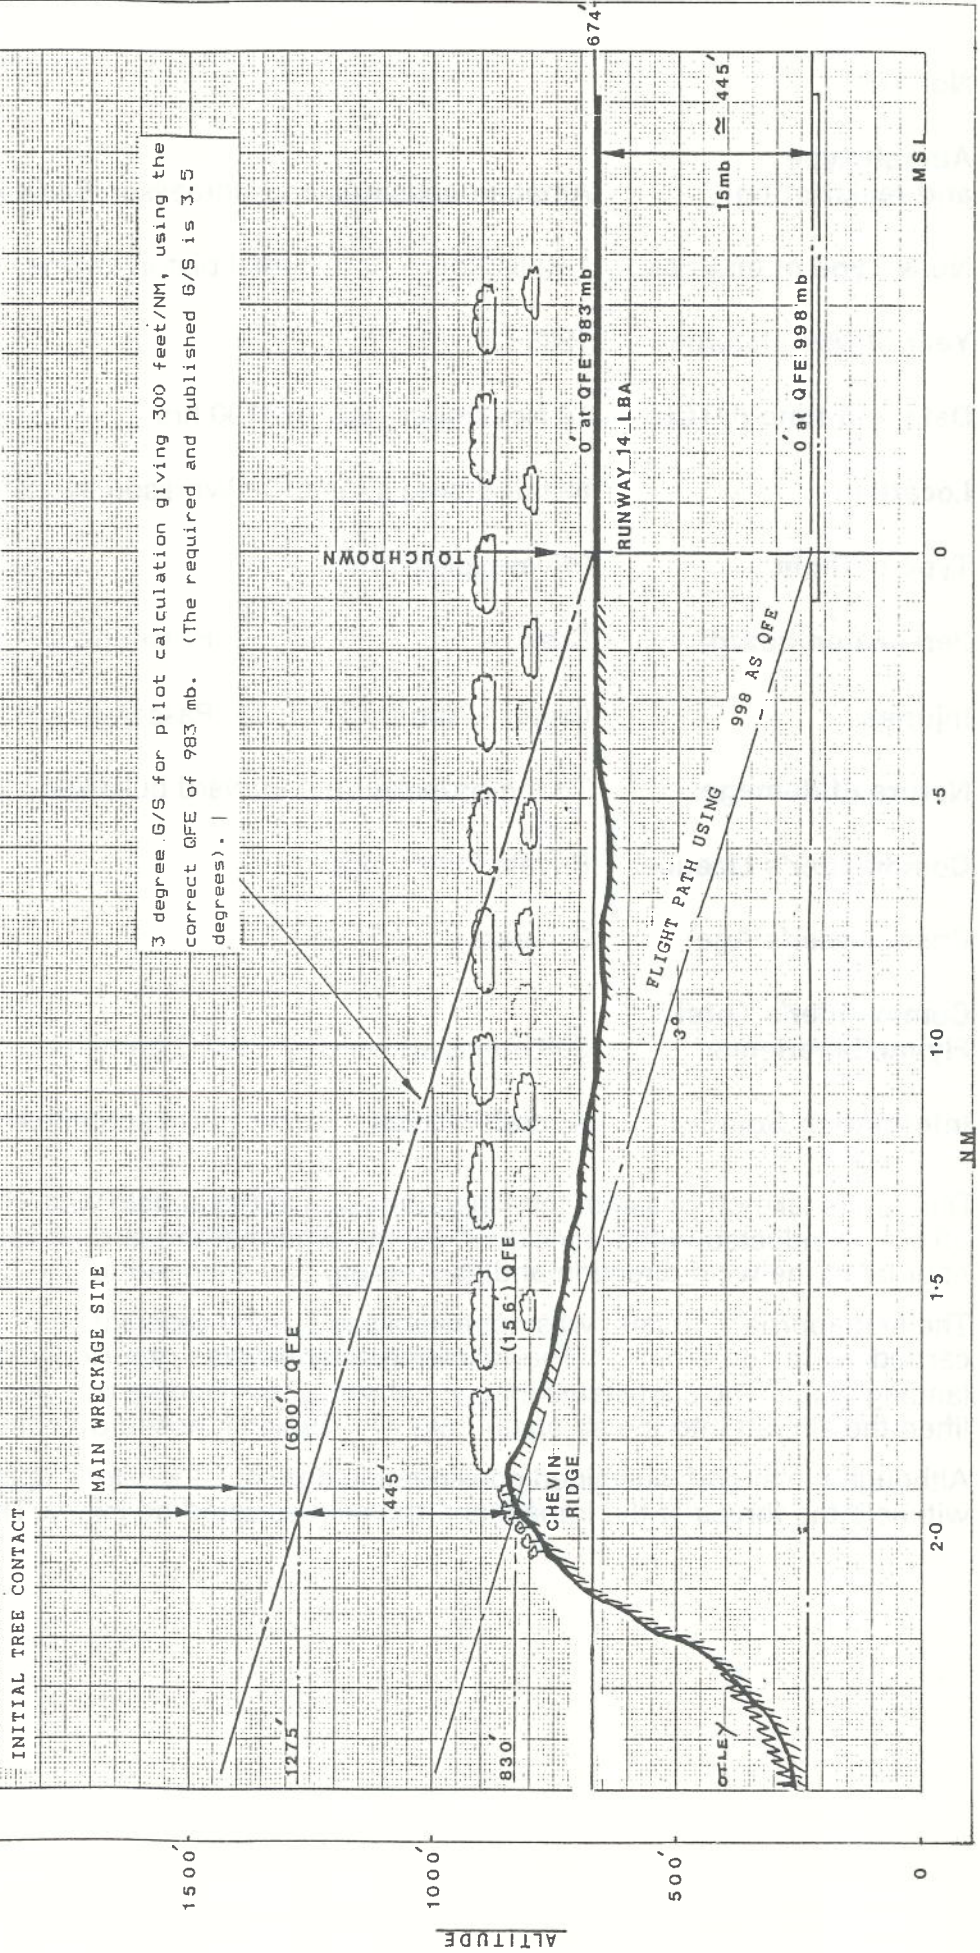
G-MDJI 19 OCT. 1987

The laid down descent angle for a Localiser/DME approach to runway 14 at Leeds/Bradford Airport is 3.5°. Whereas a standard 3 degree descent angle can readily be calculated and flown by a pilot using a formula of 300 feet per nautical mile, it is more difficult, particularly in single pilot operations, to calculate and achieve a 3.5° descent. An aircraft on a 3.5° approach angle, on a pressure setting of 998 mb, would pass approximately 100 feet above the accident site but, a 3° approach would result in ground contact in the area of the site. This is illustrated in the attached diagram.

GENERAL WIND 140/05, 4K MST, 3/100, 7/200, 1008, 983, +12, RWY WET

LAST ACKNOWLEDGED CALL BY PILOT WAS "DESCENDING ON 998 mb"

ALTIMETER FOUND INDICATING 600 ft

3 degree G/S for pilot calculation giving 300 feet/NM, using the correct QFE of 983 mb. (The required and published G/S is 3.5 degrees).
