Aircraft Type and Registration:	Piper PA-28-161 Cherokee Warrior II, G-BJYG	
No & Type of Engines:	1 Lycoming O-320-D3G piston engine	
Year of Manufacture:	1981	
Date & Time (UTC):	4 July 2004 at 1139 hrs	
Location:	Offshore, in Liverpool Bay, 2 nm north of Wallasey, Merseyside	
Type of Flight:	Private	
Persons on Board:	Crew - 1	Passengers - 1
Injuries:	Crew - 1 (Fatal)	Passengers - 1 (Fatal)
Nature of Damage:	Aircraft destroyed	
Commander's Licence:	Private Pilot's Licence	
Commander's Age:	56 years	
Commander's Flying Experience:	440 hours (of which 65 hours were on type) Last 90 days - 1 hour Last 28 days - 1 hour	
Information Source:	AAIB Field Investigation

Synopsis

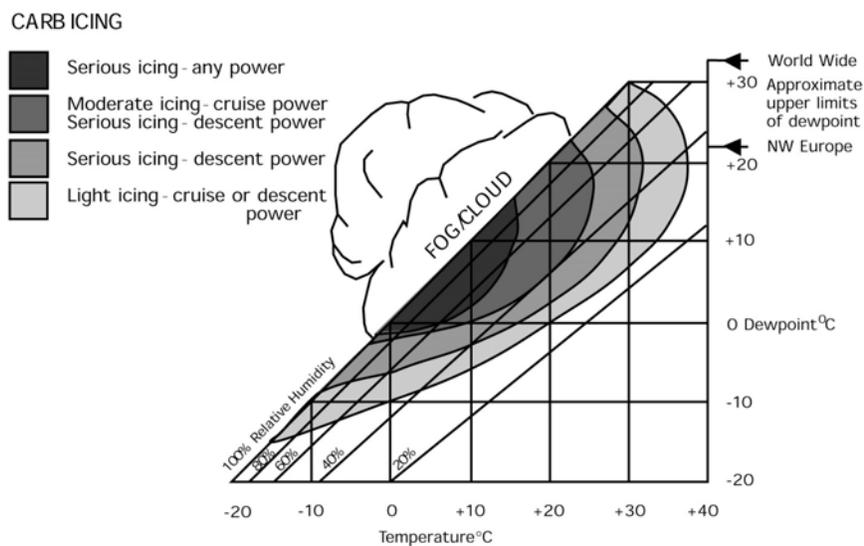
Figure 1

and an annual inspection. No fault was found with the engine and the engine failure could not be fully explained. However, the weather at the time of the forced landing placed the aircraft in conditions that lie within the 'Moderate icing at cruise power and Serious icing at descent power' category of the carburettor icing chart reproduced later in this report.

A graph to illustrate the probability of carburettor icing is reproduced below at Figure 1.

In the absence of dewpoint information assume high humidity when:

- the ground is wet (even dew)
- in precipitation or fog
- just below cloud base

The post accident examination of the engine did not reveal evidence of any mechanical problem that could have led to a failure. The aircraft had suffered a previous engine failure which was also unexplained. There is thus no clear reason for either engine failure but on both occasions meteorological conditions were such that there was a risk of moderate to severe carburettor icing. Such conditions are very common in the UK and although pilots are generally well aware of the risk carburettor icing cannot be discounted in this instance.
