**ACCIDENT**

<b>Aircraft Type and Registration:</b>	Schleicher ASW 20L glider, BGA 4354	
<b>No &amp; Type of Engines:</b>	None	
<b>Year of Manufacture:</b>	1979	
<b>Date &amp; Time (UTC):</b>	23 September 2006 at 1032 hrs	
<b>Location:</b>	Keevil Airfield, Trowbridge, Wiltshire	
<b>Type of Flight:</b>	Private	
<b>Persons on Board:</b>	Crew - 1	Passengers - None
<b>Injuries:</b>	Crew - 1 (Fatal)	Passengers - N/A
<b>Nature of Damage:</b>	Aircraft destroyed	
<b>Commander's Licence:</b>	BGA glider pilot's certificate	
<b>Commander's Age:</b>	67 years	
<b>Commander's Flying Experience:</b>	1,116 hours (of which 215 were on type) Last 90 days - 7 hours Last 28 days - 3 hours	
<b>Information Source:</b>	AAIB Field Investigation and information provided by the British Gliding Association

**Synopsis**

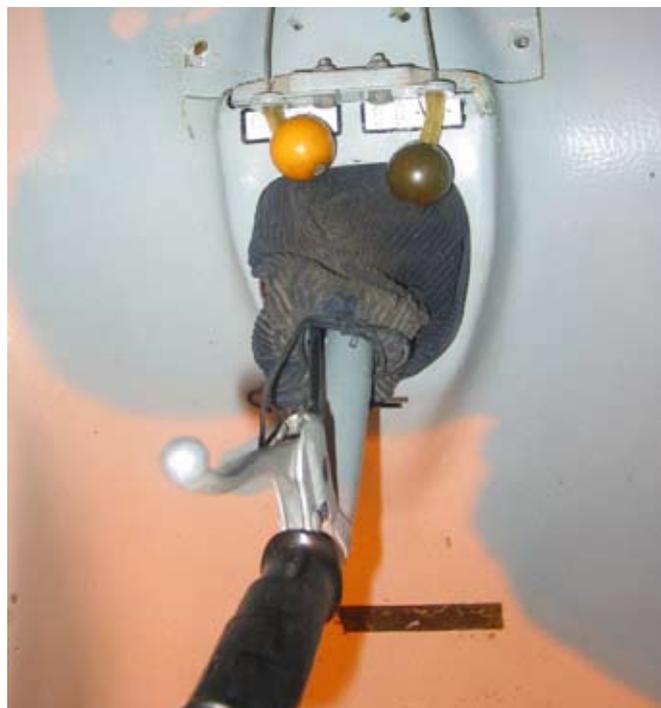
**Figure 2**

The cable release control was located to the left of the aircraft centreline, at the base of the instrument binnacle and ahead of the control column. An adjacent control, used to adjust the rudder pedals, was located just to the right of the aircraft centreline. The two control handles terminated in spherical knobs approximately 30 mm in diameter and were identical except that the cable release control was yellow and the rudder pedal adjustment control was brown (see Figure 2). Both controls were designed to operate when pulled. A more detailed description of these controls is given under the heading 'Additional information'. The Safety Member of the Gliding Club considered that during a winch launch there

was no need for a pilot to place his left hand anywhere other than on the cable release control.

Yellow cable release control on BGA 4354

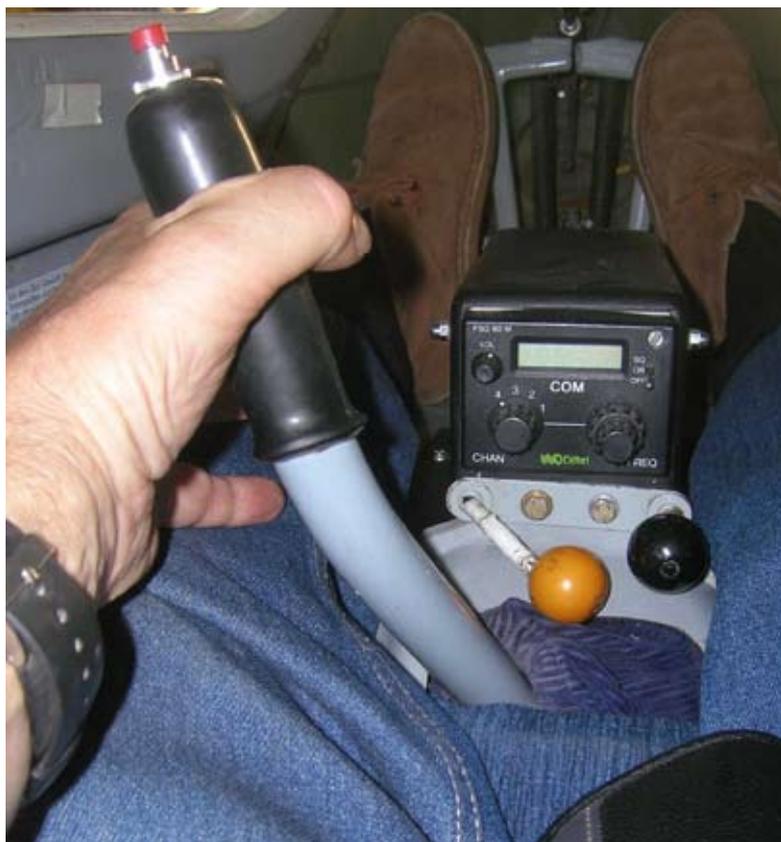
**Figure 5**

In Figure 5, the yellow cable release knob is only visible to the right of the control column because the control column is being held by the left hand, which would not usually be the case during the launch or in flight.

In order to release the cable in flight, with the control column deflected fully left, the pilot would need to reach around the front of the control column with his left hand and pull the release control at an angle to the control panel. The difficulty of reaching around the control column would require the pilot to apply this force using the strength of his wrist rather than through a direct pull using the strength of his arm. The shorter the length of protruding cable the greater the angle and the greater the problem. Additionally, whereas the pilot should ideally be able to grip the control with his full fist, a short protruding cable might inhibit the pilot from doing so.

Cable length is limited to prevent the knob fouling the control column (a problem which is reported to arise on some other glider types) and in the case of BGA 4354 it was approximately 15 mm (visible in Figure 2 and shorter than on the similar configuration ASW 19 shown in Figure 5). The Safety Member of the RAGSA considered that this combination of factors may have reduced significantly the pilot's ability to operate the cable release control in response to the right wing drop.

Cable release visible with full left control deflection
