SERIOUS INCIDENT

Aircraft Type and Registration:	Boeing 737-86N, SE-RHX	
No & Type of Engines:	2 SNECMA CFM 56-7B turbofan engines	
Year of Manufacture:	1999	
Date & Time (UTC):	9 May 2010 at 0034 hrs	
Location:	Vienna, Austria	
Type of Flight:	Commercial Air Transport (Passenger)	
Persons on Board:	Crew - 7	Passengers - 189
Injuries:	Crew - None	Passengers - None
Nature of Damage:	Left wing firewire failed insulation check, ruptured flexible duct on right air conditioning pack	
Commander's Licence:	Airline Transport Pilot's Licence	
Commander's Age:	50	
Commander's Flying Experience:	11,660 hours (of which 985 were on type) Last 90 days - 93 hours Last 28 days - 9 hours	
Information Source:	AAIB Field Investigation

Synopsis

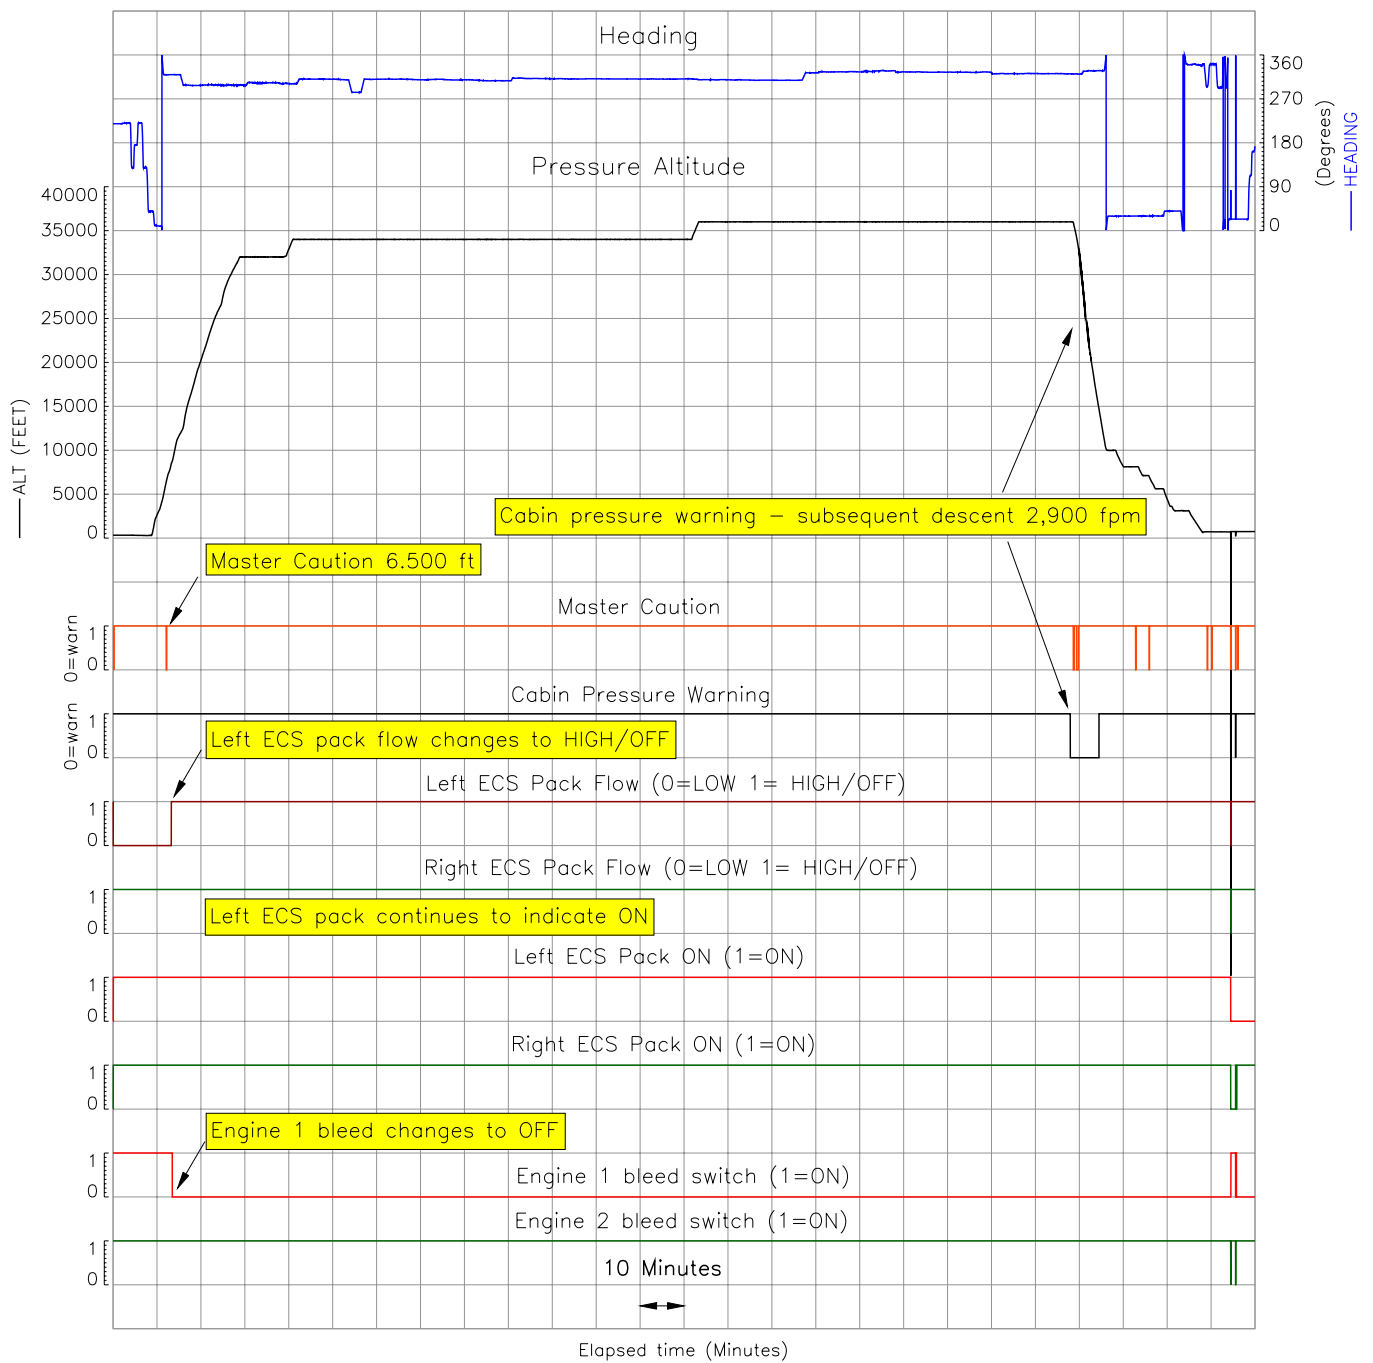
Figure 1
Salient FDR parameters (SE-RHX 9 May 2010)

FDR data was available for the entire flight, with the CVR record commencing one hour twenty minutes prior to the activation of the cabin pressure warning and ending shortly after the aircraft had landed. The CVR record did not include the time period when the left wing body overheat warning had occurred. In addition to the incident flight, the FDR also contained records of four previous flights and the subsequent positioning flight from Vienna to Lasham Airport. A time history of the relevant parameters during the incident flight is provided in Figure 1.

The takeoff was uneventful, but as the aircraft climbed through 6,500 ft, the master caution was activated. Shortly after, the number one engine bleed air switch was selected OFF, in accordance with the QRH left wing-body overheat procedure. The QRH procedure also required that the left air conditioning pack be selected OFF. The left pack flow mode parameter subsequently changed from the low flow to the high flow/off indication, as would be expected if the pack had been selected OFF, but the left pack on/off parameter continued to indicate that the left pack was still ON; a defect was subsequently identified in the left ECS, whereby the pack falsely indicated that it was ON when set to the OFF position.

During all six flights, the right pack had continually indicated that it was in the high flow mode, but this was later confirmed as being an indication fault.
