INCIDENT

Aircraft Type and Registration:	Lockheed L188C, G-FIZU	
No & Type of Engines:	4 Allison 501-D13 turboprop engines	
Year of Manufacture:	1960	
Date & Time (UTC):	19 March 2007 at 2350 hrs	
Location:	London Stansted Airport	
Type of Flight:	Commercial	
Persons on Board:	Crew - 2	Passengers - 1
Injuries:	Crew - None	Passengers - None
Nature of Damage:	Failure of propeller synchrophase unit	
Commander's Licence:	Airline Transport Pilot's Licence	
Commander's Age:	38 years	
Commander's Flying Experience:	3,625 hours (of which 1,075 were on type) Last 90 days - 60 hours Last 28 days - 15 hours	
Information Source:	AAIB Field Investigation

Synopsis

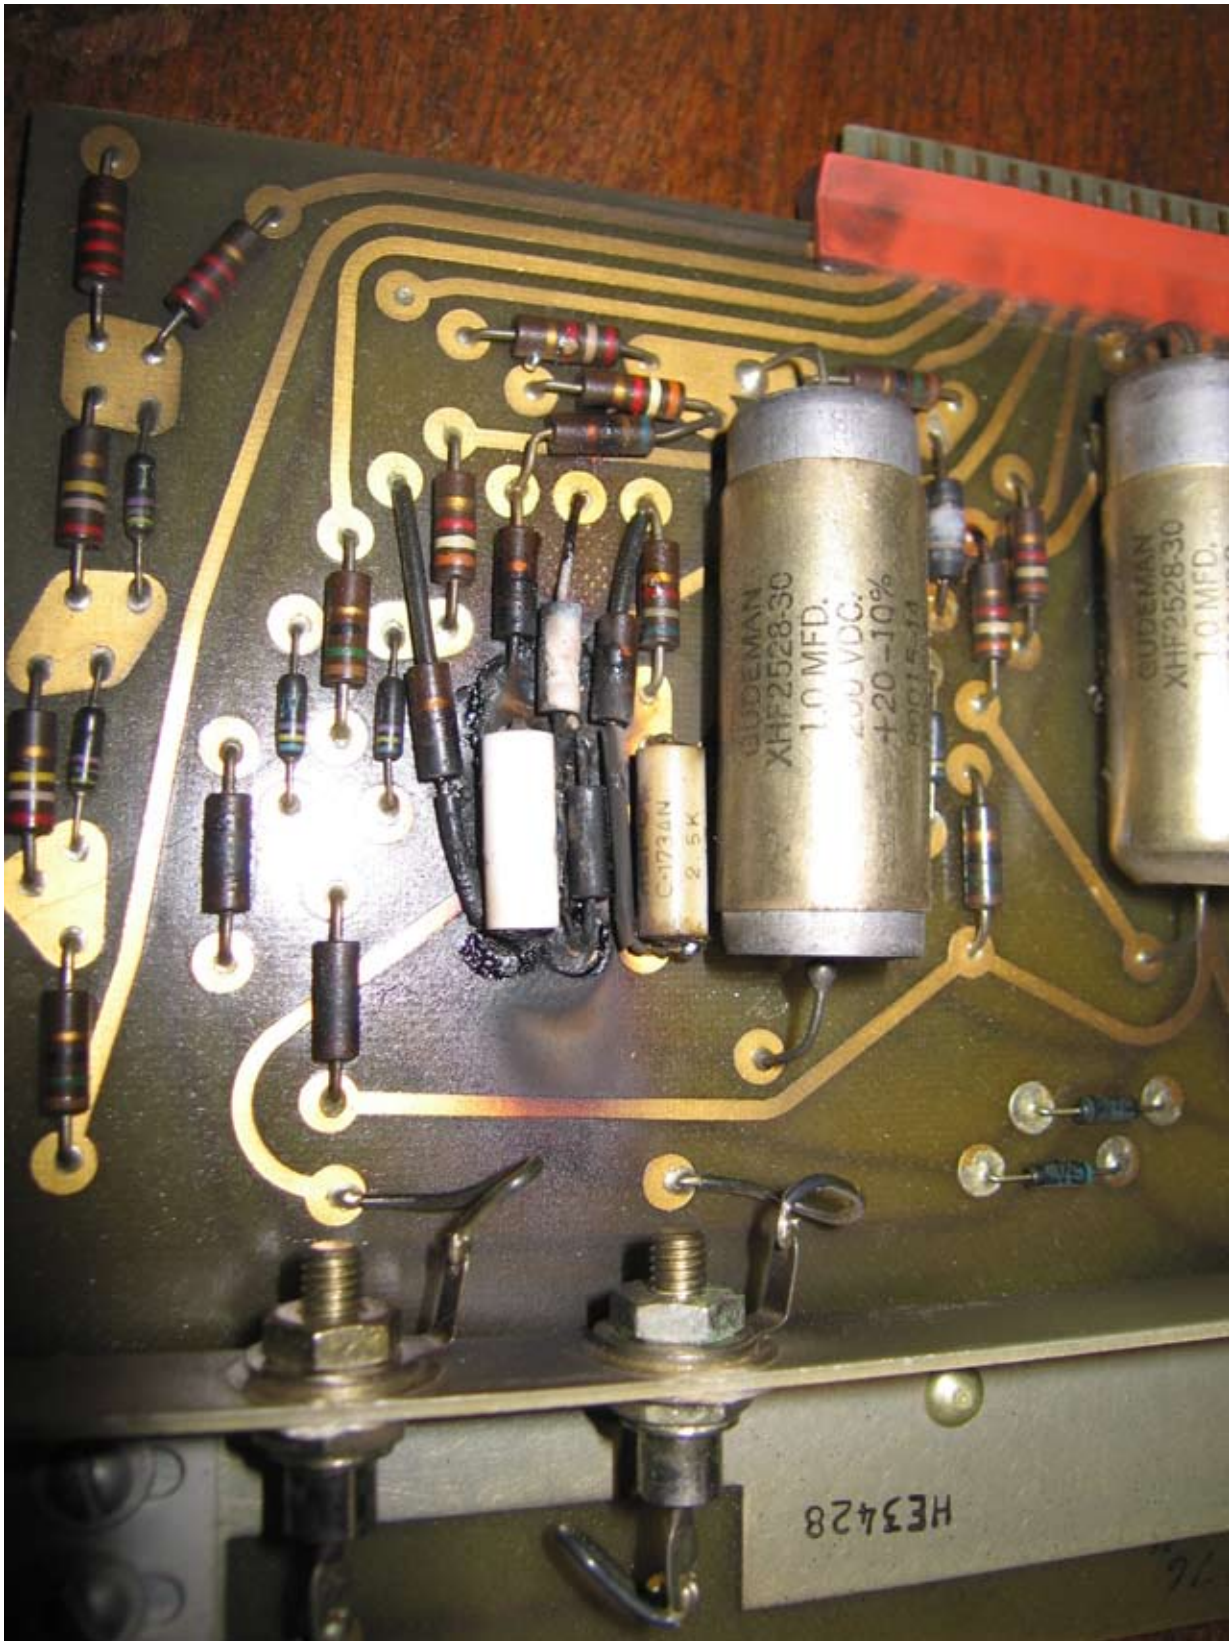
Figure 1

boards, a double synchrophaser board, a saw-tooth synchrophaser board, a speed derivative board and a power supply board. Examination of these circuit boards showed that several components within the power supply board had overheated, with one area showing localised burning of the board (see Figure 1). X-ray examination confirmed that several of the resistors had suffered a breakdown of their internal construction and that a resistor connector had melted and ‘shorted’ across several other connections within the board (see Figure 2). A review of the maintenance records for the component confirmed that the unit had recently been removed from G-FIZU due to the No 4 engine failing to follow the master engine. The unit had been inspected and the defect rectified prior to being returned to the operator in January 2007. The overhaul agency confirmed that the unit passed the post-rectification tests with no abnormalities and that no work was carried out on the power supply circuit board. Discussions with the National Transportation Safety Board of the USA and the engine and airframe manufacturers revealed that this type of unit had also been fitted to the Lockheed P3 Orion and early variants of the Lockheed C130 and L100 (the civil variant of the C130) but had been replaced in the 1980s by a solid state unit. It was confirmed that G-FIZU was the only remaining L188 Electra fitted with this type of synchrophaser unit. Due to the age and low number of these units remaining in operation, only one approved test facility existed worldwide and the damage to the circuits prevented testing of the unit to identify how the failures within the circuit board would have affected the functioning of the unit. The scale of the engine rpm gauges is such that relatively small variations in rpm would produce large movements of the gauge needle, as observed by the crew.

The cause of the incident was a failure within the power supply circuit board in the propeller synchrophaser unit. This caused significant power and rpm fluctuations on all four engines giving the flight crew difficulty in handling the aircraft. The No 2 engine exceeded its maximum governed speed which resulted in the fuel flow to the engine being cut back by its governor; this led the crew to believe that the engine had begun to run down and they shut that engine down. The remaining engines continued to fluctuate and, on final approach, the No 1 and 3 engines also appeared to run down, probably due to fuel being cut back after overspeeding.

The operator, in consultation with the UK CAA, has amended its procedures to include the checklist items specific for multiple propeller malfunctions on G-FIZU that had been erroneously omitted. They have also informed crews of the incident and of the revised procedures now in force so that they will be able to identify any reoccurrence in the future and take effective remedial action.

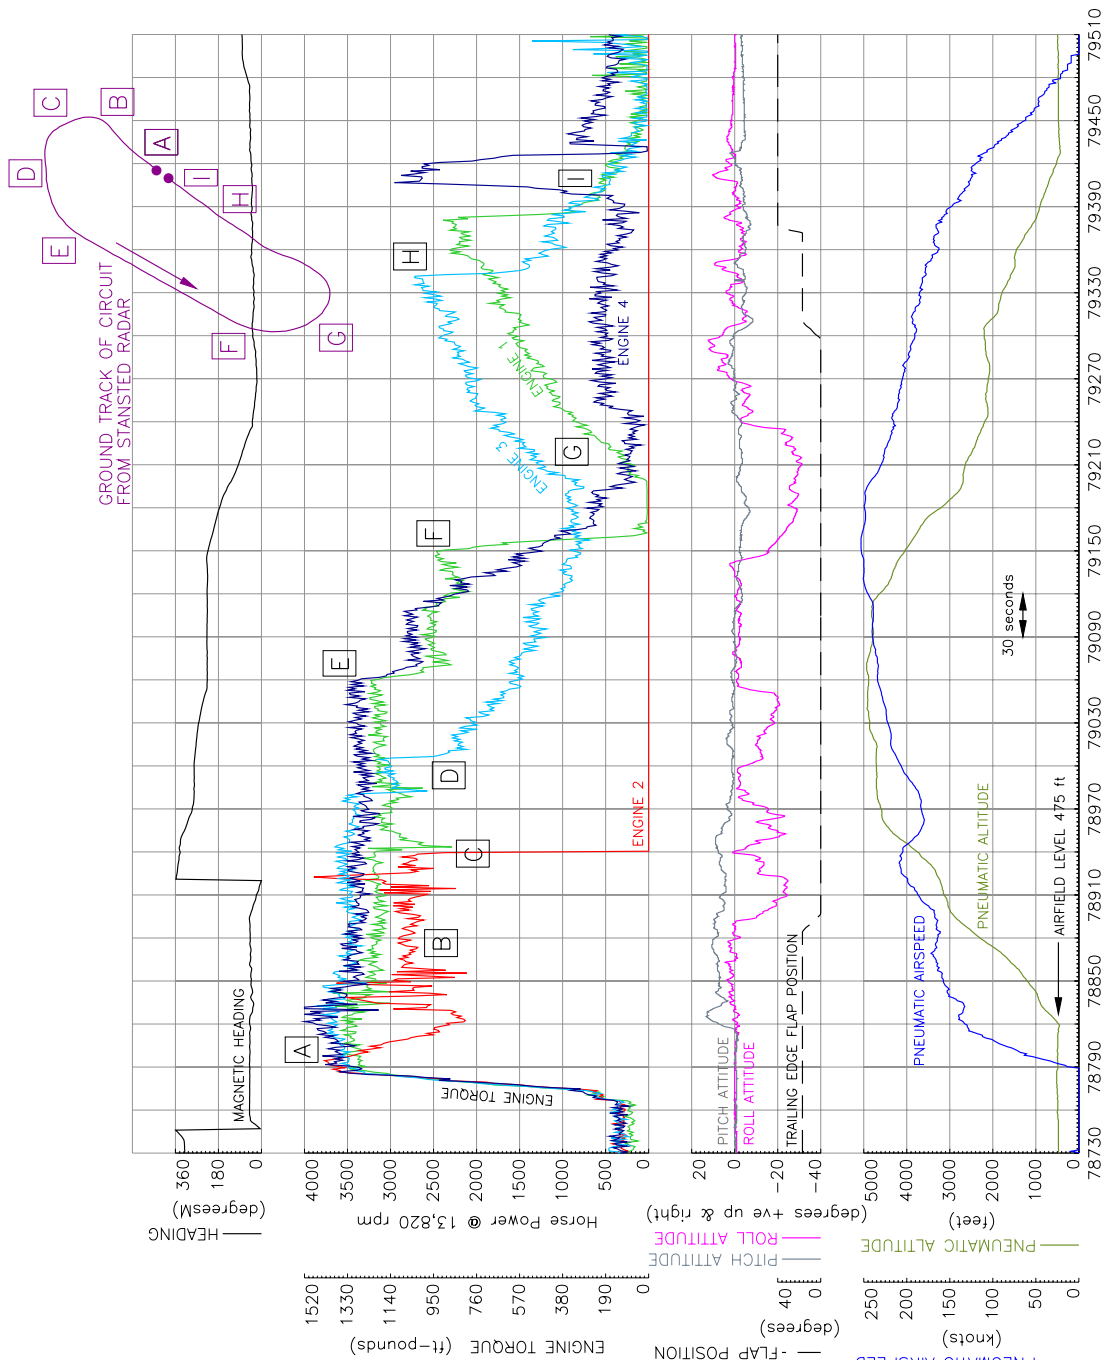
Figure 3
FDR Parameters

Of note from Figure 3 are the following points: **[A]** five seconds after the engines reached takeoff power, just as the aircraft started accelerating, the torque on engine No 2 fell, dropping to 60% of the takeoff level over 30 seconds, while the other engines' torques increased slightly. The torque on engine No 2 then recovered but appeared erratic for two minutes **[B]**, before the engine was shut down **[C]**. This was immediately

followed by a sharp drop in engine No 1 torque, before this recovered more gradually back to its original value. 30 seconds later **[D]**, the torque on engine No 3 reduced as the aircraft levelled off, and then reduced again to about 70% of the torque values of engines Nos 1 and 4. It then continued to reduce while the torque of engines Nos 1 and 4 remained nominally constant. G-FIZU, now downwind, then descended to 4,310 feet above aerodrome level (aal) as the engine No 1 and No 4 torques reduced **[E]**, while the engine No 3 torque continued to reduce. Just over halfway along the downwind leg, the torques of engines Nos 1 and 4 reduced further as the aircraft started its descent (at about 1,200 ft/min). However just as the aircraft began to turn on to base **[F]**, the engine No 1 torque fell rapidly to zero where it remained for over 30 seconds, during which time the descent rate increased to about 2,200 ft/min. Halfway around the base leg, the torques on engines Nos 1 and 3 started to increase **[G]**, with a split of about 350 lb.ft (900 HP) in favour of engine No 3, while the engine No 4 torque eventually levelled off at 190 lb.ft.

On the descent into Stansted **[H]**, at 1,130 ft aal and 180 kt airspeed, the torque on engine No 3 suddenly dropped from just over 1,000 lb.ft (2,700 HP) to about 380 lb.ft (1,000 HP) where it remained for just under 30 seconds, at which point the engine No 1 torque fell rapidly to the same level. G-FIZU was now at 510 ft aal with 160 kt airspeed. Both engine No 1 and No 3 torques continued to fall towards zero as the engine No 4 torque rose rapidly **[I]**, to over 950 lb.ft (2,500 HP) for the final stage of the approach to land. The landing and subsequent ground roll were uneventful.
