No: 1/86

Ref: EW/G85/10/06

Aircraft type and registration: Cessna 172 G-BEUX (light single engined fixed wing aircraft)

Nature of damage: Flap retraction cable failed

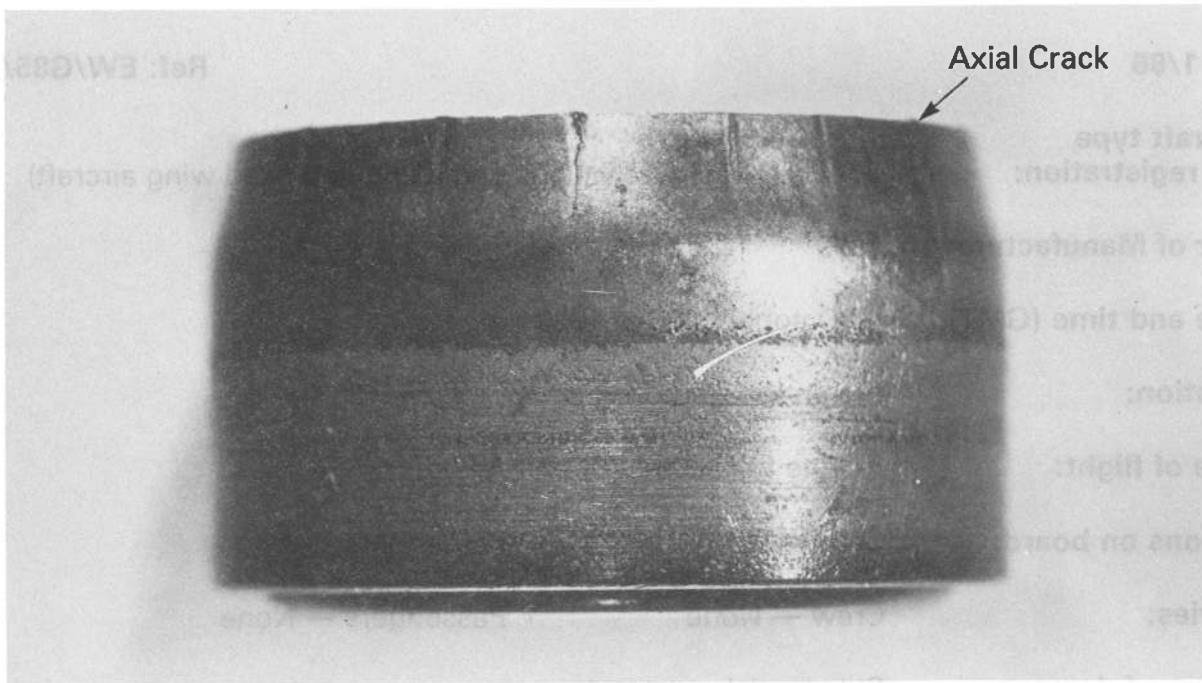
Examination of the matching roller assembly from the starboard flap of this aircraft showed that it was also in the process of breaking up.

1. Roller Assembly Pt No 0523420 from Starboard Flap. Showing axial fatigue cracks and reduction of diameter.

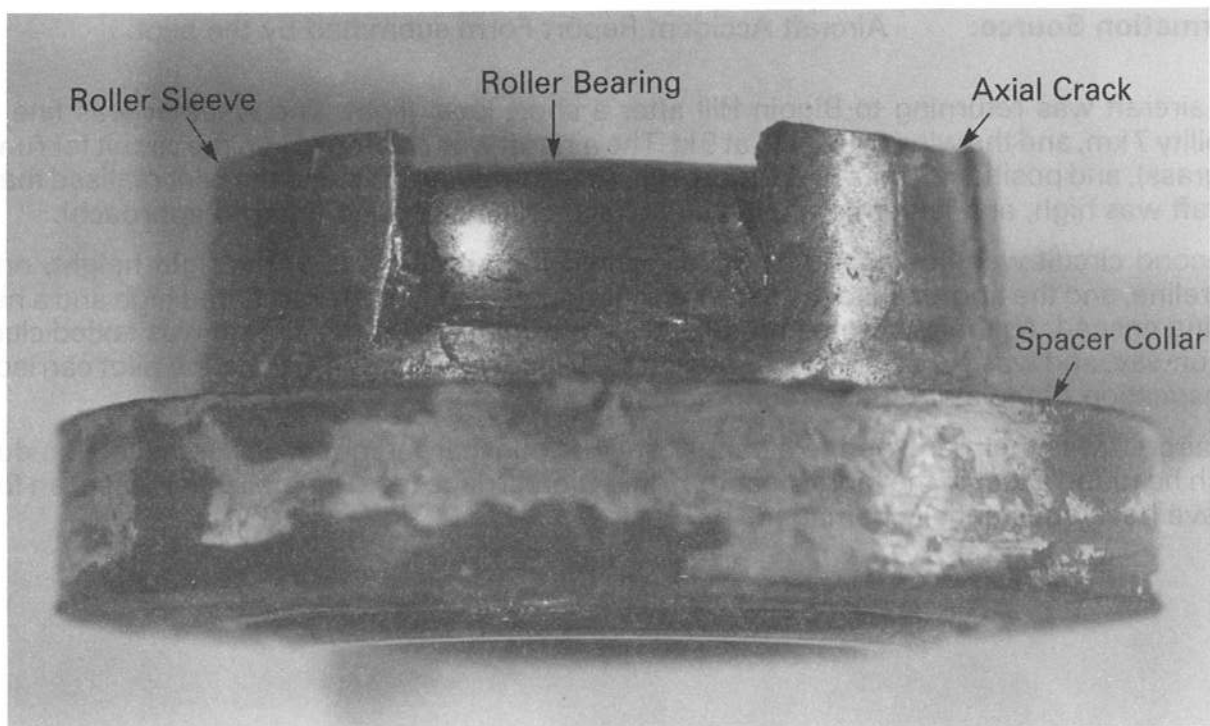
Subsequent examination revealed that the roller bearing assembly (Part No 0523420) on the port outboard aft flap attachment had broken up due to fatigue. This had resulted in severe wear of the

upper lip of flap track slot and ultimately in segments of the roller sleeve breaking off and jamming between the roller and slot. This jamming resulted in overload failure of the "Flap Up" drive cable to the port flap which was then left free to be blown back to the "Full Flap" position.

2. Roller Assembly from Port Flap with nylon spacer collar fitted (Pt No 1220114-2). Showing loss of segment of sleeve between axial cracks.
